Topping Off Diesel Exhaust Fluid

Topping Off Diesel Exhaust Fluid	1
AutoStop Active during Low-Speed Maneuvers	2
Multi-Media Interface Tester Tool Update	3
Truck and Snow Plow Headlamp Flicker	3
Avoid Turbocharger Damage during Service Work	4
Service Know-How	4

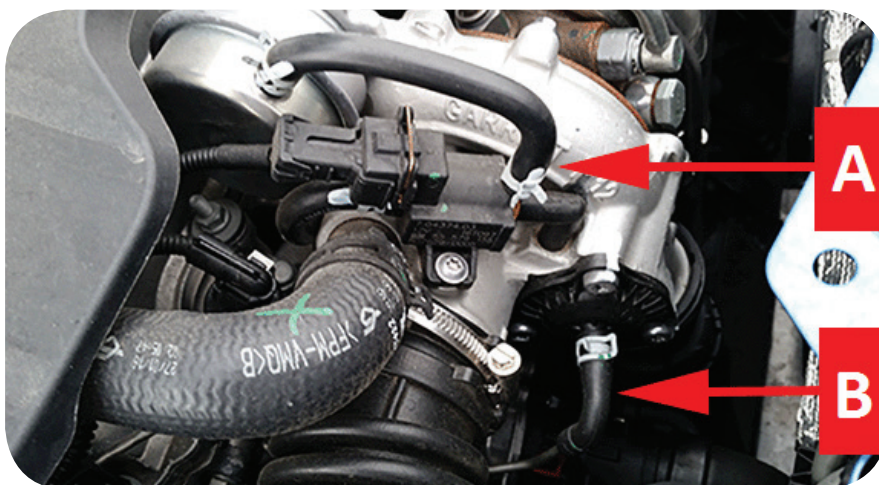
Wastegate actuator solenoid vacuum port fitting (A) and bypass valve port fitting (B)

Recently, turbochargers returned under warranty have had damage to the wastegate actuator solenoid vacuum port fittings and bypass valve port fittings. Service parts are available for the bypass valve, wastegate solenoid and wastegate actuator in kits.

Do not replace the turbocharger assembly for damage to these components.
