## NEW WEBSITES AND ROLES FOR GM Dealer Services and GM Dealer Equipment

# Loose ECM-TCM Ground Connection

GM TechLink is published for all GM retail technicians and service consultants to provide timely information to help increase knowledge about GM products and improve the performance of the service department.

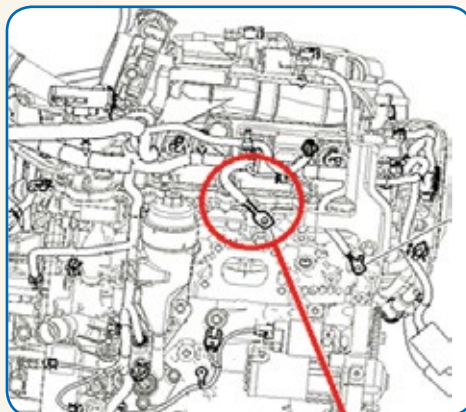
Ground G104 location

Some 2017 Colorado and Canyon models equipped with the 3.6L engine (RPO LGZ) may have an intermittent no crank condition. There may be a loss of communication with the Engine Control Module (ECM) and Transmission Control Module (TCM), the ignition key may be stuck in the ignition cylinder, and a dead battery.

The following DTCs also may be set: P018C, P0449, P0452, P0463, U0101, U0100, U0401, U0121, U0131, U18A2, P0522, P16E5, or P0118.

These conditions may be caused by a loose ECM-TCM ground (G104) on the driver's-side cylinder head. Inspect G104 for a loose connection.

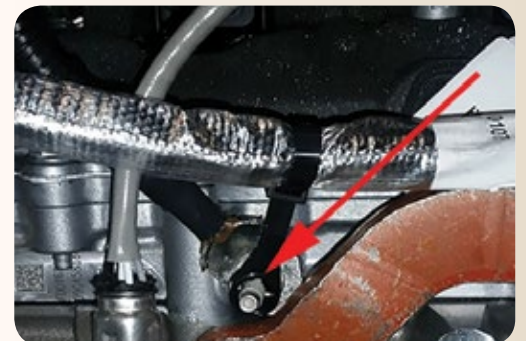
Loose ground connection

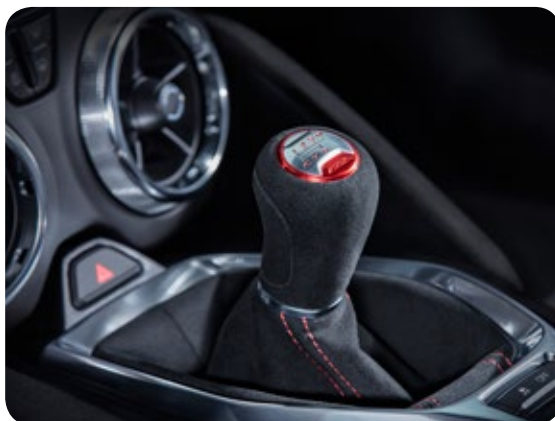
ZL1 manual transmission

The 2017 Camaro ZL1 with a manual transmission (RPO MJK) may have a vibration condition during deceleration in 6th gear. Drivers may feel the vibration in the floor, seat, console and steering wheel.

The vibration is most noticeable at speeds from 70 to 60 mph. Using a Pico scope (CH-51450) will show a vibration at 46 Hz.

The vibration will only be present in 6th gear on deceleration with the clutch pedal not applied. If the clutch pedal is depressed and the condition is not present, the cause may be related to the transmission main shaft. A repair is currently being developed. Do not attempt any repairs at this time.

If the clutch pedal is depressed and the vibration condition remains the same or is present in 5th gear during the same speed range, continue with diagnosis following the appropriate Service Information.

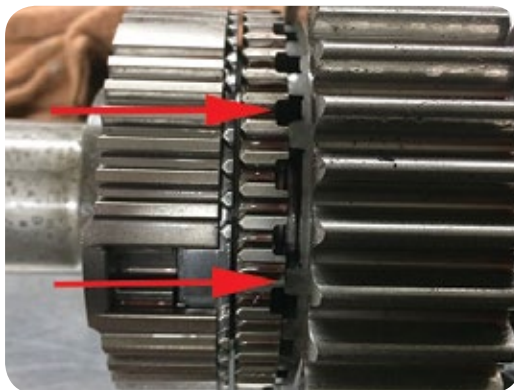
If no power is transmitted to the front axle in 4WD on some 2015-2017 Silverado 4WD and Sierra 4WD models (RPOs NQF, NGQ), the transfer case front output shaft drive sprocket body ring may be separated. The transfer case must be in the 4WD mode with the 4WD indicator light on in the transfer case select knob (NQF) or on the instrument cluster (NQG).

Body ring separated from the transfer case front output shaft drive sprocket.

If the front propeller shaft can be rotated independently of the rear, the disconnect may be in the transfer case. Check that the body ring that the synchronizer engages has not separated from the transfer case front output shaft drive sprocket. The ring is a press fit and should not separate from the gear. If it is separated, replace the transfer case front output drive shaft sprocket as needed.
