## Misdiagnosis of Returned Turbochargers

All turbochargers that are returned to the Warranty Parts Center (WPC) are inspected by GM Engineering for root cause failure. Many of the turbochargers from 2011-2016 Cruze, 2012-2018 Sonic, 2013-2018 Encore, and 2014-2018 Trax models equipped with the 1.4L turbocharged engine (RPO LUV, LUJ) being returned have no trouble found.

### CONTENTS

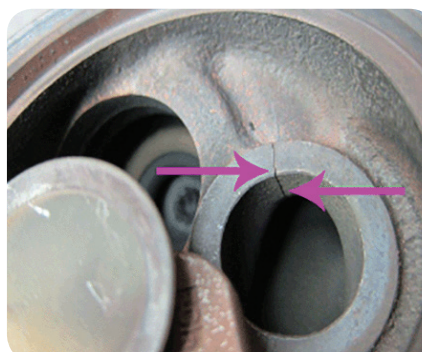
- Crack(s) at the wastegate port (this is normal)
- Broken wastegate solenoid valve port (replace solenoid valve)
- Bent wastegate actuator port (replace actuator)
- Missing wastegate actuator clip (replace clip)

Normal wastegate port crack

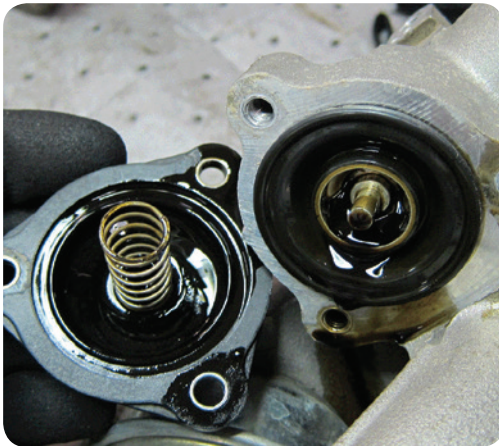
- Tamper paint have been removed, the seal broken, or the actuator has been adjusted
- Broken bypass (recirculation) valve cover port or water/oil found inside the valve (clean the components)
- Restrictions in the induction system
- Soft, twisted or collapsed air ducts
- Restrictions to air flow to the turbocharger
- Excessive exhaust system backpressure

Oil inside bypass valve

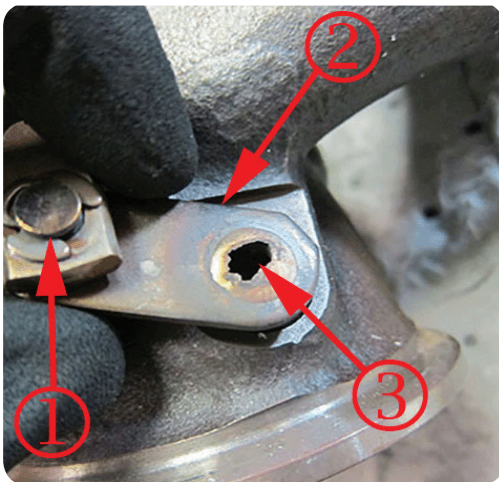
1. Wastegate lever arm pin  
2. Wastegate lever arm (crank)  
3. Shaft

- Disconnected wastegate lever arm (crank) from the shaft
- Seized wastegate valve/linkage
- Turbine wheel not rotating, broken turbine wheel shaft, or missing wheel nut

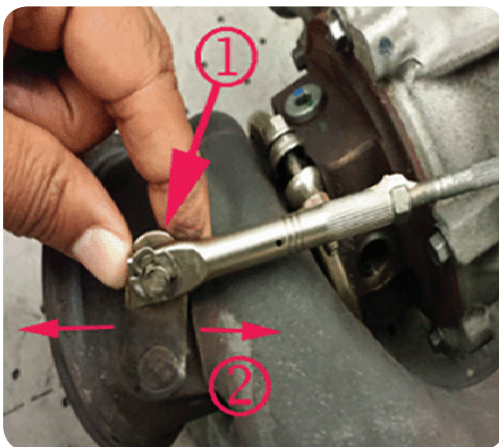
Wastegate lever arm (1) movement direction (2) with insufficient preload

If the wastegate lever arm moves or wiggles with little effort while the actuator rod remains static, the preload is insufficient and the turbocharger must be replaced. This insufficient preload condition applies to 2011-2012 models with original equipment turbochargers. The wastegate actuator design was updated for the 2013 model year.

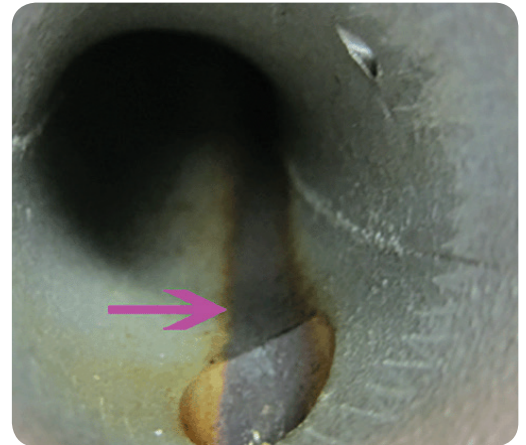
Normal oil staining in the turbocharger outside air inlet

In addition, remove the turbocharger rubber outside air inlet duct (there will be normal oil staining in the turbocharger outside air inlet) and inspect the inlet tube for oil leaking into the opening of the turbocharger bore for the PCV bypass hose. Also check the turbocharger oil feed and return pipe for leaks, restrictions or damage.

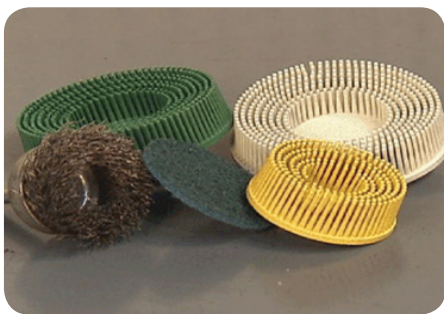
Examples of surface conditioning discs

- Abrasive pads will produce fine grit that the oil filter will not be able to remove from the oil. This grit is abrasive and may cause internal engine damage. Abrasive pads can easily remove enough material to round cylinder head surfaces, which

can affect the gasket's ability to seal, especially in the narrow seal areas between the combustion chambers and coolant jackets.

- Abrasive pads, wire, and rubber finger wheels can remove enough metal to affect cylinder head, block, oil pan rail, and intake manifold runner flatness, which can cause coolant and oil leaks and air leaks. It takes about 15 seconds to remove 0.203mm (0.008 in.) of metal with an abrasive pad.
- Abrasive pads, rubber finger wheels and wire wheels with high-speed grinders produce air-borne debris that can travel throughout the shop and contaminate other work being performed outside of the immediate work area.

When using surface conditioning discs that contain abrasives, aluminum oxide (a common component of sandpaper) is dislodged from the disc along with metal particles from the engine component. Even the finger-type discs, which don't appear to have any type of abrasive material, contain aluminum oxide. The presence of aluminum oxide in engine oil has been shown to cause premature engine bearing failure, in some cases, in as little as 1,367 miles (2,200 km) or less after the repair has been made.

GM recommends the use of a razor blade or plastic gasket scraper to clean the gasket surface on engine components that are to be reused. When using a razor blade-type gasket scraper, use a new razor blade for each cylinder head and corresponding block surface. Hold the blade as parallel as possible to the gasket surface to ensure that the razor blade does not gouge or scratch the gasket surfaces. Do not gouge or scrape the combustion chamber surfaces or any engine-sealing surface during the cleaning process.

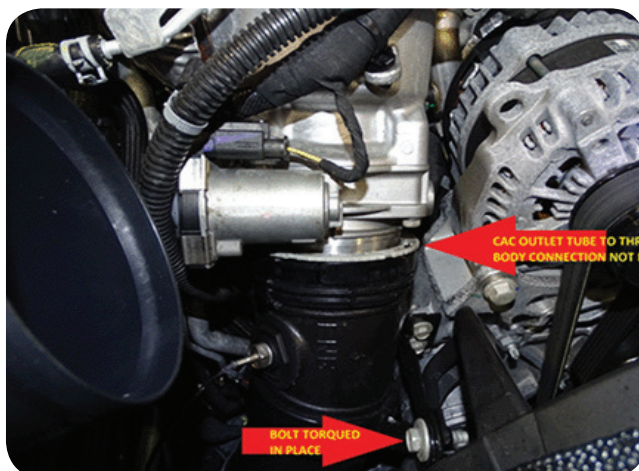
If any of the DTCs are set, check for loose charge air cooler ductwork at the turbocharger outlet pipe, the charge air cooler inlet pipe, the charge air cooler outlet pipe, and the connection at the intake air flow valve (throttle body). The loose ductwork is most likely to become disconnected during engine roll or brake torque.

Charge air cooler pipe at the intake air flow valve

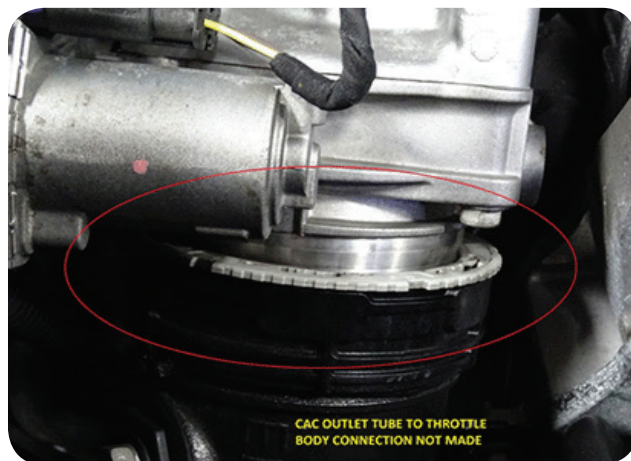
Loose connections of the charge air cooler ductwork on some 2017 Silverado and Sierra models equipped with the 6.6L Duramax diesel engine (RPO L5P) may result in an illuminated Check Engine light and DTCs P0101, P0299, P11CC, P11DC, P20EE, P2002 and/or P2463 set.

Non-secured connection of the charge air cooler pipe.

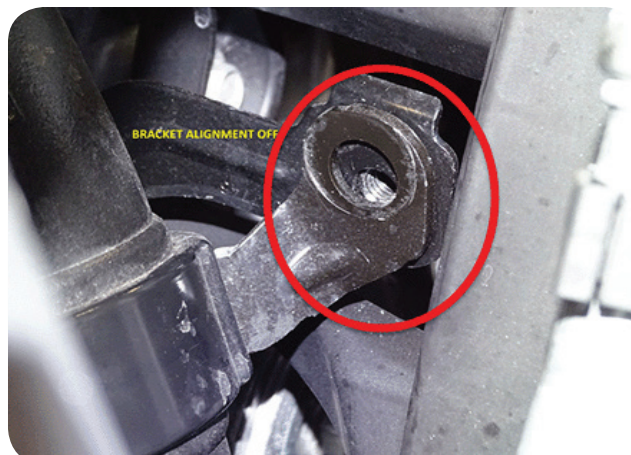
Charge air cooler pipe bracket and bolt hole misalignment

Also check for proper alignment of the charge air cooler pipe bracket and bolt hole. The bracket and bolt hole may require realignment after the charge air cooler outlet hose is properly connected to the throttle body.
