SPID Label Content Now Included with Certification Label

SPID Label Content Now Included with Certification Label	1
Proper Oil Filter Use on the 1.4L Engine	2
Programming a Replacement OnStar Module	3
Mark of Excellence Q3 Test on Center of Learning.	4
Lack of Performance in High Ambient Temperatures	4
Fuel Odor or Leak from Underhood Fuel Feed Pipes	5
Service Know-How	5

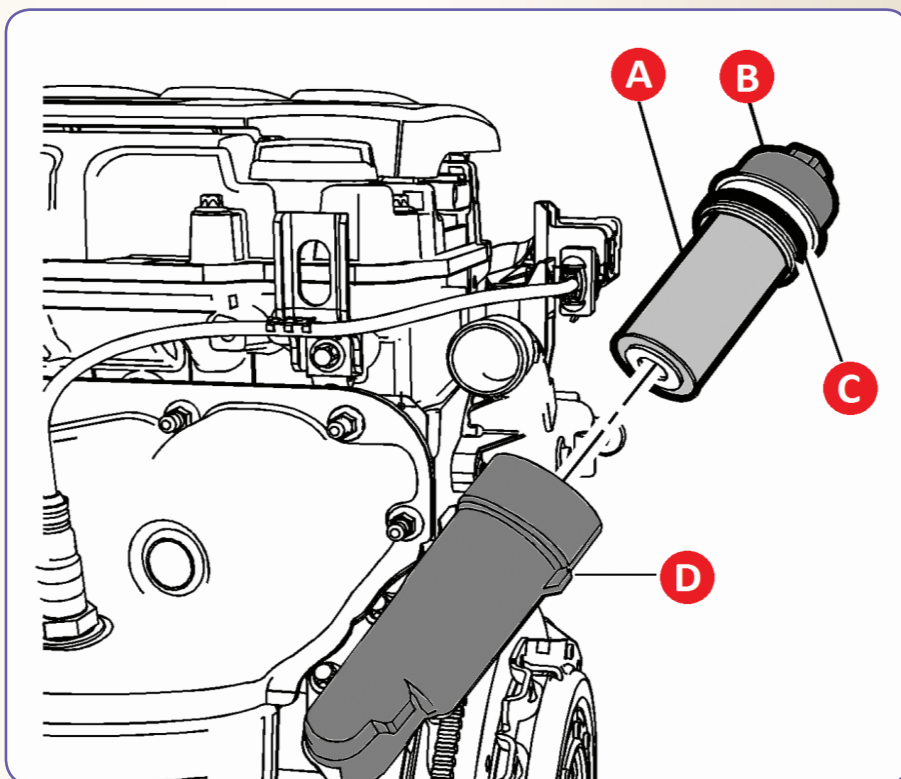
Two different suppliers provide the oil filter housing assembly for the 1.4L engine. Each housing assembly requires a different oil filter. The correct oil filter must be used based on the oil filter housing assembly application.

- A. Oil filter element
- B. Oil filter cap
- C. Oil filter cap seal ring
- D. Oil filter housing assembly

Use the VIN to identify the correct vehicle in the electronic parts catalog (EPC). For part number and usage, see Filter Kit, Oil in Group 01.836 in the EPC.

TIP: Install a new oil filter cap seal ring at each oil change. Ensure the oil filter cap is completely seated on the oil filter housing assembly. If not completely seated, an oil leak may occur. Do not overtorque the oil filter cap.

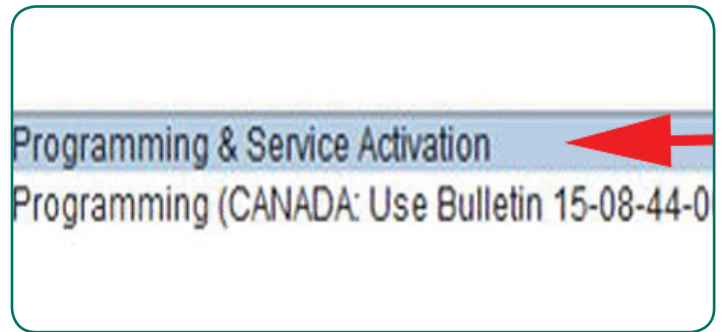
Do not select Canada bulletin programming.

- U.S. dealerships should not select the TIS2Web selection that refers to Canadian upgrade bulletin #15-08-44-001 on a vehicle that has not had the Canadian upgrade performed. Programming and Service Activation should be selected.

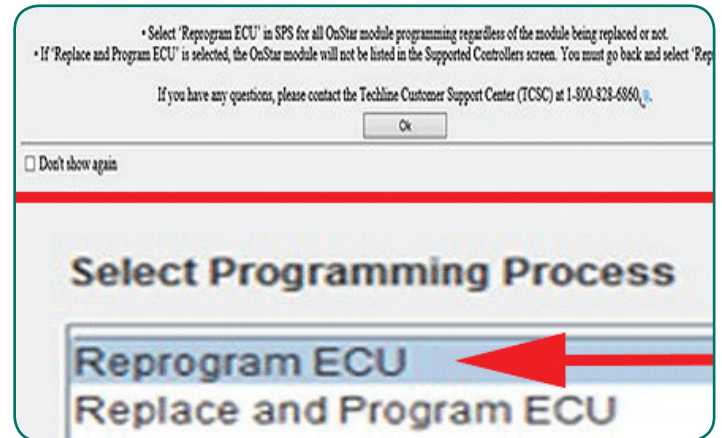
Select Reprogram ECU when launching TIS2Web.

- Select the Reprogram ECU option at the start of TIS2Web programming. Do not select the Replace and Reprogram ECU option.
- Do not select the OnStar Wi-Fi Enable (Gen 10 only) Programming procedure until the TIS2Web Programming and Service Activation procedure has been completed (RPO VV4 only).

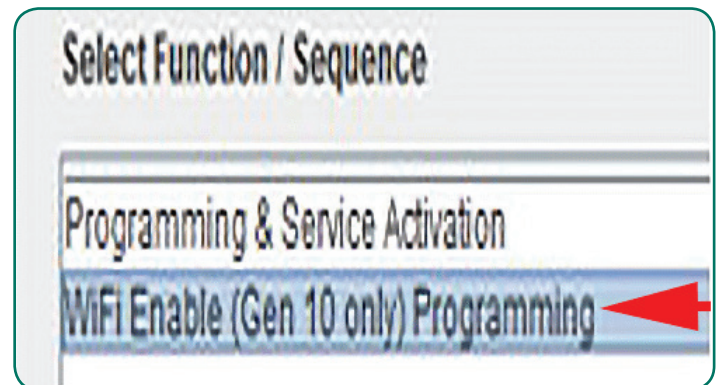
Do not select OnStar Enable Programming until after Programming and Service Activation is completed.

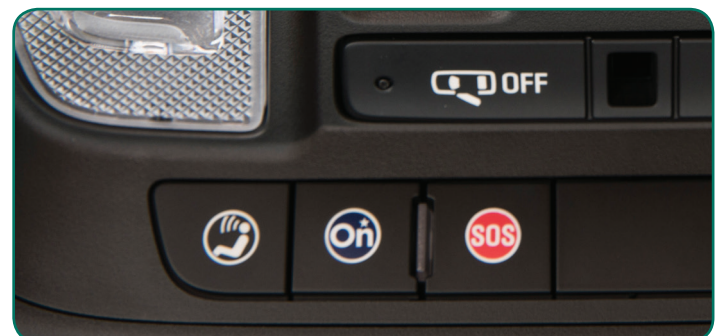
Press the blue OnStar button to confirm proper operation after programming if required in the Service Information procedure.

- Press the blue OnStar button to call OnStar and confirm proper operation once the TIS2Web Programming and Service Activation procedure has been completed if required in the Communication Interface Module Programming and Setup procedure. To ensure that OnStar receives everything from TIS2Web needed to confirm proper operation, wait at least five minutes with the vehicle in an area with a clear view of the sky before pressing the blue OnStar button.

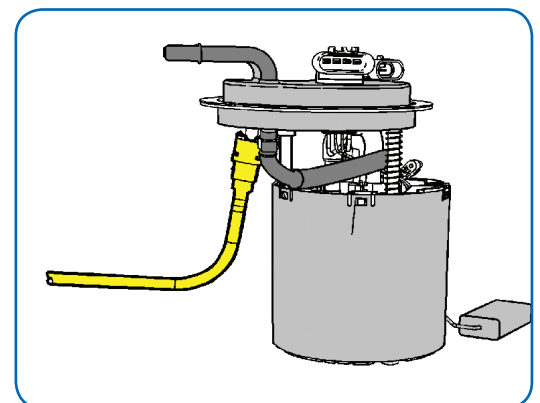
Fuel pump module

Some 2013-2017 GM models may have a lack of performance in excessively hot and sustained ambient temperatures over 100° F (37.7° C) due to vapor buildup in the fuel feed line. DTCs P2635 (Fuel Pump Flow Performance) and P018B (Fuel Pressure Sensor Performance) may be set.

If the vehicle has not had a fuel pump replaced, refer to #PIP5411 for additional diagnostic information. It may be necessary to replace the fuel tank fuel pump module assembly.

If the vehicle has had a fuel pump replaced, advise owners to use fuels with an octane rating higher than 91 and to refrain from periods of extending idling, if possible.

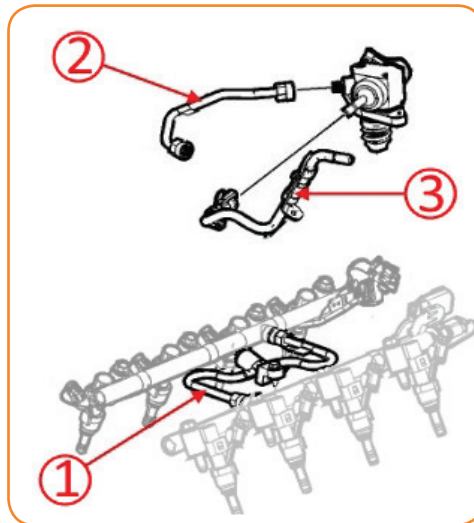
A fuel odor or fuel leak in the front of the vehicle may be noticed on some 2016-2017 CTS, Camaro; 2015-2017 Escalade/ESV, Tahoe/Suburban, Yukon/XL, and Corvette models equipped with a V8 engine (RPOs LT1, LT4, L83, L86) and 2014 Silverado 1500 and Sierra 1500 models equipped with a V6 or V8 engine (RPOs LV1, LV3, L83, L86). A fuel leak may be found around the bellhousing or valve lifter oil manifold (VLOM).

These conditions may be caused by a fuel leak at one of the high pressure fuel rail pipe connections that was incorrectly installed during service of another engine component that required the fuel system to be opened, such as fuel rails, fuel injectors, high pressure fuel pump, etc.

1. Fuel feed intermediate pipe
2. Fuel feed intermediate pipe
3. Fuel feed pipe

If any of these conditions are found, find the fuel leak by installing dye, P/N 88861206 (in Canada, P/N 88861259), into the fuel system via the fuel filler neck. Idle the engine for 15 minutes and then remove the intake manifold and inspect for leaks.

Tightening a nut is not an approved procedure. If a leak is found at any nut location, follow these procedures:

- Leak in pipe 2 – change only pipe 2 (intermediate pipe 2)
- Leak in pipe 1 – change pipe 1 and pipe 2 (intermediate pipe 1 and 2)
- Leak in pipe 3 – change only pipe 3 (fuel feed pipe).

Ensure that all interfaces are clean and free of debris before installing. After installing the new pipes, idle the engine for three minutes and recheck for leaks.

Replace the engine insulator if it absorbed fuel or emits a fuel odor.
