October 2017, Volume 19, No. 19

Intake Rocker Arm Oil Control Valve Components

Forward Collision System Reduced Message

UPDATE: Loose Charge Air Cooler Ductwork

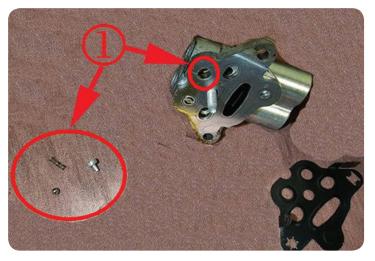
Some 2014-2015 Impala (VIN 1) and Malibu models equipped with the 2.5L engine (RPO LKW) may have several driveability conditions, such as a surge, rough idle, or misfire. The engine may misfire on cylinders 1 and 2 or cylinders 3 and 4. DTCs P0101 (MAF Sensor Performance), P0106 (MAP Sensor Performance), P0171 (Fuel Trim System Lean) or P0300 (Engine Misfire Detected) also may be set.

Valve with missing components

If any intake rocker arm oil control valve components are missing, replace the intake rocker arm oil control valve and the camshaft cover. The camshaft cover must be replaced because some components may have become lodged in the camshaft cover oil passages.

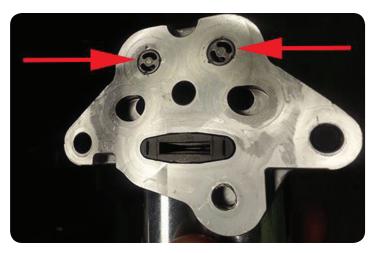
Valve with all components in place

If the intake rocker arm oil control valve is not missing any components, only replace the intake rocker arm oil control valve.
