## Coaxial Cable Repair Kit Now Available

## Remanufactured V6 Engine Misfire

# Pop Sound from Front Suspension Area while Making Turns

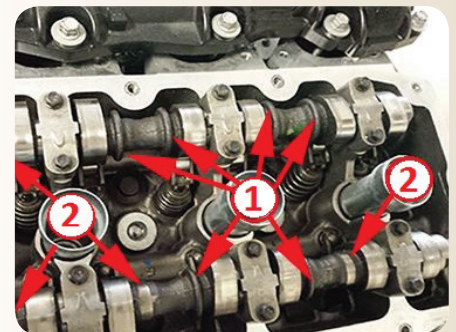
An engine misfire may be found on some GM remanufactured 2.8L, 3.0L and 3.6L High Feature V6 engines immediately after installing the engine. The misfire is usually limited to one bank or one cylinder, often cylinder 5 or 6.

If the misfire condition is present, it may be caused by the wrong camshaft installed in the engine at the remanufacturer's facility.

Ring strategy camshaft identification is a series of rings along the camshaft that are either simply cast on the camshaft or machined down. There are five rings on each camshaft, which can be identified by the order in which the machined or cast rings are on the camshaft.

1. Cast ring  
2. Machined ring

Inspect the camshafts to ensure the correct camshaft is installed in each intake and exhaust position by comparing the ring strategy to either the engine that was removed (recommended) or to the charts included in #PIP5528.

If the wrong camshaft is installed, either replace the camshaft with the same one from the original engine if undamaged or with a new camshaft. It is not necessary to replace the engine.

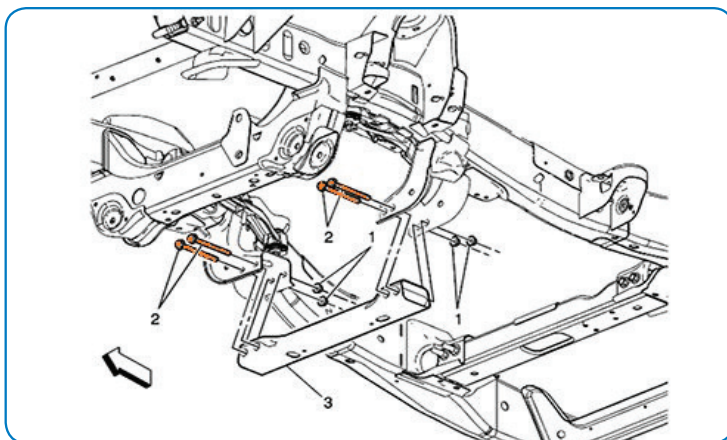
Some 2015-2018 Escalade, Silverado, Suburban, Tahoe, Sierra and Yukon models may have a clicking, popping, or cracking sound coming from the front suspension or front frame area while the vehicle is making turns. The sound also may be felt in the foot-well area.

The sound may be caused by either insufficient torque of the front frame crossmember or lower control arm bolts.

Front frame crossmember bolts

To correct the sound coming from front frame crossmember, loosen and re-torque the four crossmember bolts to 70 Nm (52 lb.-ft.) on the first pass, followed by 110 degrees on the final pass.

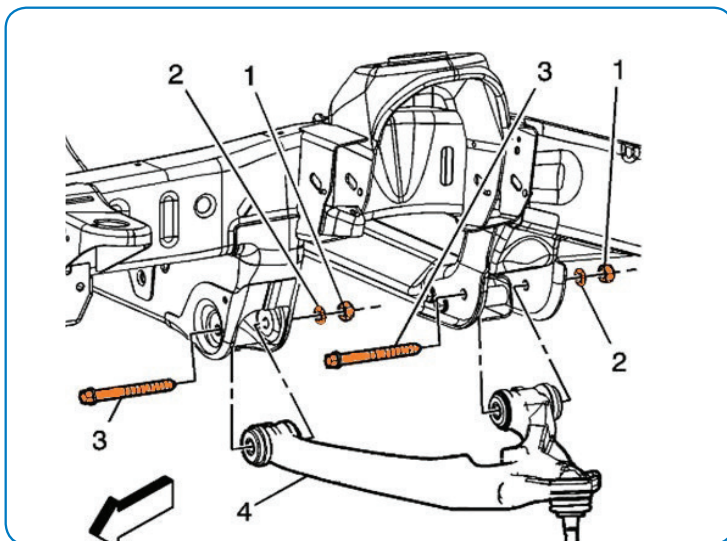
Front lower control arm bolts

To correct the sound coming from the front lower control arm, loosen and re-torque the four lower control arm bolts to 175 Nm (129 lb.-ft.).

**TIP:** If the front lower control arms nuts and washers are removed, the directional washers must be installed in the same direction as they were removed.
