## Instructional Videos and Active Website Links Now Included in GM Service Information

# Rear Differential Clutch Module Corrosion

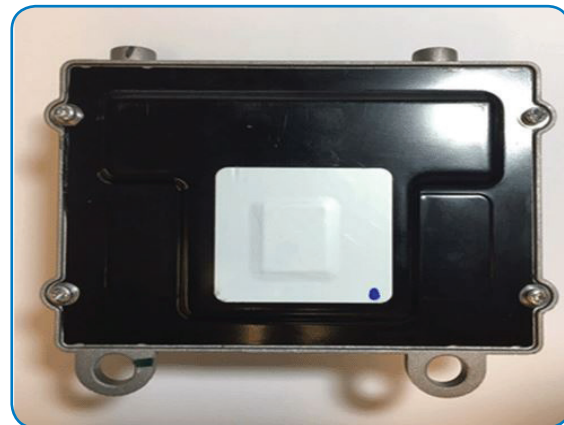
Some 2013-2018 Encore and 2014-2018 Trax models equipped with full-time All-Wheel Drive (AWD) (RPO F46) may display an illuminated Malfunction Indicator Lamp (MIL) and/or a Service AWD message on the Driver Information Center along with a loss of power steering assist, a dead battery and a loss of communication on the high-speed LAN. DTCs C0800 (Device Power 1 Circuit Voltage) and U0136 (Lost Communication With Differential Control Module - Rear) also may be set.

These conditions may be caused by corrosion of the Rear Differential Clutch Module (RDCM) at the seam between the base plate (black) and the top housing (grey), which may include the connector and the four screws.

Look for corrosion between the base plate and the top housing.

If corrosion is found, replace the RDCM and inspect the associated wiring and connector. Only 3% of vehicles have been found to have a corroded RDCM connector, so do not replace the RDCM wiring harness if there is no evidence of corrosion in the connector.

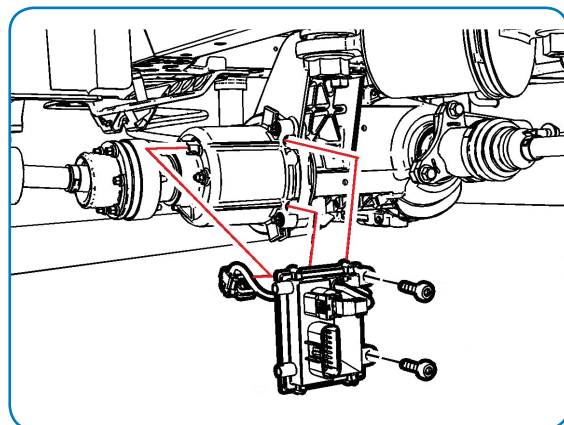
RDCM location on the rear axle

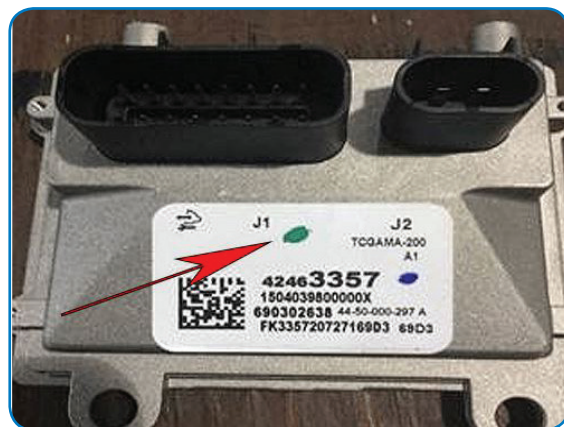
Only install a new module with a green dot on the part label.

The replacement RDCM is part number 42463357. Inspect the replacement RDCM for the presence of a green dot on the part label.

- If the replacement RDCM has a green dot, install and program it following the appropriate Service Information instructions.
- If the replacement RDCM does not have a green dot, order a new part. Do not install a new RDCM that does not have a green dot on the part label.

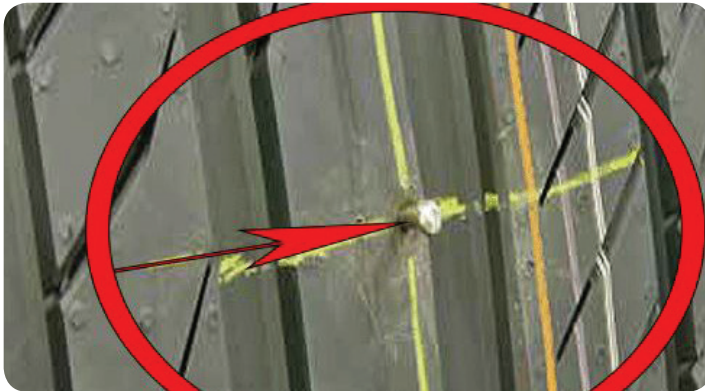
Puncture in tire tread

First, identify the location of the object that has punctured the tire in the tread area. If the tire can be repaired, the quiet foam must be removed prior to sealing the puncture.

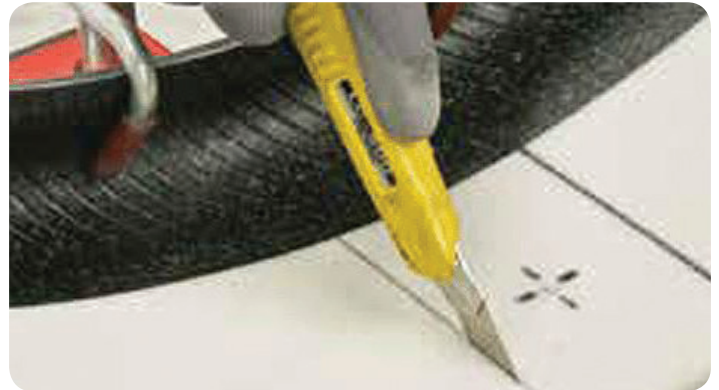
Remove a piece of foam 101 mm (4 inches) wide.

In the punctured tread area inside the tire, remove a piece of the quiet foam, 101 mm (4 inches) wide, across the whole section of foam. Do not discard the piece of foam.

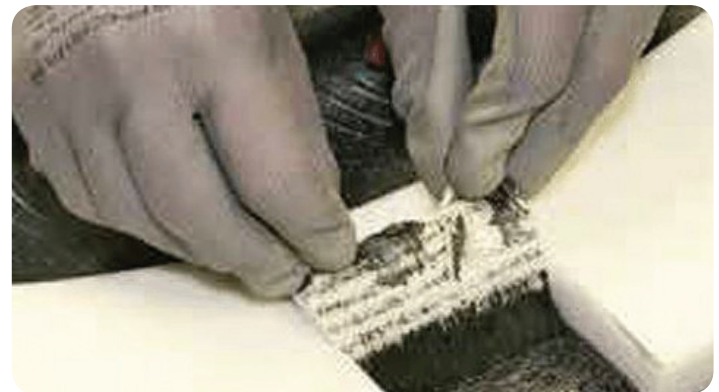
Remove the foam to make the tire repair.

Be sure to remove the foam without damaging the inner liner surface. Additional buffing may be needed to completely remove the foam adhesive from the inner liner surface.

After the tire repair has been made, reinstall the foam piece using the cement that was used to plug the puncture.
