Close TAC Cases Using the Dealer Case Management System

Close TAC Cases Using New DCM System	1
Normal Tailgate Cable Slack	2
Download Latest AFIT Software Update. . .	3
Transfer Components when Installing Seat Frame.	4
Reconnect Fog Lamps after Accessory Installation	5
6.2L V8 Charge Air Cooling System Draining	6
Service Know-How	6

Customer Care and Aftersales

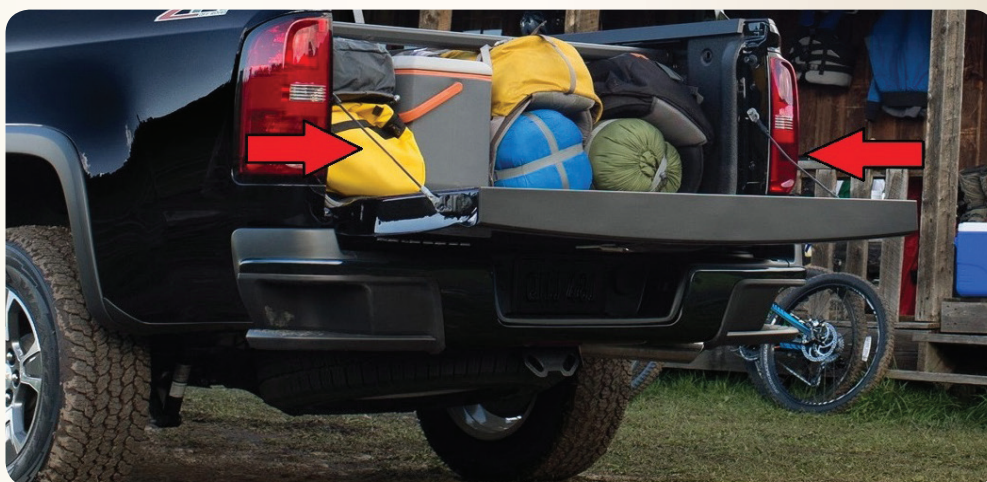
With the tailgate down, one of the tailgate cables may appear to have slack in it on some 1998-2000 Chevrolet C/K Classic, GMC C/K Classic; 1998-2004 S10, Sonoma; 1999-2018 Silverado Sierra; 2002-2013 Avalanche, Escalade EXT; 2004-2012 Colorado, Canyon; and 2015-2018 Colorado and Canyon models. The slack in the cable may lead some owners to perceive that one cable is longer than the other.

The cable slack is a normal condition due to build variation and

There may be slack in one of the tailgate cables.

does not affect the operation or reliability of the tailgate. In most cases, the slack in the cable is eliminated when weight is put on the tailgate.

Tailgate cables should not be replaced and no repair attempts should be made for this condition. Any warranty claims for this condition may be debited.

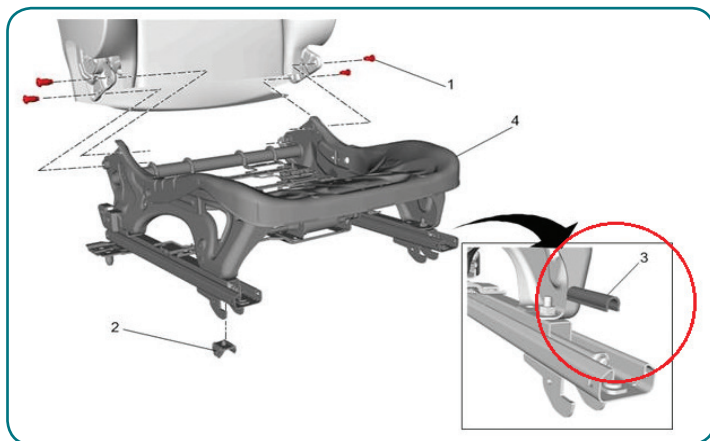
Front seat adjuster stops (#3)

When replacing the seat cushion frame on any GM model, it's critical to transfer the necessary parts from the current seat frame to the new frame. Recently, the GM Warranty Parts Center has received several seat cushion frames that still had some critical parts installed on the frames that should have been transferred to the new seat frames. Parts that should be transferred include brackets, adjuster stops, control modules and sensors, such as the seat heater control module, seat position sensor and seat control module bracket.

On many models, for example, the current front seat adjuster stops (or seat travel limiters) or the seat brackets may need to be installed on the new seat frame.

In addition to the normal parts that should be transferred to the new seat frame, always check the appropriate Service Information to help determine any unique parts from the current seat frame that should be moved to the new frame or replaced.

TIP: Any brackets or adjuster stops not moved to the new seat frame when required will need to be ordered separately. These brackets or adjusters are not included with the new seat frame.

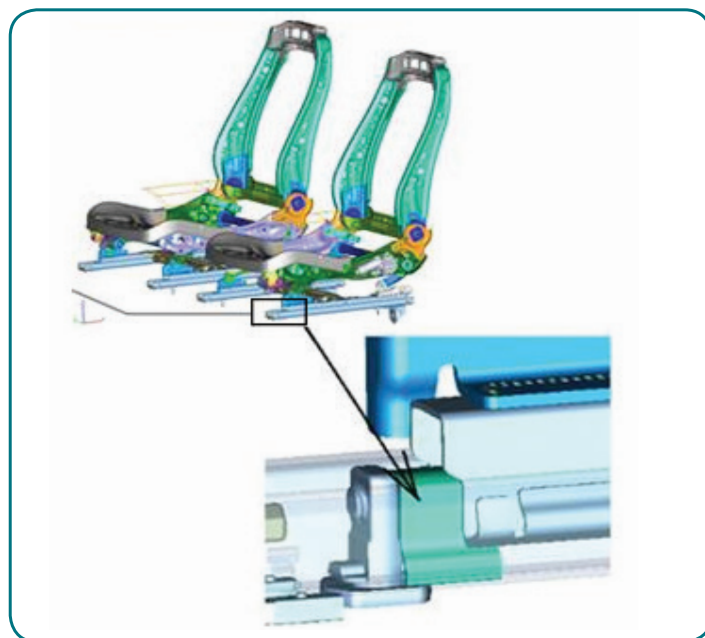
Power seat adjuster stop

There are different styles of stops for power adjustable seats and manually adjustable seats. The frame may need to be adjusted to access the stops.

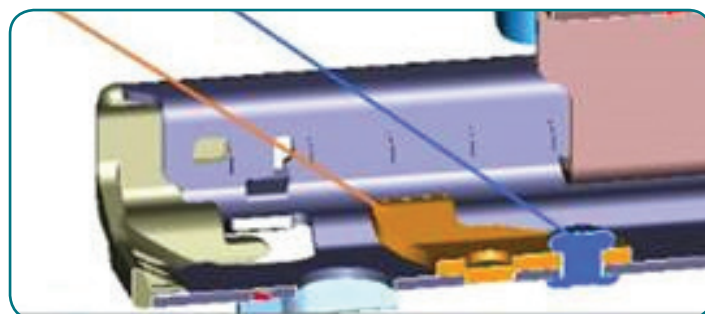
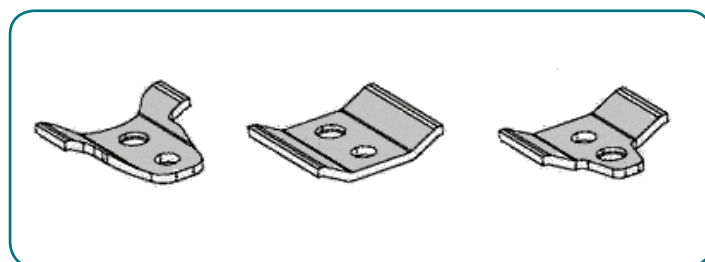
Manual seat adjuster stop

Typically, the manual seat stops are metal clips or brackets that are riveted on inboard and outboard lower seat frame channels.

Typical metal stops for manual seats

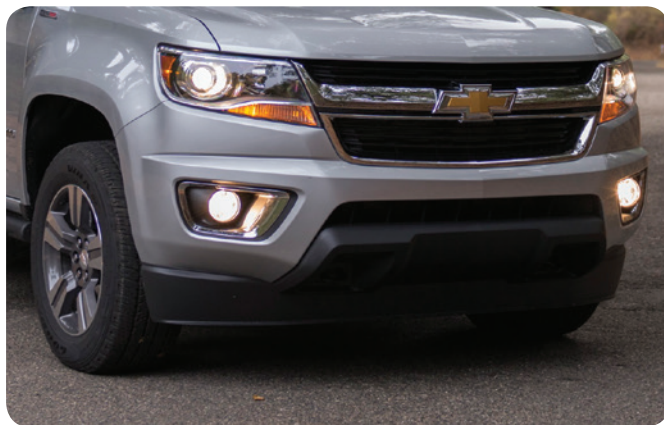
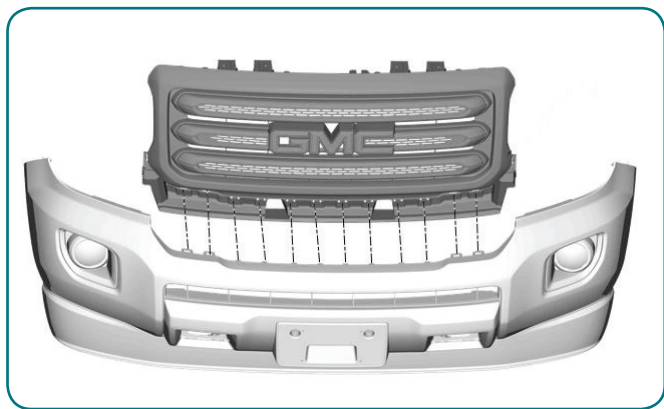
When installing GM Accessories, such as a front grille or front bow tie accessory, on 2015-2018 Colorado and Canyon models, all associated components must be reconnected before installation is complete. In some recent warranty claims, it has been noted that the fog lamps were not reconnected after installing the Front Grille Package and Body Emblem Package.

Be sure to follow all steps in the installation instructions for all GM Accessories. In the instructions for the Body Emblem Package, for example, it states to connect the fog lamp connectors and to test and confirm headlamp and fog lamp operation.

The fog lamp connections should be verified when completing the following service procedures:

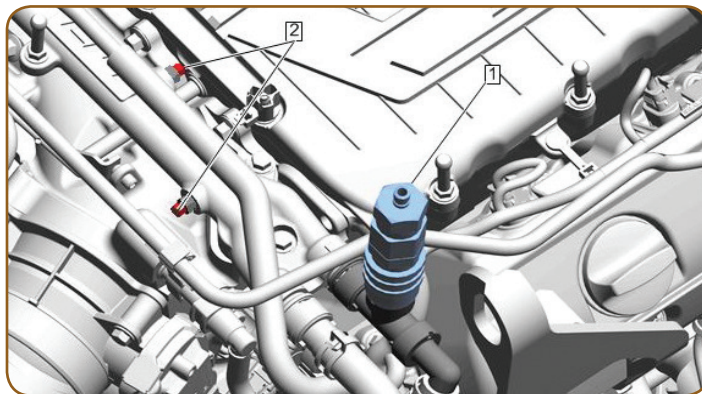
GE-47716-30A Vac-N-Fill Adapter (#1)

TIP: If the supercharger's cooling system is not properly evacuated and filled after service, DTC P0300 (Engine Misfire Detected) may set at high ambient temperatures during track speeds above 100 mph.

On Camaro ZL1 and CTS-V models, install the GE-47716-30A Vac-N-Fill Green Colored Adapter to the Charge Air Cooler quick connect fitting. On Corvette Z06 models, install the GE-47716-20 Cooling System Fill Adapter to the Charge Air Cooler fill port. Next, follow the instructions in the appropriate Service Information to attach the GE-47716 Vac-N-Fill tool to the appropriate adapter.
