New Medium-Duty Truck Essential Tools

Shipped to Dealerships

Customer Care and Aftersales

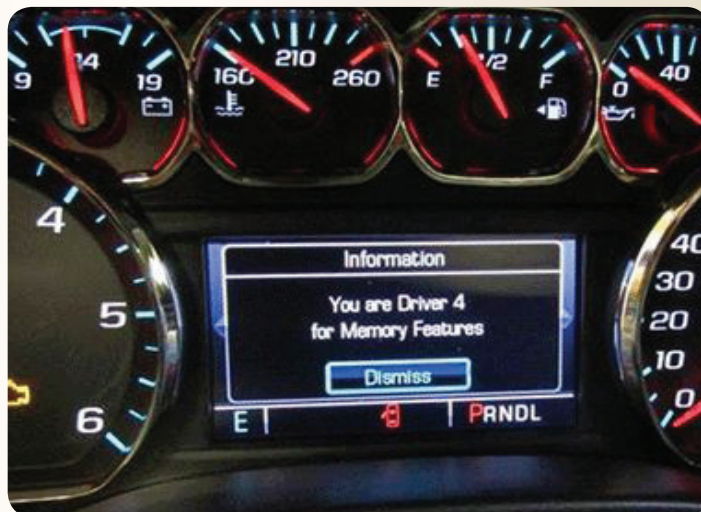
Driver 4 DIC message

After adding additional keys/fobs (Remote Keyless Entry transmitters) on some 2014 Silverado 1500, Sierra 1500; 2015-2018 Silverado, Sierra, Tahoe, Suburban, Yukon and Escalade models equipped with Automatic Memory Recall (RPO A45), the Driver Information Center (DIC) may display a "You are Driver 3 (or 4) for Memory Features" message. This message may prompt some owners to question how to access the memory features for driver positions 3, 4, etc.

The automatic memory recall feature is only available for keys/fobs learned to driver positions 1 and 2. If additional keys/fobs are added to a vehicle, the DIC will prompt a message to indicate the driver position that the key/fob has been learned to.

The DIC message appears only to let the driver know which driver position that key/fob has been learned to. There are no Automatic Memory Recall features available for key/fob positions after driver 2. This is normal operation and no additional repairs should be made.

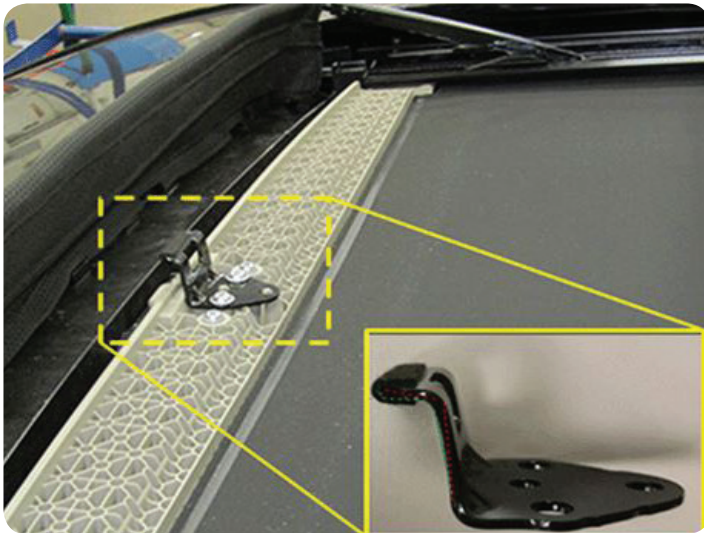
Auto open bracket

The front sunshade latch handle may break or be noisy when the sunroof is opened without opening the manual shade first. Check the sunroof sunshade auto open bracket for damage. Remove the sunshade auto open bracket and replace the latch handle if it is broken.

To remove the sunshade auto open bracket, open the front sunshade and then open the front sunroof. Pull down slightly on the front edge of the sunshade to close it with the sunroof open. Remove the two screws and the auto open bracket from the sunshade.

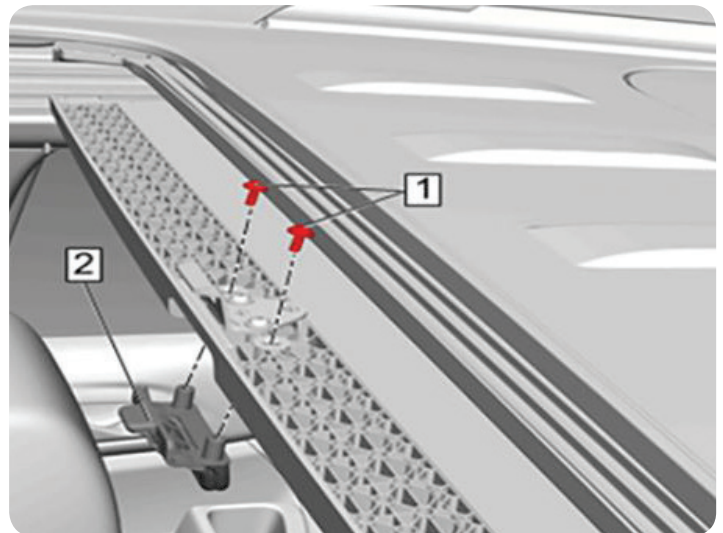
Sunshade latch handle

Some 2017-2018 Acadia (VIN N) and 2018 Enclave and Traverse models equipped with a sunroof (RPO C3U) may have a broken front sunshade latch handle or the automatic open feature may be inoperative.

If the sunshade latch handle is broken, replace the handle only. Do not replace the sunshade assembly.

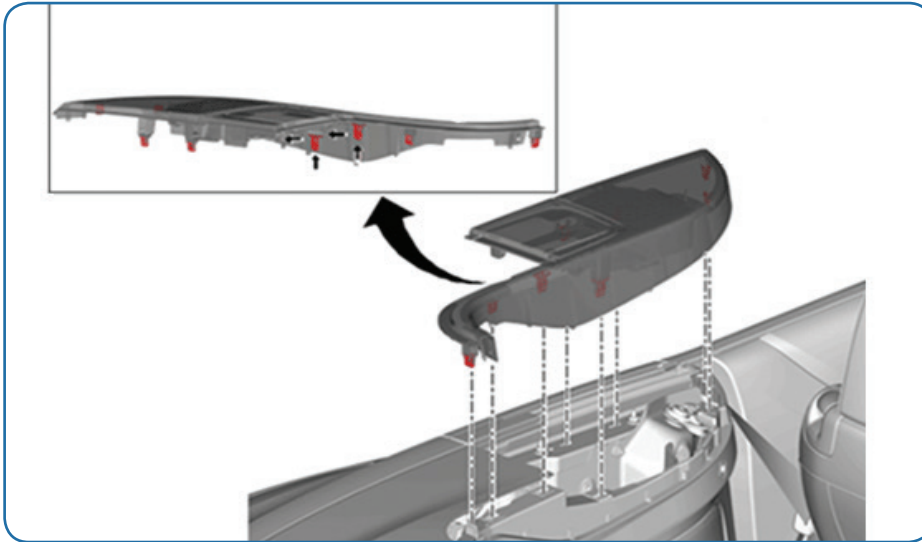
Quarter upper trim panel

The trim door on a quarter upper trim panel on some 2016-2018 Camaro convertible models may malfunction or may make a noise during convertible top operation. In some cases, the quarter upper trim panel may be broken and the increased interference, under continued use, may eventually cause the convertible top to be inoperative.

There may be various reasons that the quarter upper trim panel may have failed. If the trim panel is found to be broken, replace the panel.
