## Hunter Road Force Balancer Training Available to all GM Dealerships

# Oxygen Sensor Failure Due to Power Steering Leak

Mid-January 2018

# Low Engine Oil Pressure after Major Engine Repairs

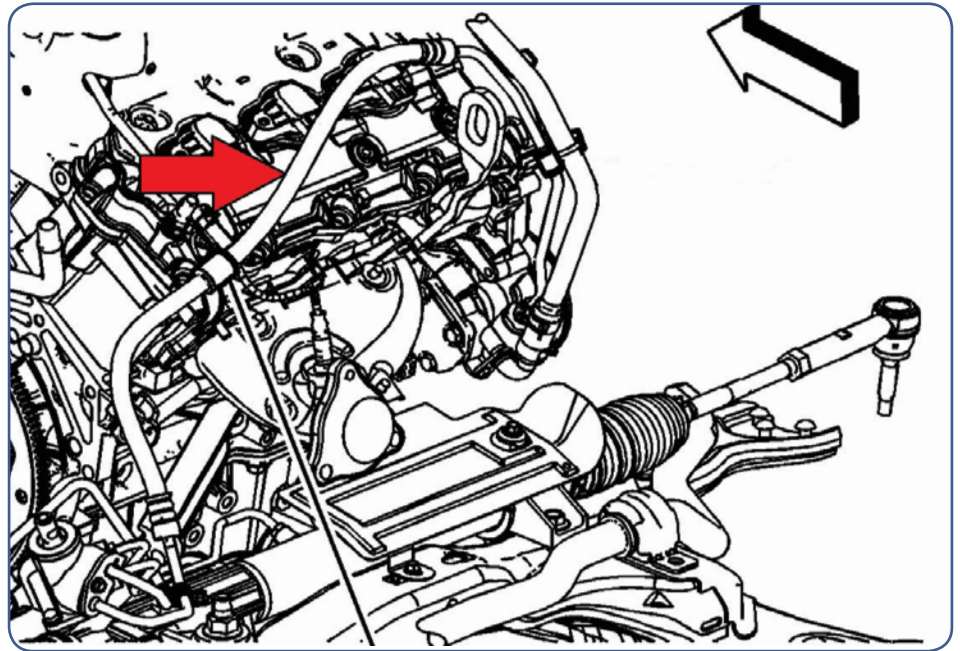
A rough idle, low power and an illuminated Malfunction Indicator Lamp (MIL) may be found on some 2016-2017 Acadia, Enclave and Traverse models. Several DTCs also may be set for the bank 1 oxygen (O2) sensor.

If these conditions are present, check for a power steering leak from the power steering hose above the wiring harness for the bank 1 oxygen sensor. The leak may be contaminating the O2 sensor wiring and impacting O2 sensor performance. In some cases, this may be a repeat concern.

Check the power steering hose above the wiring harness for the bank 1 O2 sensor.

To correct this condition, inspect the power steering inlet hose for any sign of leakage. If power steering fluid is found leaking onto the hose going into the O2 sensor wiring harness, it will be necessary to replace the bank 1 oxygen sensor and the engine wiring harness due to fluid contamination as well as the power steering gear inlet pipe/hose to stop the leak.

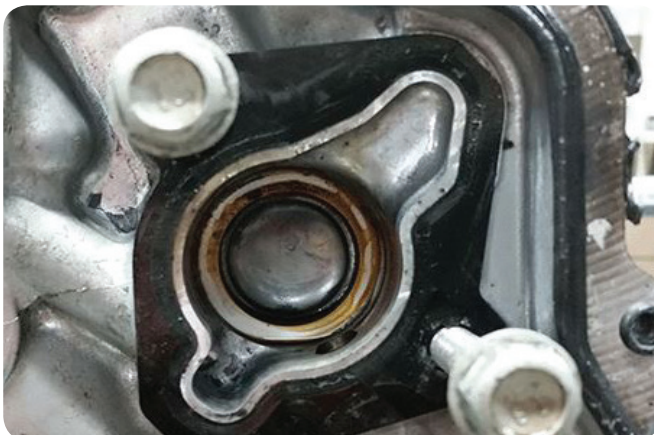
Correctly installed gasket

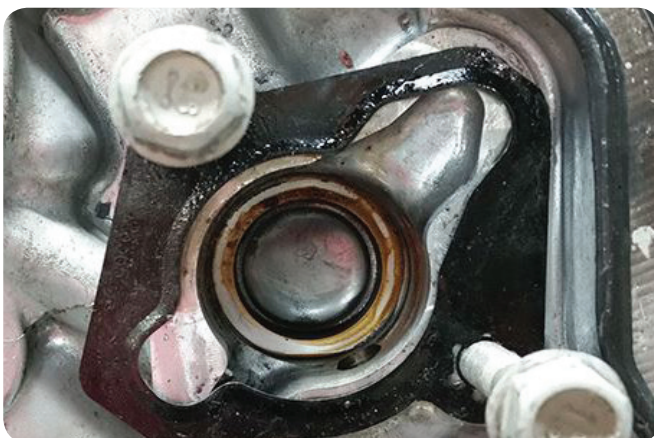
After major engine repairs, low engine oil pressure and DTC P06DE (Engine Oil Pressure Control Solenoid Valve Stuck On) set in the Engine Control Module (ECM) may be the result of an improperly installed or out-of-position timing chain tensioner gasket on some 2016-2018 Encore, Cruze, and Trax models equipped with the 1.4L 4-cylinder engine (RPO LE2); 2016-2018 Spark equipped with the 1.4L 4-cylinder engine (RPO LV7); 2016-2018 Malibu equipped with the 1.5L 4-cylinder engine (RPO L3A); and 2018 Equinox and Terrain models equipped with the 1.5L 4-cylinder engine (RPO LYX).

An incorrectly installed gasket may provide a leak path for pressurized oil to bleed off behind the timing chain cover.

Incorrectly installed gasket

If oil pressure is confirmed to be below specification and major engine repairs were performed recently, check that the timing chain tensioner gasket is installed correctly and not out of position.

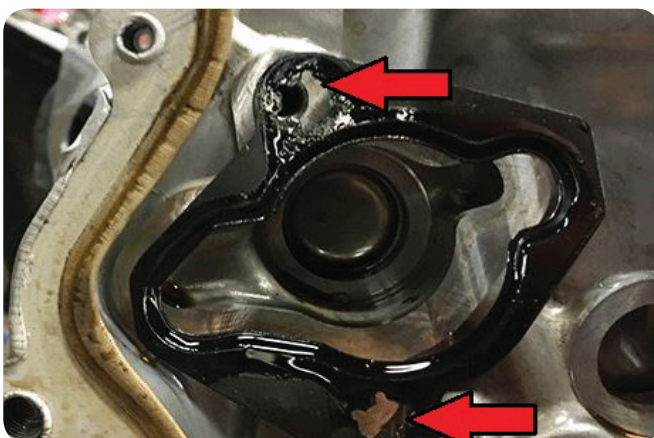
Gasket properly lined up to mounting bolt holes

When installing the timing chain tensioner gasket, ensure it lines up properly in relation to the mounting bolt holes.
