Common Questions on Super Cruise Operation

Updating the Super Cruise Digital Map Module

Customer Care and Aftersales

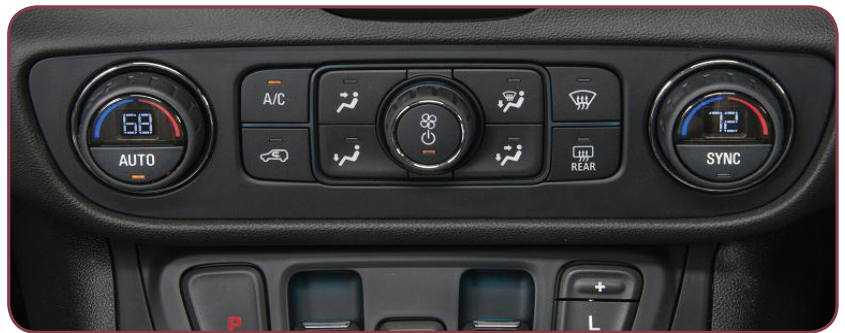
The climate controls pop-up display may show an incorrect temperature setting on some 2018 Terrain models. The Heating, Ventilation and Air Conditioning (HVAC) temperature setting shown on the temperature control knobs will indicate the correctly set temperature, but the pop-up display that appears on the infotainment screen when an HVAC control is adjusted does not show the same set temperature. In many cases, the pop-up display shows a temperature of 61 degrees.

In addition, other icons in the pop-up display for the air conditioning, fan speed, and HVAC modes may appear to be blank.

The incorrect pop-up display may be caused by the data messages between control modules not being received correctly. GM engineering is currently working toward a solution to this condition. Do not replace any parts if this condition is found.

Temperature settings in the temperature control knobs

Pop-up display with incorrect temperature setting and blank settings.

These conditions on the pop-up display are shown for the entire ignition cycle. The display may reset and operate correctly by cycling the ignition off. Even though the display is incorrect, the HVAC system is functioning properly.

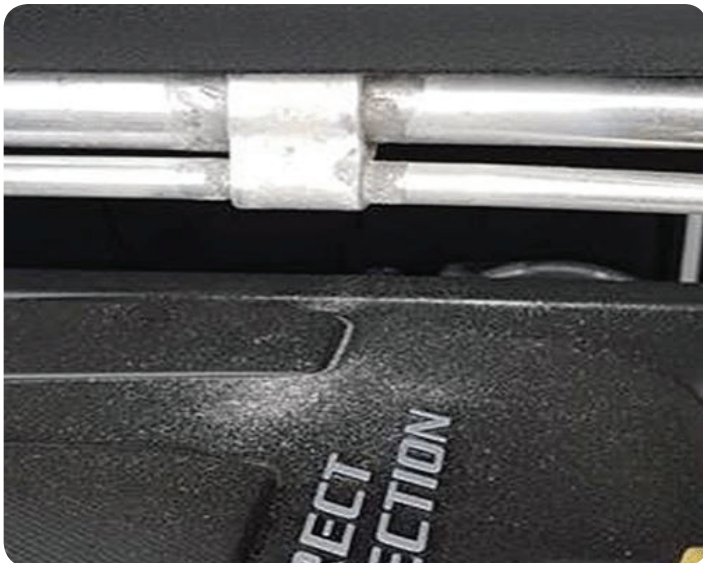
The appearance of white powder below the air conditioning lines in the engine compartment may be noticeable on some 2017-2018 Colorado and Canyon models.

The powder substance is not corrosion. It is most likely caused by flux build-up on the A/C line during the supplier brazing process.

White powder appearance in engine compartment

Verify that there are not any leaks on the A/C line and clean the flux build-up using a soft wire brush.

Do not replace the A/C lines for this condition. It is a cosmetic condition only.

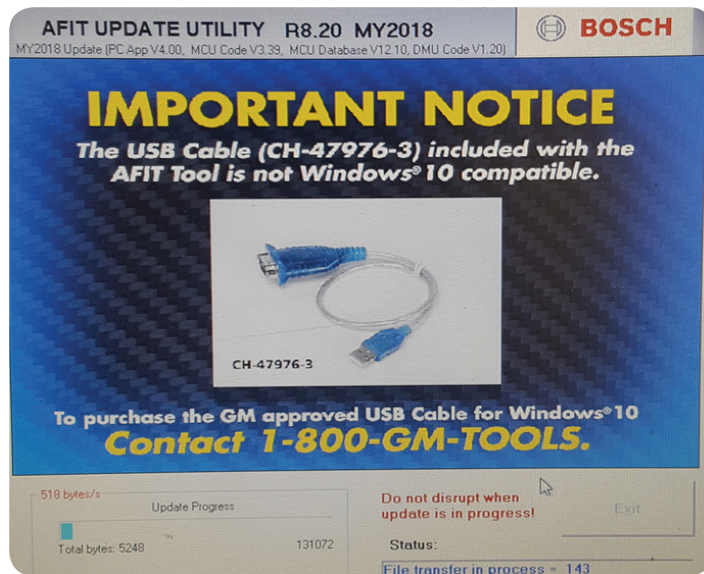
When updating the Active Fuel Injector Tester (AFIT) (CH-47976) software, some users may receive a notice about the AFIT USB cable (CH-47976-3) that is used to connect the Main Control Unit (MCU) to a computer. The original USB cable included in the AFIT kit is not compatible with computer systems running Windows 10.

AFIT USB Cable notice

To order a new AFIT USB cable adapter (CH-47976-3A) that is compatible with Windows 10 and earlier operating systems, go to gmtoolsandequipment.com and search for CH-47976-3A.
