New Wireless Charging System Retrofit Kit

Properly Connect AFIT Cables to Avoid TCM Damage

Low Air Conditioning Refrigerant Charge or Leak

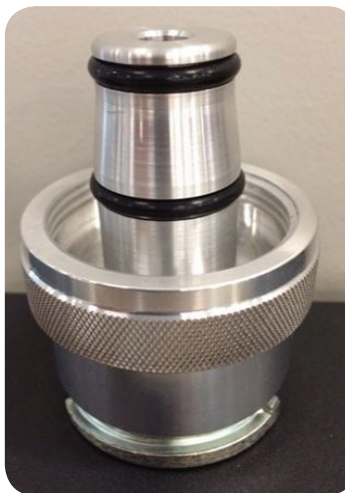
Do not use the GE-52098 Coolant System Pressure Test Adapter when servicing the cooling system on 2017-2018 Silverado and Sierra models equipped with the 6.6L Duramax diesel engine (RPO L5P).

The GE-52098-A adapter has two seals and an extended component that close off the vent chamber portion of the surge tank. Without these two seals, the adapter cannot properly evacuate the cooling system because air will leak back in from the atmosphere vent cap on the side of the radiator surge tank.

Discard adapter GE-52098

Remove the GE-52098 Coolant System Pressure Test Adapter from your tool inventory and discard it. A replacement adapter (GE-52098-A) will be shipped at no charge to your dealership.

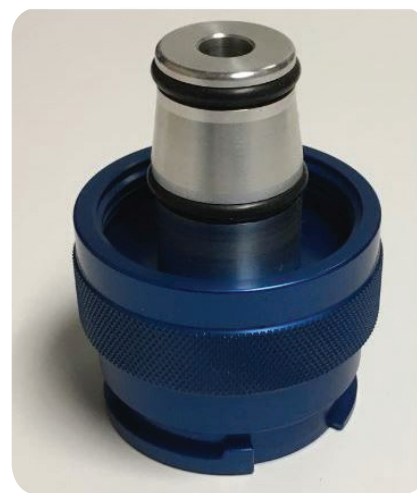
Use replacement adapter GE-52098-A

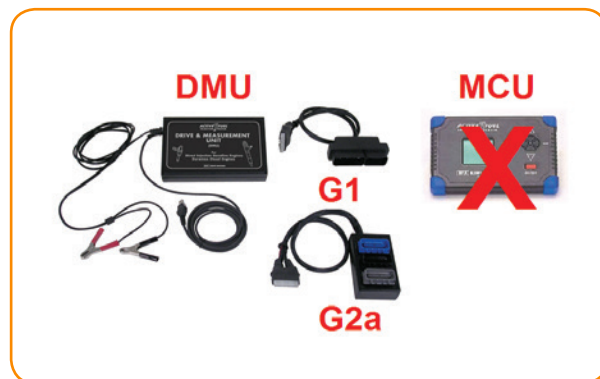
If the G1 cable or the G2a cable is inadvertently plugged into the AFIT Main Control Unit (MCU), the engine may unintentionally crank and the Transmission Control Module (TCM) may be damaged.

The G1 and G2a cables are to be plugged into the DMU, not the MCU.

TIP: Two permanent red connector adapters were also shipped to dealerships several years ago that require installation on the connector ends of the cables to prevent incorrect connections. If the cable adapters cannot be found in your dealership, they will be soon be available to order on the special service tools website at gmtoolsandequipment.com. Search for tool number CH-47976-15.

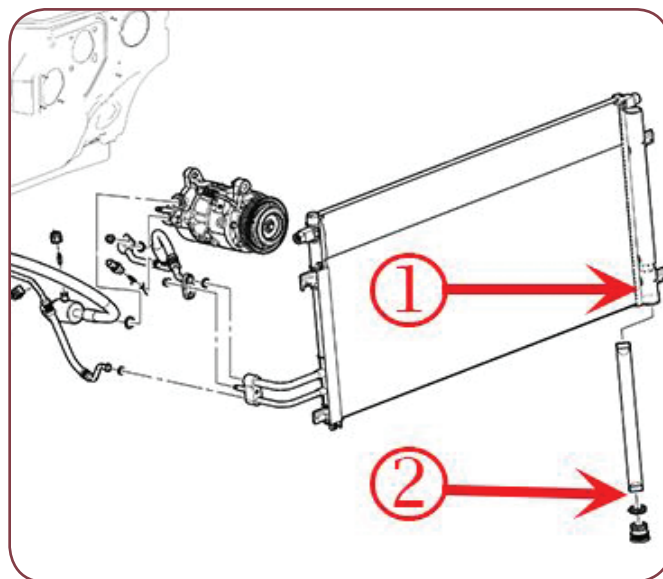
Some 2017-2018 Silverado, Tahoe, Suburban, Sierra, Yukon models and Escalade models may have a low refrigerant charge or a refrigerant leak. As a result, the air conditioning system will be inoperative or have insufficient cooling performance.

If this condition is found, inspect the receiver/dehydrator plug at the bottom of the desiccant tube on the driver's side of the condenser. Dye is usually evident at the plug connection.

1. Desiccant tube
2. Receiver/dehydrator plug

If there are signs of leaking, replace the A/C receiver/dehydrator plug assembly. Dye will appear more prominent on high mileage vehicles and on systems with more severe leaks. Dye will be more difficult to see on low mileage vehicles. Dye should not be found at the blind coupler or tube connections with this condition.

When replacing the plug assembly, apply a light coating of A/C oil to the O-rings prior to installing the assembly.

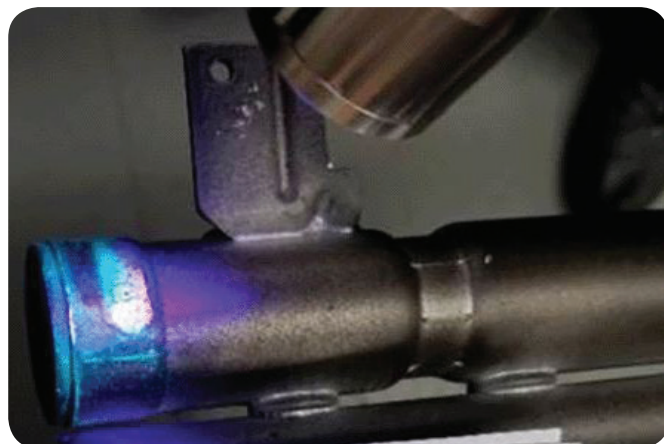
Bottom of the desiccant tube

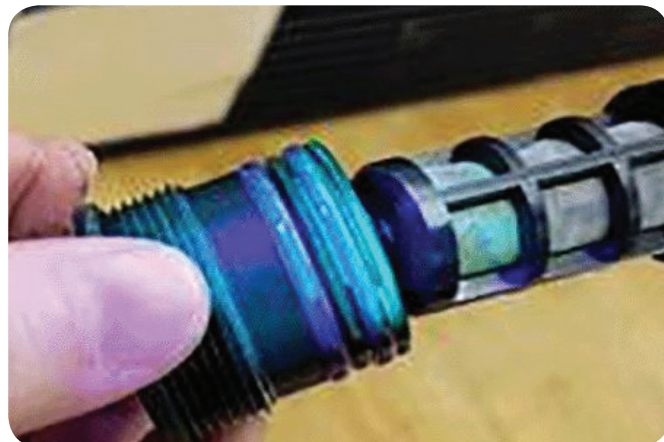
Check for leaks on the receiver/dehydrator plug.

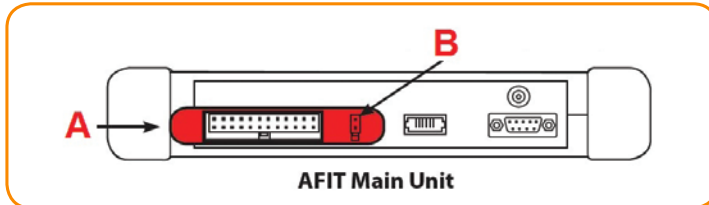
Once installed on the G1 and G2a cables, the plastic adapter blocks the power port on the MCU, which prevents powering of the AFIT MCU if the cables are plugged into the MCU instead of the DMU.

A. Adapter B. Blocked power port

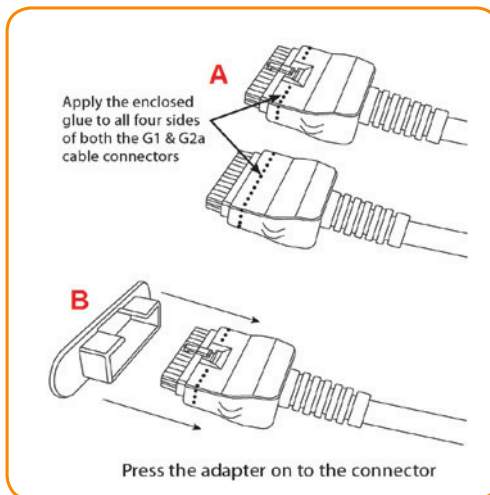
A. Apply glue to the connectors.
B. Install the adapter with the latch facing upward.

When installing the adapters, thoroughly clean the cable connector boot end and the adapter to remove all grease and dirt. Apply the glue shipped with the adapters to all four sides of each connector boot end. Install the adapter on the connector so that the connector boot is completely inserted into the adapter and the latch is facing upward in the adapter.
