2019 Model Year Full-Size and Medium-Duty Truck Names and Identification

Brake Shudder While Towing Gooseneck or 5th-Wheel Trailers

Proper Seat Cover Installation

Center Console Sliding Door Latch Replacement

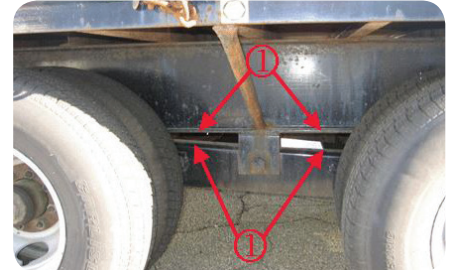
The trailer should be level from front to rear when connected to the truck. Height difference between the front and rear of the trailer may contribute to the magnitude of pulsing force the trailer can produce. Trailers that have a tandem axle assembly using a load equalizer beam, as a component in the trailer's suspension, can produce more pulsing force when the front of the trailer is higher than the rear of trailer.

Non-parallel (1) load equalizer beam

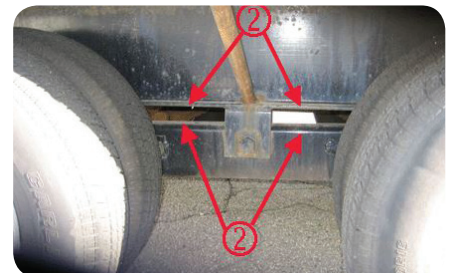
Parallel (2) load equalizer beam

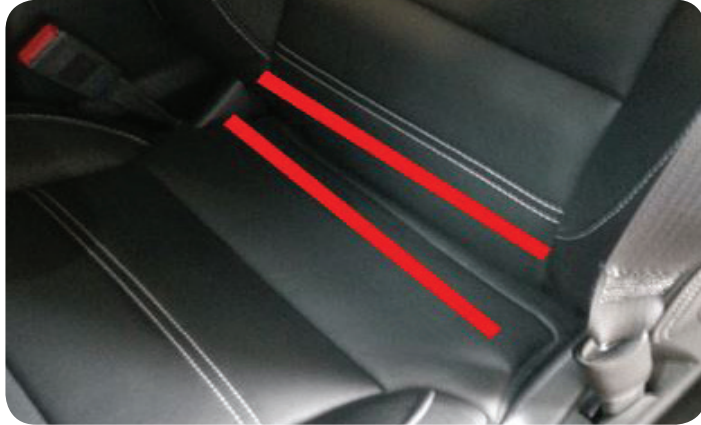
The incorrectly installed seat cover may not be completely and squarely installed onto the cushion/foam, which gives it the appearance that the seat is leaning.

Incorrectly installed seat cushion cover

The seat bottom trim cover should be reinstalled so it is square to the cushion.

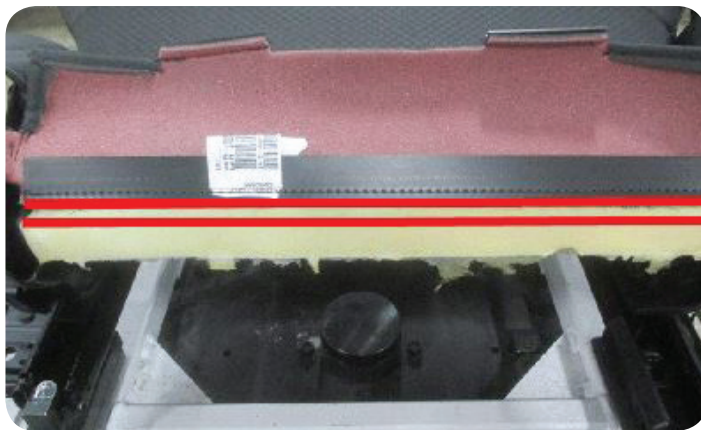
Cover should be square to cushion

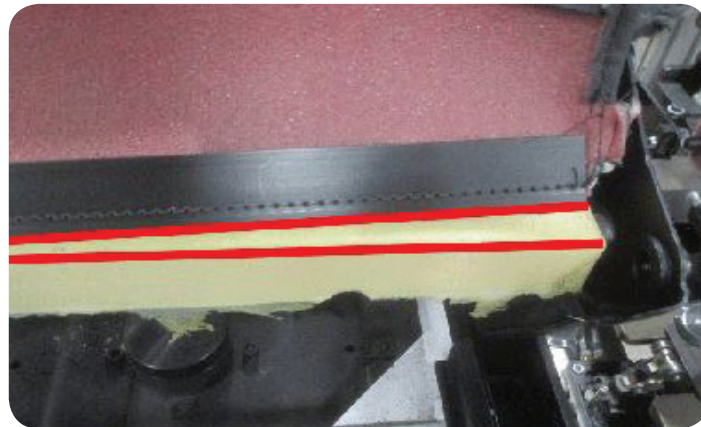
Cover not completely installed on cushion

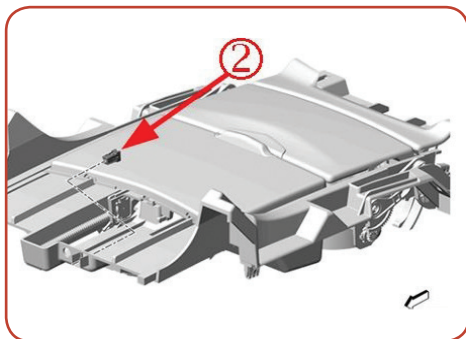
Sliding door latch

The sliding compartment door is a “push-push” door, which means it is designed to be pushed to open and pushed to close. When the door is pushed forward to close, the latch releases and the door closes. If the push handle on the door is used as a pull handle to close the door, the door latch can be damaged.

If the sliding door latch is damaged, do not replace the floor center console compartment assembly. The sliding door latch is available separately to repair this condition without having to replace the complete console assembly. Follow the Front Floor Console Cup Holder Door Latch Replacement procedure in the appropriate Service Information to replace the latch.
