## 2019 Sierra 1500 MultiPro Tailgate

## Engine Harness Rubbing on Battery Tray

## Multiple DTCs Set Due to Engine Harness Damage

## Rear Vision Camera Missing Guidance Lines or Distorted Image

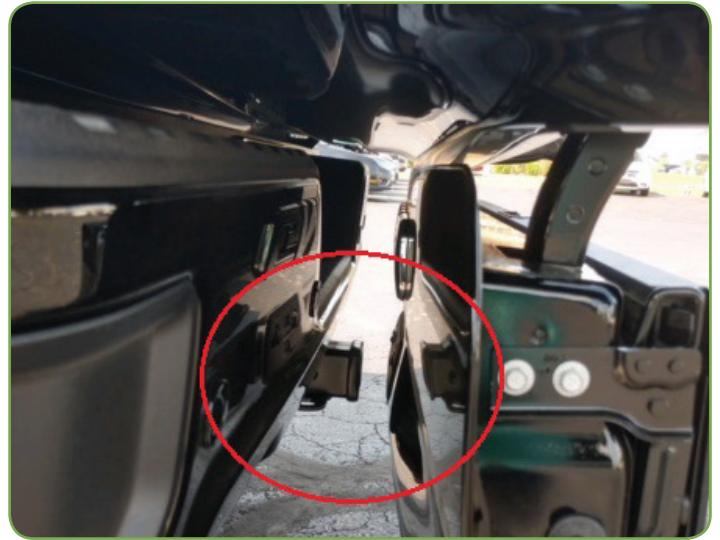
Do not lower the inner gate with the primary gate open (easy access or step positions) if a hitch ball or trailer is attached. This may damage the tailgate due to the amount of clearance between the hitch receiver and the lowered inner gate.

Clearance between hitch receiver and lowered inner gate.

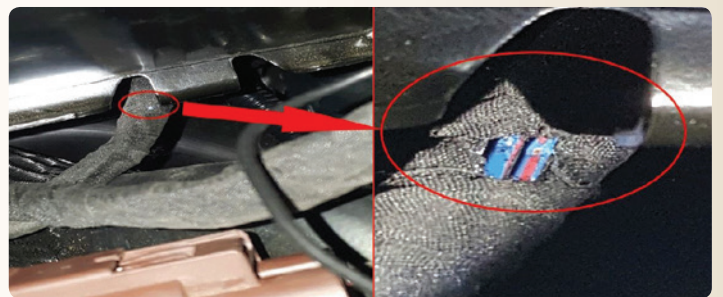
The engine wiring harness may be rubbing on the edge of the battery tray on some 2016-2018 Malibu models equipped with the 1.5L engine (RPO LFV). As a result, the Check Engine MIL may be illuminated.

The harness is a multi-bundled harness and damage to one of the wires may set a variety of DTCs. One or more of the following DTCs may be set: P0089, P0101, P0121, P0236, P0237, P0336, P0557, P057C, P0575, P057E, P0641, P0651, P0700, P1101, P15F6, P15FD, P16E4, P2227, P2230, P2544, P3051, U0014, U0073, U0101, U0121, U0140, U1814, U18A7. Due to the position of the wires in the engine harness, it is unlikely that more than one circuit or fuse will be affected by the condition.

Check the engine wiring harness conduit and wires for any chafing on the edge of the battery tray. Repair the wires as instructed in the appropriate Service Information.

Harness damage at the battery tray

Use woven Polyester Electrical Tape (PET) to tape all contact points of the engine harness. Apply the tape in a double layer, extending along the engine harness past the battery tray. Once the harness is taped, use tie straps to position the harness away from the battery tray.

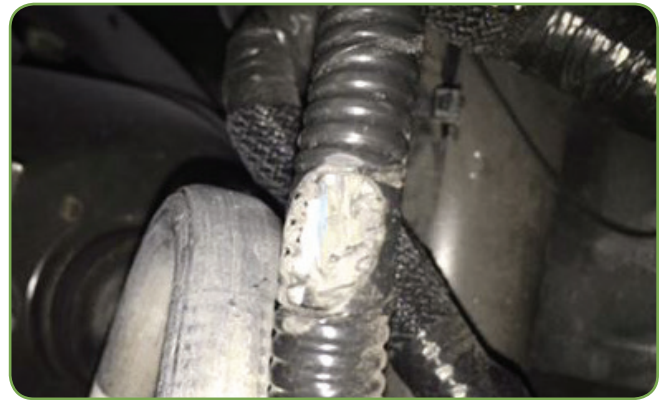
Multiple intermittent Malfunction Indicator Lamps (MIL) may be illuminated and a loss of communication with several modules, including several U-codes (DTC) set, may be found on some 2016-2018 Colorado and Canyon models equipped with the 2.5L engine (RPO LCV).

Harness rubbing on A/C pipe

These conditions may be caused by the main engine wiring harness chafing on the low side air conditioning pipe on the left side of the engine, below the exhaust manifold.

Repair the wiring harness following the instructions in the appropriate Service Information and secure the harness away from the pipe.

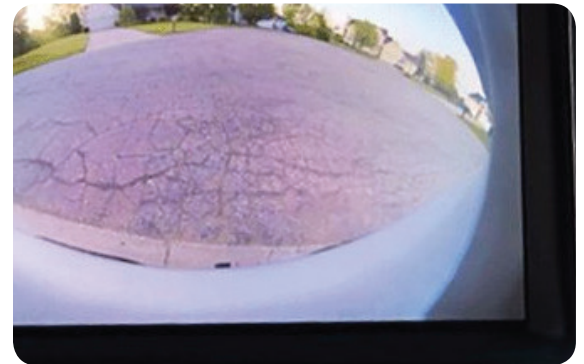
Some 2019 Equinox, Colorado, Silverado 1500, Terrain, Canyon, and Sierra 1500 models equipped with the HD Rear Vision Camera (RPO UVB) may have a distorted or "fisheye" camera display or the guidance lines/Rear Cross Traffic Alert symbols are temporarily not available while the vehicle is in Reverse. The Rear Vision Camera returns to normal operation once the vehicle is shifted out of Reverse. No DTCs are set.

Distorted camera display

The distorted image and missing guidance lines condition is most likely to occur if the vehicle is started and quickly shifted into Reverse while the infotainment system is still in the initial boot-up process. If the system is not fully booted prior to receiving a Reverse input, it may enter a "robust" Rear Vision Camera mode to ensure a rear-view camera image is available for the duration of the reverse cycle.

These conditions are the design intent of the system to ensure a camera image is available under all operating scenarios. They are not malfunctions of the system, but a limitation due to the high work load of the system during start-up. The conditions can be cleared by shifting out and back into Reverse gear.

Do not replace any parts for these conditions. Verify proper operation of the system by allowing sufficient time after start-up to complete the boot-up process before shifting to Reverse. The boot-up time should be relatively quick. To confirm operation, wait approximately 45 seconds before shifting to Reverse. If the guidance lines are missing and/or the image is distorted after a sufficient boot-up time is given (up to 45 seconds), follow the appropriate Service Information to continue diagnosis.
