New V8 Engines Feature Dynamic Fuel Management

Customer Care and Aftersales

TECH LINK

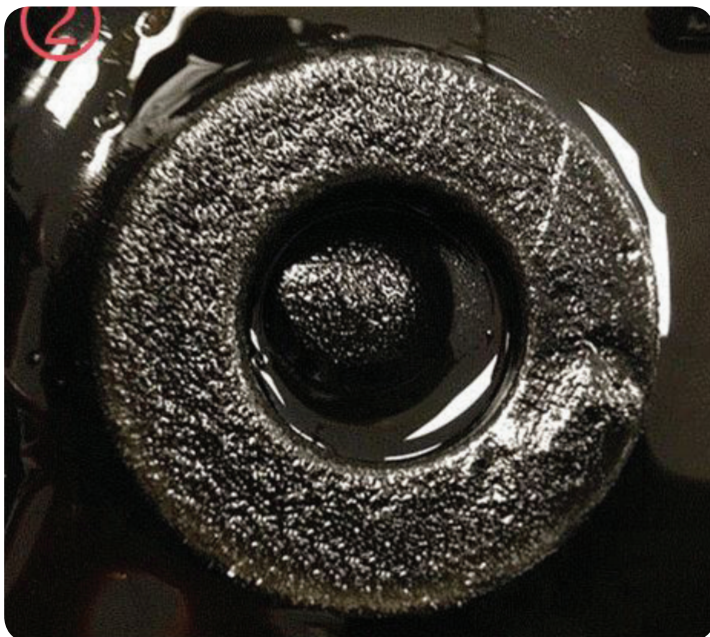
Degradation of the CVT transmission fluid may alter the friction characteristics of the transmission and lead to shudder concerns during a shift from high or low range.

Normal amount of debris in the fluid.

Drain and replace the fluid to reduce the shudder condition. Start the procedure by first removing the fluid pan and inspecting the magnets for metal debris. It is normal to have some metallic build-up on the magnets. If the magnets show only normal magnetic sludge, reinstall the pan using a new gasket, if needed. Do not replace the transmission if metal chips cannot be felt in the magnetic sludge. Refer to #PIP5548 for additional information.

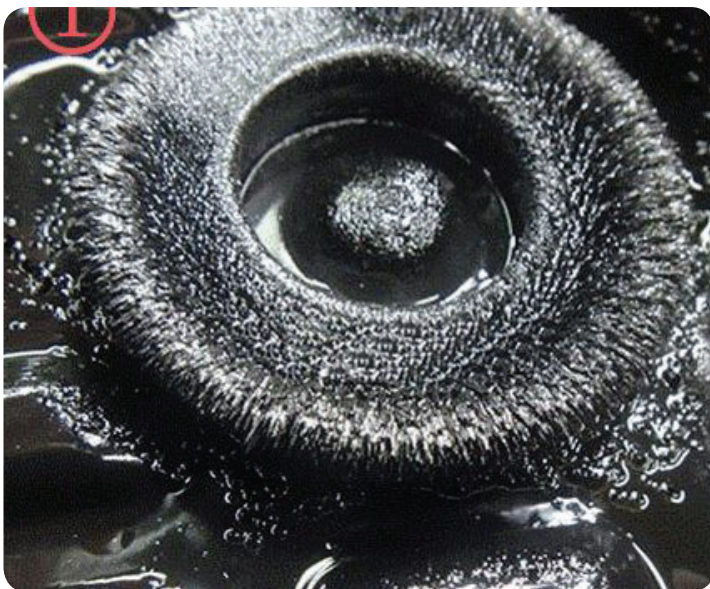
Abnormal amount of debris in the fluid.

Reinstall the fluid pan and fill the transmission with five quarts (4.73 L) of ACDelco CVT fluid (P/N 19260800, U.S.; 19299096, Canada). Filled with five quarts, the transmission will be over full.

Disconnect only the transmission cooler return line from the transmission and route it into a suitable container. The cooler return line connects at the lower port at the transmission.

Run the engine for 30 seconds and then check the amount of fluid in the container. The flow rate should be approximately one quart per 10 seconds. It will take 3-4 quarts (2.8-3.8 L) to flush the torque converter and discharge clean fluid from the return line. If necessary, run the engine again, but for no more than 20 seconds.

Reinstall the cooler return line and add two quarts of CVT fluid to the transmission. Adjust the fluid level following the instructions in the appropriate Service Information.

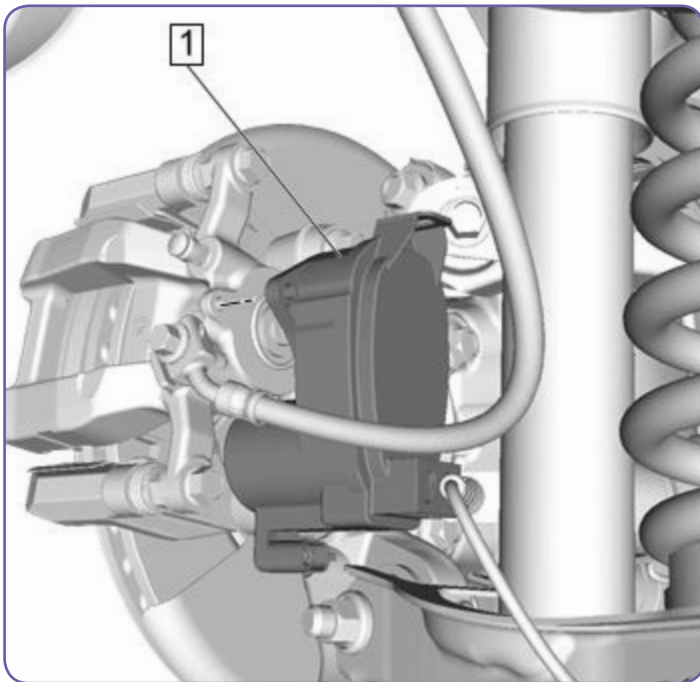
If the electric parking brake is inoperative and DTC C028F (Left Park Brake Actuator Circuit) or DTC C1586 (Right Park Brake Actuator Circuit) is set in the Electronic Brake Control Module (EBCM), check for water leaking into the rear actuator, causing a short to ground.

If DTCs C028F 04 (short to ground) and/or C1586 04 (short to ground) are set, verify which EPB actuator set the DTC and replace the actuator following the appropriate Service Information.

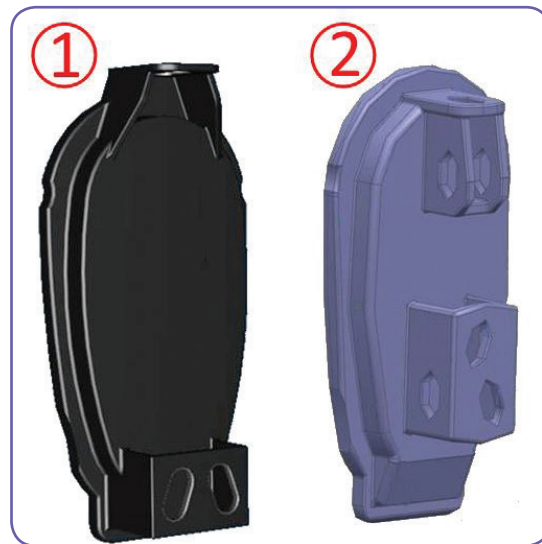
1. Old cover design
2. New cover design

The brake actuator has a newly designed cover. When replacing the actuator, verify that it has the updated cover, not the old cover design.

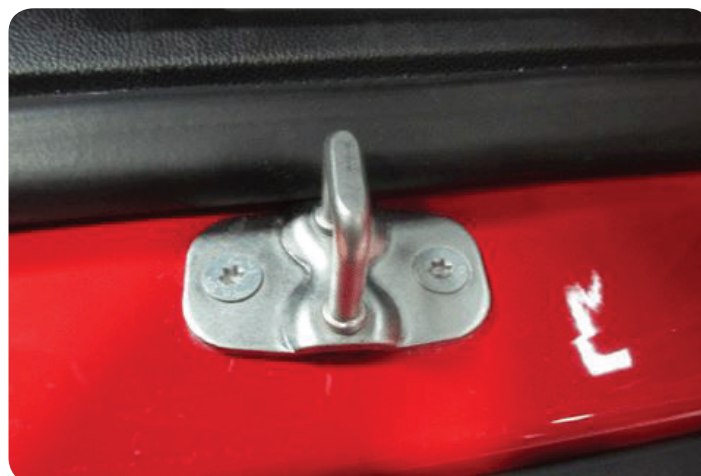
Lower rear striker

The rear door may be hard to close on some 2015-2017 Colorado and Canyon extended cab models. In addition, there may be a rattle sound from the lower rear door area and a Rear Door Ajar message may be displayed on the Driver Information Center (DIC).

If these conditions are found, the rear door lower striker may be out of position.

To correct these conditions, first verify which rear door is causing the conditions and verify the front door is adjusted properly. Adjusting the rear door lower striker will address a hard to close door condition, but additional diagnosis will be necessary if the doors are misaligned.
