New Sliding Cam Valve Lift System Provides Power and Economy

TECH LINK

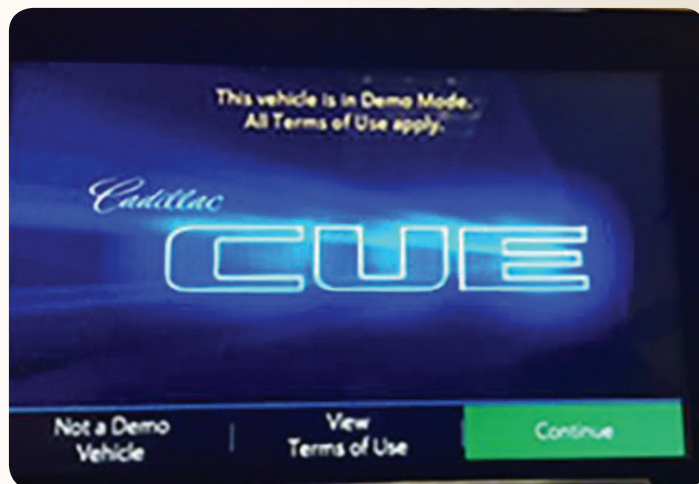
Infotainment system in demo mode

The loss of functionality of these settings is the design intent of the infotainment system while it is operating in demo mode. No repairs should be made.

Once the vehicle is sold, select the option labeled "Not a Demo Vehicle" to exit demo mode.

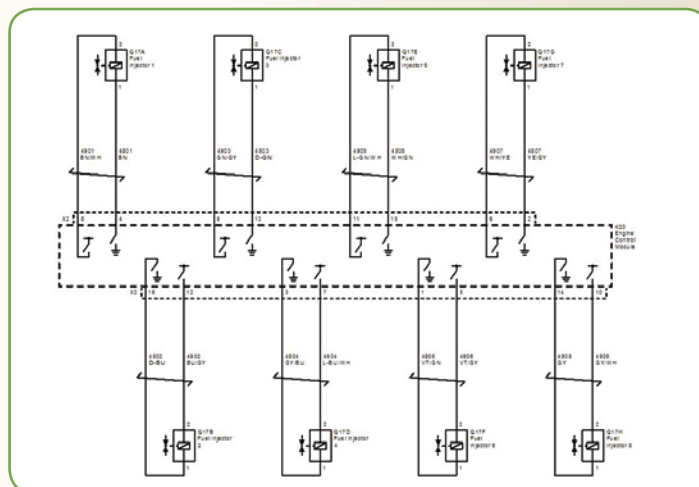
ECM and fuel injectors

Several injector timing-related DTCs may be set along with an illuminated Check Engine light on some 2017-2018 Silverado and Sierra models equipped with the 6.6L Duramax diesel engine (RPO L5P).

The DTCs may include the following codes related to injector timing being retarded or advanced: P01CB, P01CC, P01CD, P01CE, P01CF, P01D0, P01D1, P01D2, P01D3, P01D4, P01D5, P01D6, P01D7, P01D8, P01D9, P01DA; and the following codes related to injectors exceeding the maximum or minimum learning unit: P02CC, P02CD, P02CE, P02CF, P02D0, P02D1, P02D2, P02D3, P02D4, P02D5, P02D6, P02D7, P02D8, P02D9, P02DA, and P02DB.

Vehicle vibrations, such as those created by “knobby” or aggressive tread tires may induce or aggravate the injector timing-related DTCs.

Do not replace any fuel injectors if any of the injector timing-related DTCs are set. First address any vehicle or engine vibrations or any other vehicle conditions.

After addressing any vibration conditions, clear the DTCs and return the vehicle. GM Engineering is investigating this condition and additional information will be released when available.

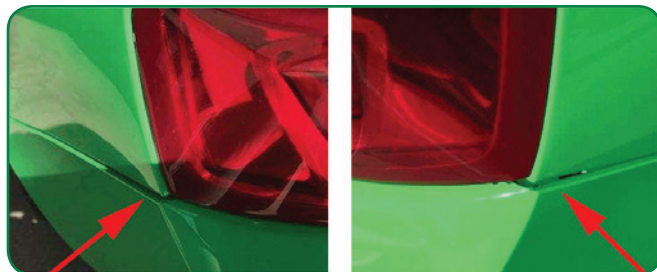
The rear fascia gap near either tail lamp on some 2016-2018 Camaro models may be more noticeable in hot temperatures. The gap is due to a possible misalignment of the center impact beam as well as the rear fascia brackets allowing for too much growth of the fascia. The impact beam mounting stud must be readjusted.

Rear fascia gaps

Prior to performing any repairs on the fascia, obtain the new service part guides for each side of the rear fascia and the shim material listed in Bulletin #17-NA-336.

Begin the repair by removing the rear fascia and then loosening the six nuts securing the impact beam. Fully remove the top two nuts and move the impact beam up 3 mm (0.12 inches) so the stud is centered in the hole of the impact beam mounting plate. Ensure both sides of are centered and re-secure the impact beam.
