Generation 2 Volt Manual Service Disconnect Base Inspection

Excessive Steering Play, Lash, and/or Steering Gear Leak Conditions

TECH LINK

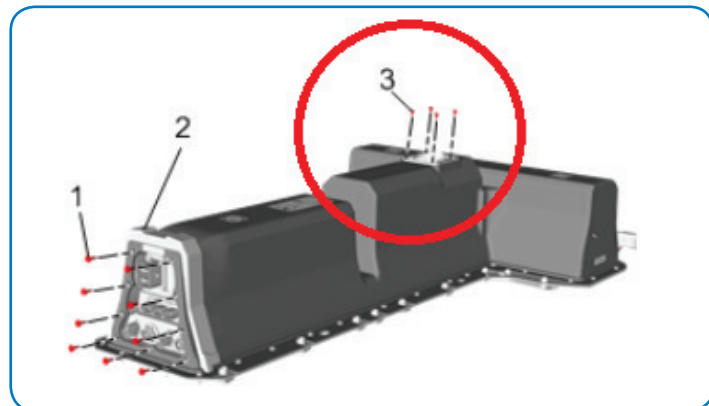
Four MSD base fasteners

When servicing a 2016-2019 Volt (2nd Generation) high voltage battery, it may be possible to neglect to remove the four fasteners on top for the Manual Service Disconnect (MSD) base and lift the high voltage battery cover with the MSD base still attached. As a result, the two high voltage terminals can become strained inside the MSD base and not operate properly when the MSD is reinstalled.

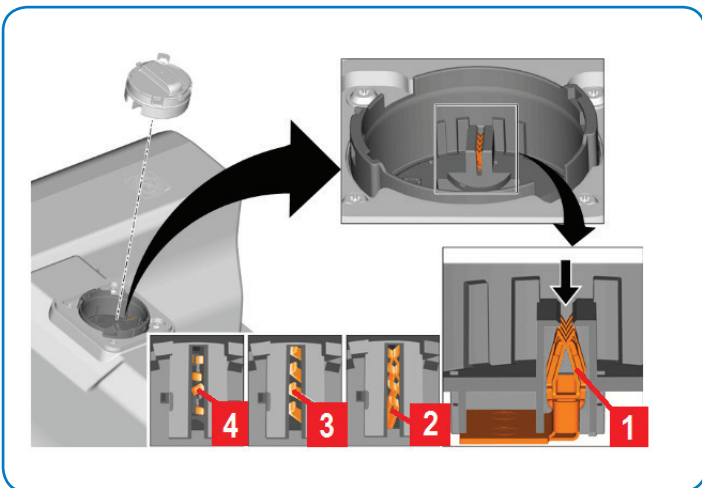
Misalignment of the MSD base and subsequent terminal damage can cause a high resistance connection that causes further damage to the base.

When checking the terminals, ensure the terminal fingers are aligned to the terminal slot. The terminal fingers should be centered to the terminal slot and should not be misaligned, bent or deformed.

Ensure proper alignment (1) and identify terminal damage (2, 3, 4)

The new installation procedure in the Service Information includes instructions for the MSD base to be discarded and replaced with a new base should the terminals show any signs of damage.

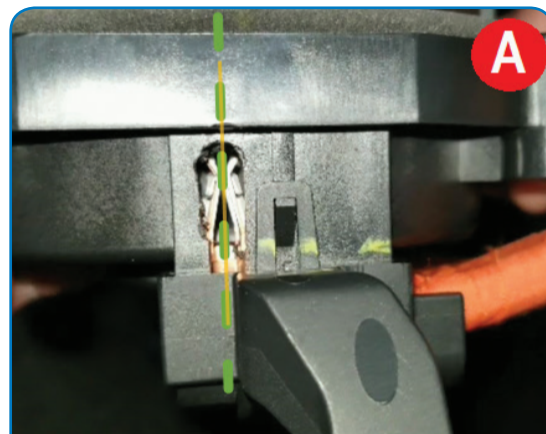
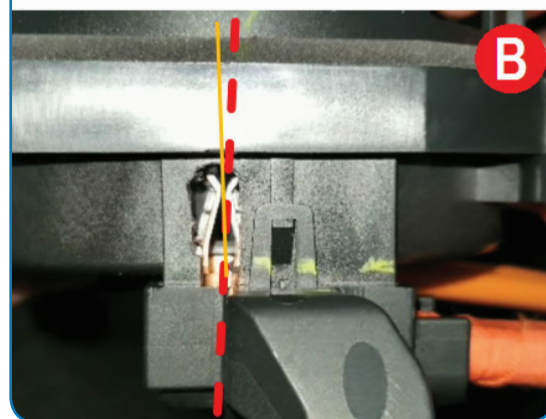
The proper vertical alignment of the terminals depends on the positioning of the orange high voltage cable. If the cable is moved or manipulated, the terminals may rotate out of the correct position.

Proper vertical alignment of the terminals (A) and misaligned terminals caused by manipulating the orange high voltage cable (B).

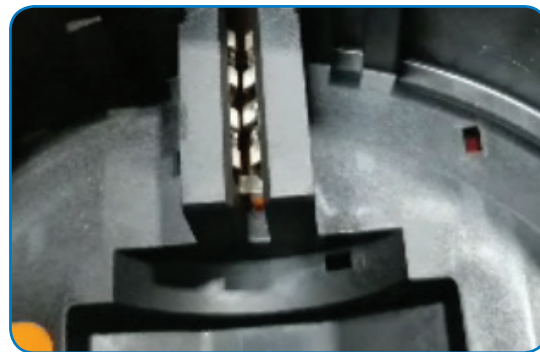
A properly aligned terminal without any damage will easily receive the MSD when the high voltage battery cover is reinstalled. Be sure to use four new fasteners for the MSD and tighten them in sequence.

Properly aligned terminals with no damage

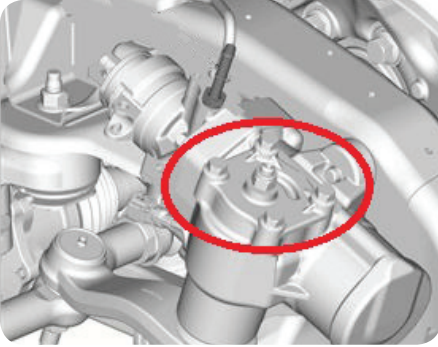
There may be excessive play in the steering or the steering may feel loose on some 2016 Silverado 2500/3500 and Sierra 2500/3500 trucks. There also may be a small power steering fluid leak from the steering gear lash adjuster stud/nut area on top of the steering gear.

These conditions may be caused by the pitman shaft adjuster stud unthreading up or out of the cover plate, which can cause excessive lash in the steering gear as well as a small fluid leak past the stud threads. These conditions are not caused by the steering gear pitman shaft adjuster lock nut turning on the adjuster stud. Do not turn the lock nut on the adjuster stud.

Steering gear with pitman shaft adjuster stud

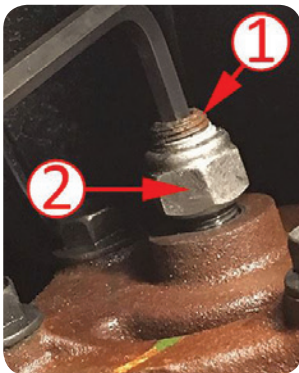
1. Steering gear lash adjuster stud
2. Adjuster stud lock nut

- The adjuster stud nut will not be seated up against the cover plate if the adjuster stud has become unthreaded.
- The adjuster stud can easily be turned in or out by hand using an Allen wrench.
- Oil residue may be seen leaking past the stud onto the cover plate.

If the pitman shaft adjuster stud has unthreaded from the cover, threadlocker should be applied on the stud threads.

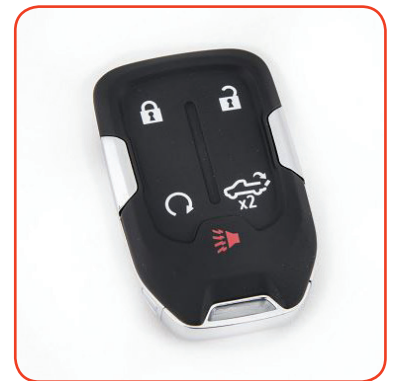
If these conditions are found, it may be due to invalid data stored in the key fob. Reprogram all key fobs for the vehicle. Follow the reprogramming procedure for Replacing Transmitters (with SPS) in the appropriate Service Information.

Reprogram all key fobs.

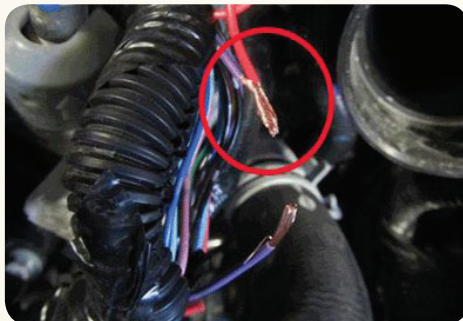
The misfire may be caused by the incorrect wires being spliced together or a poor splice connection made during a previous repair to the engine EGI harness for a crank/no start condition.

The repair used the largest gauge red wire and largest gauge purple wire.

Verify the correct wires were spliced together during the previous repair, which used the largest gauge red wire and largest gauge purple wire. If the incorrect wires were spliced, return the wires to the original

routing and perform the splice repair again using the correct wires. After the wiring repair is made, clear the DTCs and evaluate engine operation.

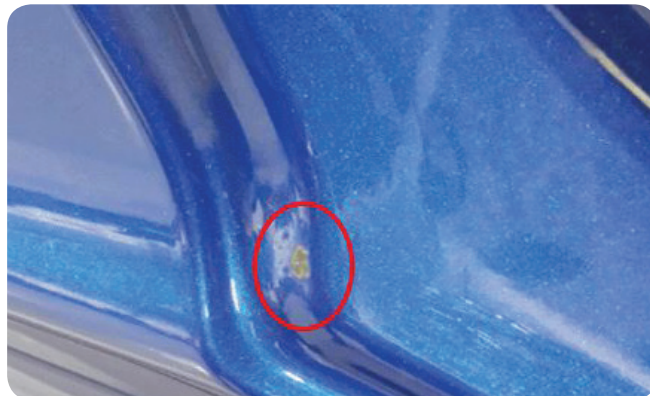
Some 2016-2018 Camaro models may show a paint chip or wear mark (marring) on one or both of the rocker panel moldings. The chipping or marring may occur when the door makes contact with the rocker molding during an over-slam door closure. The door does not contact the molding once the door is closed. The tight door hem sealer to rocker molding clearance is by design. Adjusting the door will not resolve the wear or mark condition.

Paint chip

Do not replace the rocker panel molding or adjust the door if this condition is found. Complete a partial paint repair to the rocker molding to correct the paint chip or wear mark.

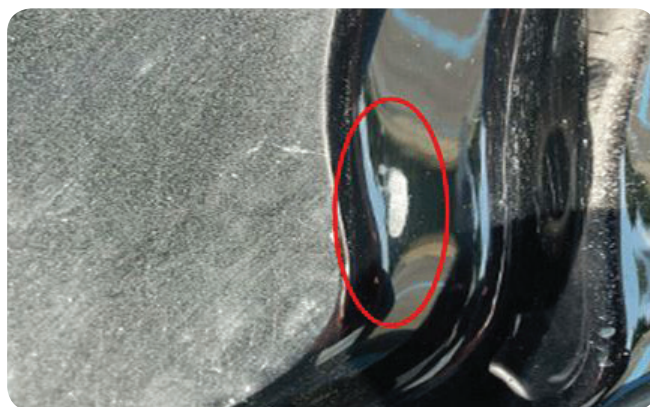
Wear mark
