2019 Camaro Touts New Looks, More Technology

Mid-October 2018

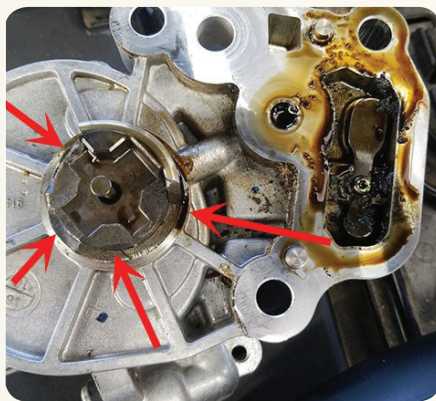
Check the vacuum pump drive lugs.

During disassembly, also check the vacuum pump drive lugs for any damage.

If the exhaust camshaft reluctor is out of position or the vacuum pump drive lugs are damaged, it will be necessary to replace the exhaust camshaft and the vacuum pump.

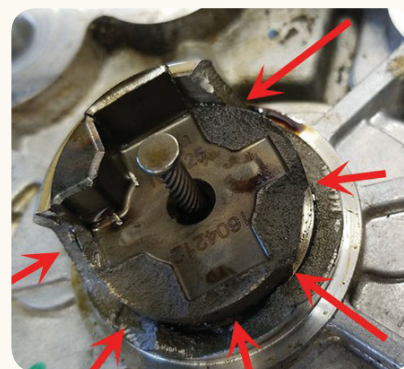
Damaged vacuum pump drive lugs

If replacing the vacuum pump, be sure to remove the broken vacuum pump drive lugs and any other metal debris during repairs.

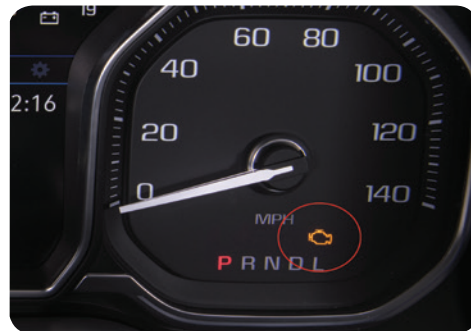
On some 2019 Silverado 1500 and Sierra 1500 models equipped with the new 5.3L V8 engine (RPO L84) or new 6.2L V8 (RPO L87) engine, the Check Engine lamp also may be illuminated, but without any accompanying drivability or performance concerns. If only the Check Engine MIL is on, it may be necessary to reprogram the K20 ECM with the latest calibrations available in TIS2Web. DTC P0300 (Engine Misfire Detected) also may be set in the ECM.

Check Engine lamp

Refer to Bulletin #18-NA-292 for more information.

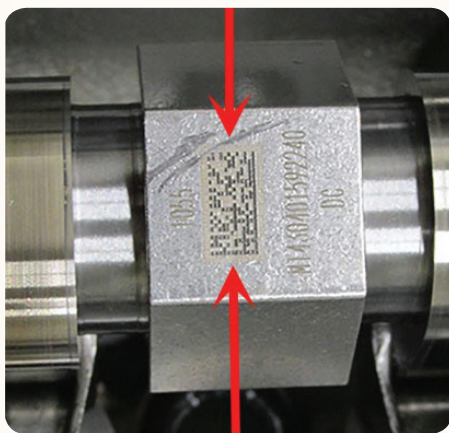
To check the orientation of the exhaust camshaft reluctor, rotate the camshaft so the 2D matrix on the camshaft hex is in the 12 o'clock position.

2D matrix on the exhaust camshaft

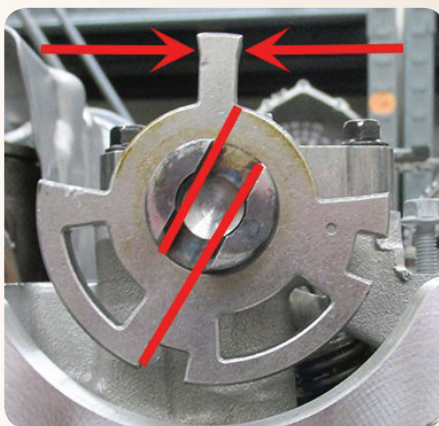
With the 2D matrix in the 12 o'clock position, the small tang on the camshaft reluctor ring should be in line with the 2D matrix.

Small tang on the camshaft reluctor ring

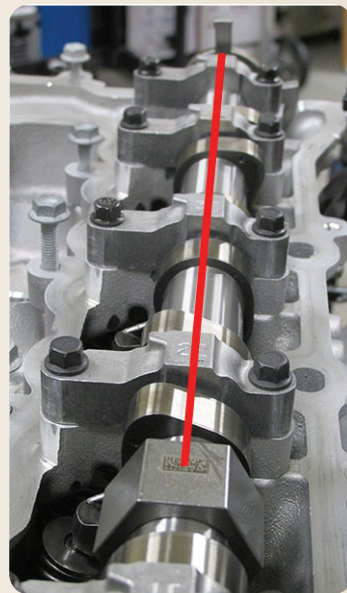
Verify the small tang is in the correct position and is in the proper relationship with the exhaust camshaft reluctor wheel.

Proper relationship between the 2D matrix and the tang on the exhaust cam reluctor wheel.

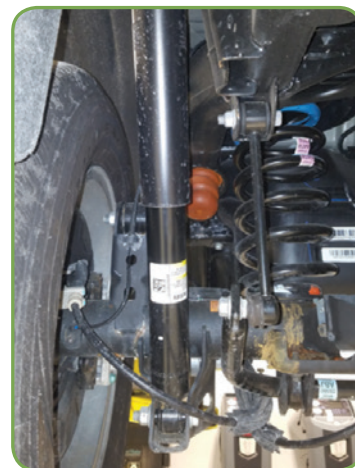
The new diagnostic procedures point out that shocks/struts are designed and intended to operate independently of each other and should be serviced individually to avoid unnecessary repairs. If only one shock or strut has been found to be the cause of a suspension condition, only the shock or strut that has failed should be replaced.

Replace only the failed shock, not both on an axle.

Shocks/struts should only be replaced as a pair if diagnosis shows that both components have failed.

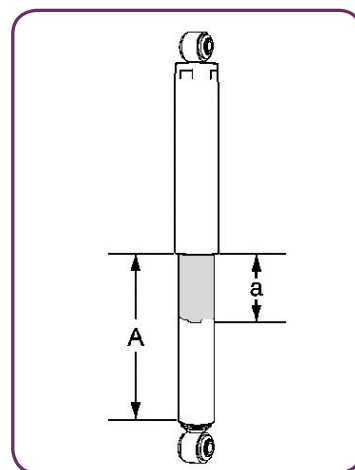
When inspecting the suspension, the shock or strut does not have to be removed from the vehicle. Visually inspect each shock/strut for external fluid leaks. A light film or residue on the top portion (approximately 1/3) of the lower shock or strut tube, originating from the shaft seal, is normal.

Normal residue on the shock tube

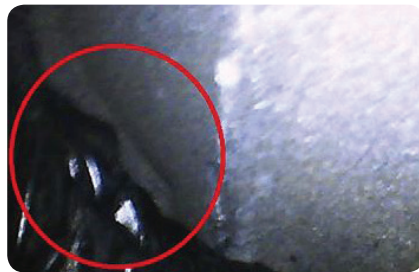
The Check Engine lamp may be illuminated and DTCs P0282 (Cylinder 8 Injector Control Circuit Low Voltage) and P0300 (Engine Misfire Detected) may be set on some 2015-2019 Escalade models equipped with the 6.2L V8 engine (RPO L86) and some 2015-2019 Suburban, Tahoe, and Yukon models equipped with the 5.3L V8 engine (RPO L83) or 6.2L V8 engine (RPO L86). The DTCs may be current or set in history. These conditions may be caused by a damaged wiring harness near the transmission bell housing.

Harness rubbing on the transmission bell housing.

If performing the Service Information diagnostic checks does not isolate the cause of the condition, remove the intake manifold to inspect the #8 injector wiring area where the Bank 2 injector harness breaks out of the main engine harness. Check for hard contact with the transmission bell housing.

It may be necessary to remove the transmission crossmember, lower the transmission, and pull the wiring harness up into the engine compartment to locate the chafed wire.

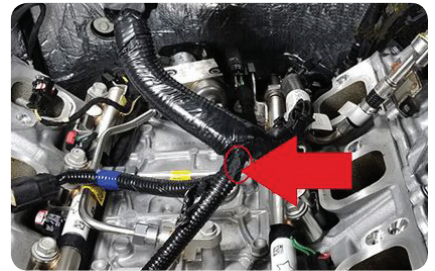
At the branch of the harness, there will be a rub-through mark where the harness is chafing on the bell housing. Open the harness to repair the wiring as needed.

Look for a rub-through mark near the branch of the harness.

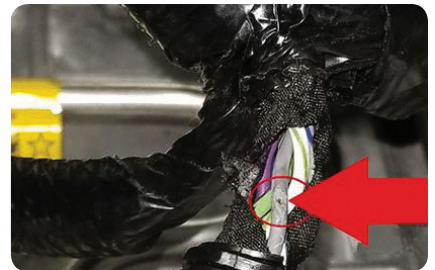
Open the harness to make any wiring repairs.

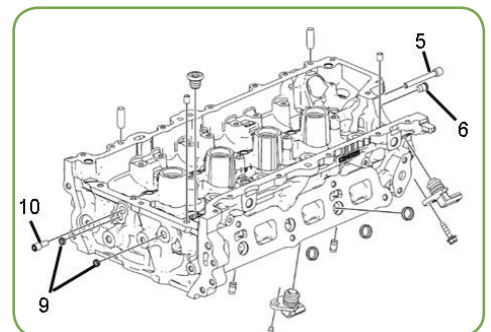
After the cylinder head has been replaced on some 2014-2015 Impala and Malibu models equipped with the 2.5L 4-cylinder engine (RPO LKW), an external oil leak may be found, random misfires may occur on all cylinders when the camshaft is on low lift with light throttle, and DTCs P16D0 (Intake Rocker Arm Solenoid Valve 2 Stuck Off) and P0300 (Engine Misfire Detected) may be set. If these conditions are found, check for the presence of several oil galley plugs.

If the cylinder head has an external oil leak, verify that oil galley plugs #5 and #6 have been installed.

If DTC P16D0 and/or P0300 are set or a random misfire occurs on all cylinders only when the camshaft lobe is on low lift, verify that oil galley plug #10 has been installed. The #10 oil galley plug, located in the cylinder head behind the timing cover, would have an oil leak that is internal to the engine.

In addition, check that oil galley plugs #9 are installed. These plugs should have come installed in the new cylinder head.

Check that oil galley plugs are properly installed.
