Updated Field Product Reporter App Part of New Certified Service Mobile Toolbox

Charge Air Cooler Moisture Conditions

TECH LINK

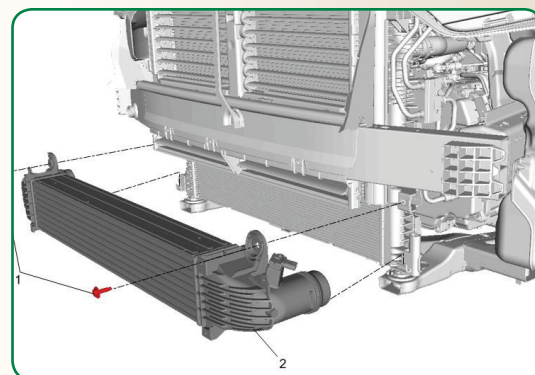
Charge air cooler

Some 2018 Equinox and Terrain models equipped with the 1.5L 4-cylinder engine (RPO LYX) or 2.0L 4-cylinder engine (RPO LTG) may have an illuminated Check Engine lamp and DTCs P0299 (Engine Underboost), P2227 (Barometric Pressure Sensor Performance), or P0300 (Engine Misfire Detected) may be set.

The DTCs may set due to moisture build-up inside the charge air cooler. Long drives through rainy conditions and/or high humidity conditions (heavy fog) may cause moisture to collect in the charge air cooler.

Under heavy acceleration, moisture can be drawn into the engine, which would cause DTC P0300. In cold temperatures, ambient and PCV moisture can freeze in the charge air cooler, which would restrict flow and cause DTCs P0299 and/or P2227.

If these conditions are found, perform a smoke leak test of the charge air cooler. If a leak is determined, replace the charge air cooler. A newly designed charge air cooler is now available.

- For vehicles built before March 1, 2018, replace the charge air cooler with the newly designed part.

On vehicles equipped with the 2.0L engine (RPO LTG), remove the boost sensor from the intake charge pipe to the throttle body and wipe the area with a clean rag to remove any residual moisture.

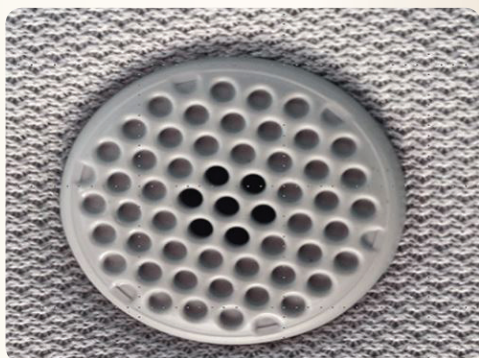
- Microphone resistance is 105k to 110k ohms
- Microphone is centered in the opening in the headliner
- Microphone is mounted flush to the headliner with no gaps.

ANC microphone centered in the headliner opening

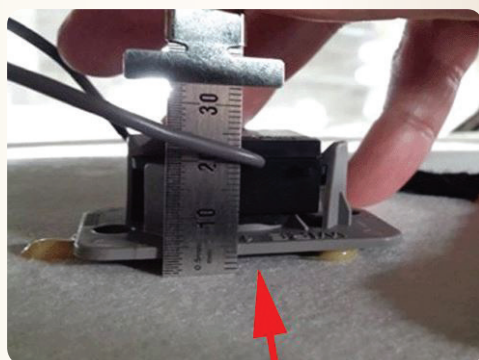
The Active Noise Cancellation (ANC) module filtering function may not be operating properly or the ANC microphone may not be seated correctly in the headliner on some 2016-2018 Malibu models. As a result, a loud boom, moan or phasing sound may be heard from the infotainment system either at a low speed/low RPM or at a high speed/high RPM.

The microphone shown below is not flush with the headliner.

ANC microphone not flush with the headliner

After correcting the positioning of the ANC microphone, if needed, drive the vehicle at a low speed/low RPM — approximately 15–20 mph (24–32 km/h) or 1,100–1,200 RPM — and at a high speed/high RPM — approximately 60–70 mph (97–113 km/h) or 1,900–2,000 RPM — to verify if the sound is still present.

If the boom/moan sound is confirmed at a high speed/high RPM, replace the ANC module.

If the boom/moan sound is confirmed at a low speed/low RPM, disconnect the ANC module X3 connector. Drive the vehicle again at a low speed/low RPM. If the sound is eliminated, leave the X3 connector disconnected and secure it to prevent any rattling.

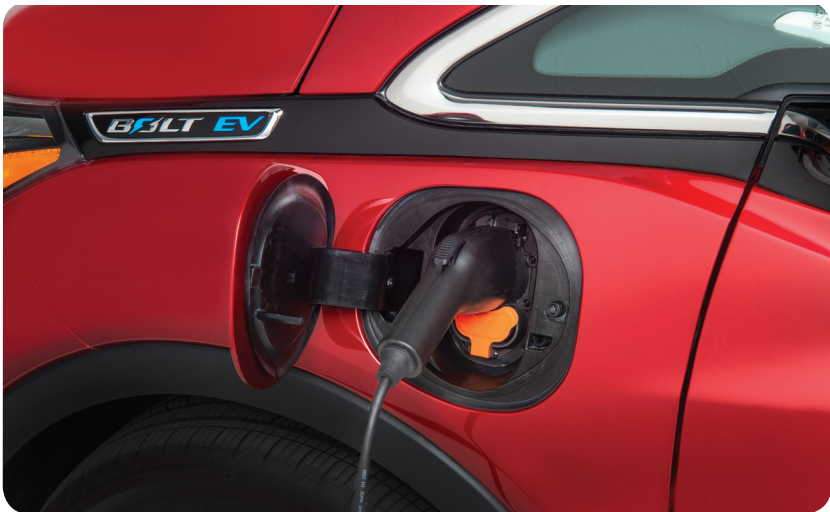
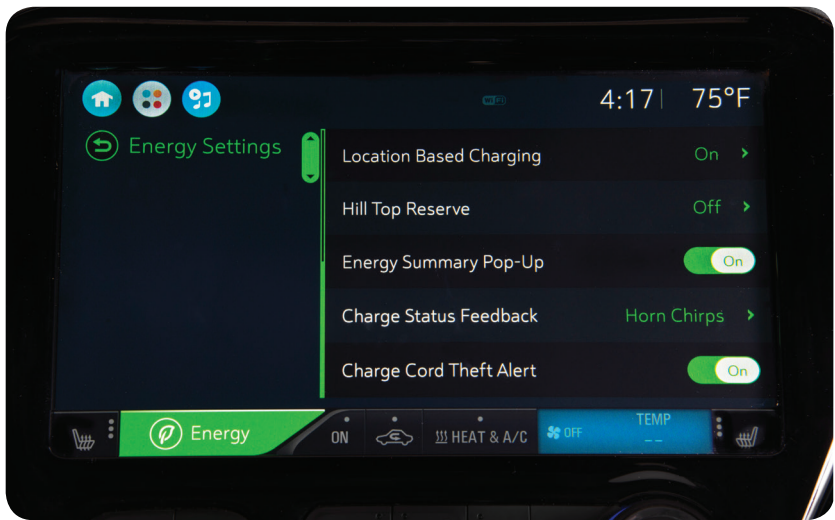
Some 2017-2019 Bolt EV models may not have charged to a full charge level, as shown on the power indicator gauge on the instrument cluster, after a complete vehicle charge event. The top indicator bar on the charge gauge will not be illuminated.

If the vehicle is not charging to full capacity, check if the Hill Top Reserve setting is selected. Hill Top Reserve enables regenerative braking efficiency to be maximized when driving from a higher elevation immediately after charging. When this feature is turned on, charging will stop before the high voltage battery is fully charged, which allows space for energy from regenerative braking.

Hill Top Reserve option in Energy Settings

To check if the Hill Top Reserve setting is on, press the Energy button on the infotainment screen and then select Energy settings > Hill Top Reserve. Press the On/Off button to select or deselect the setting.

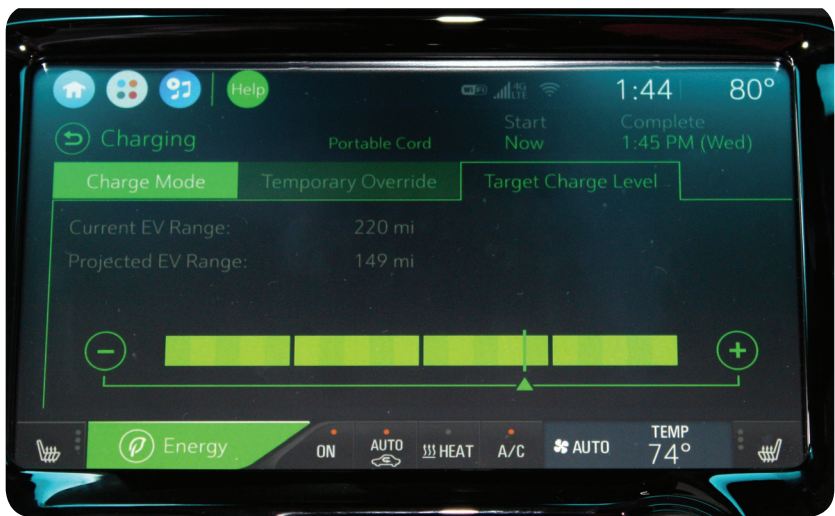
If the vehicle is not charging to full capacity, the Target Charge Level may be activated and set to a lower charge rate than 100%. With this setting, a reminder will be displayed on the instrument cluster indicating Target Charge Level Active.

Target Charge Level setting

To determine if the Target Charge Level is turned on, press the Energy button on the infotainment screen and then select Charging > Target Charge Level. Adjust the charge level to the desired level of charging capacity using the plus/minus buttons on the screen.
