6.6L Duramax Diesel Engine Operating Characteristics

Customer Care and Aftersales

TECH LINK

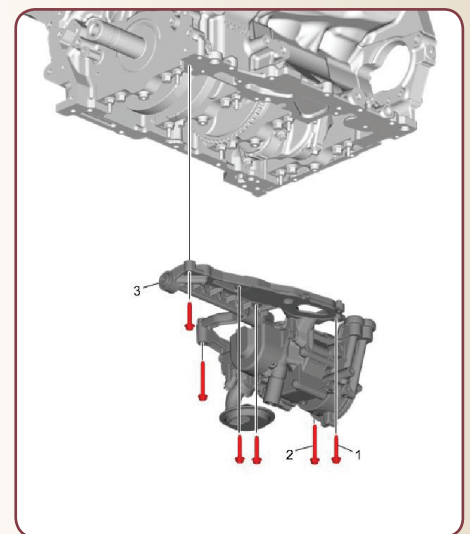
Oil pump (#3) for the 3.6L V6 engine

Some 2016-2017 ATS, CTS, CT6, Camaro; 2017 LaCrosse, XT5 and Acadia models equipped with the 3.0L V6 engine (RPO LGW) or 3.6L V6 engine (RPO LGX) may have a hollow knocking or tapping sound coming from the engine compartment when the engine is hot. The sound may be due to the operation of the mechanical vacuum pump for the brake system. The sound does not affect the ability of the vacuum pump to supply vacuum to the brake booster or the longevity of the vacuum pump.

If the sound is present, pump the brakes 3-5 times to check if the sound goes away. If the sound stops, it will return a short time later. The sound occurs when the brake booster system is at equilibrium (fully drawn down). Pumping the brakes requires the vacuum pump to create more vacuum to compensate.

If the sound goes away when applying the brakes, replace the engine oil pump. The mechanical vacuum pump is part of the oil pump assembly inside the oil pan and is the source of vacuum for the brake system.

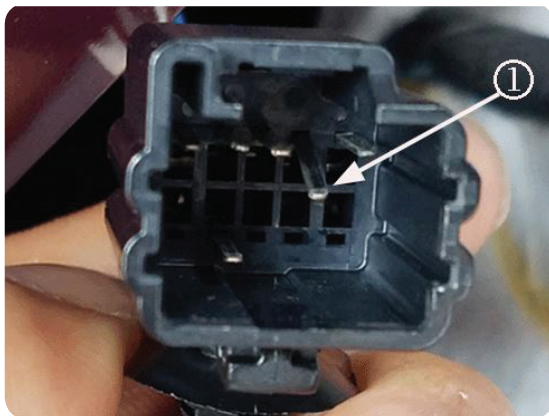
Bent pin condition

If DTCs B153E or B396A are set, the cause may be that the male terminals in the body harness 10-way in-line connector to the liftgate power assist actuator may not be dimensionally stable or may be misaligned, causing intermittent electrical contact.

Inspect the body harness male in-line connector for any bent or misaligned terminals. Straighten any misaligned terminals and reconnect the connectors. Verify proper opening and closing of the power liftgate.

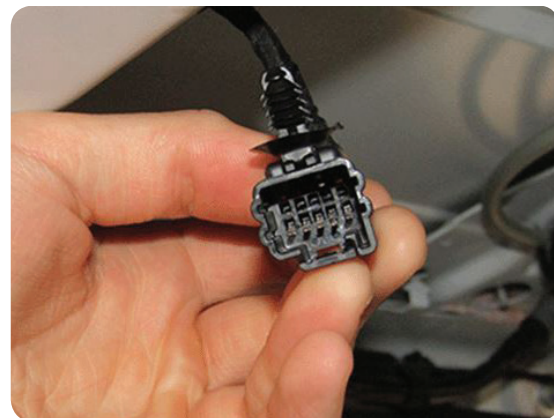
Inspect the body harness male in-line connector terminals.

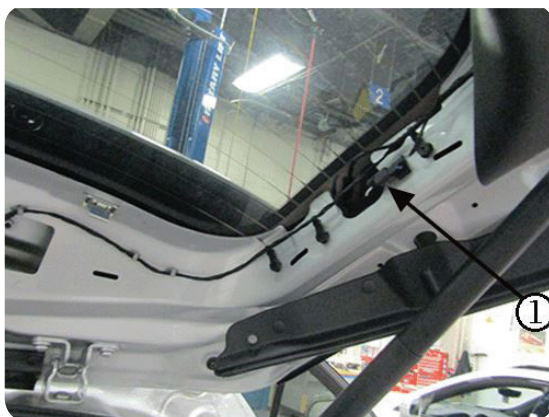
Remove the liftgate upper center and upper side trim panels to access the connectors.

Remove the liftgate upper center and upper side trim panels to access the B71L Liftgate Object Sensor – Left or B71R Liftgate Object Sensor – Right connectors.

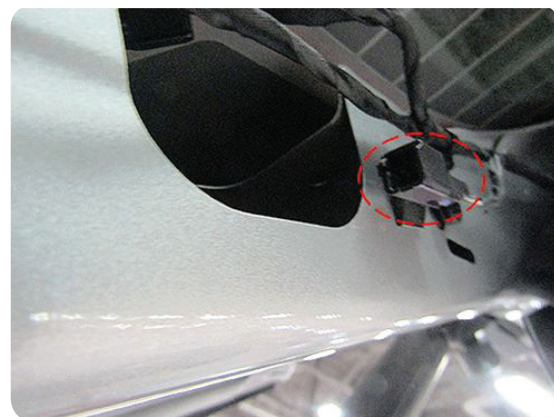
If DTC B153F is set, check that the male terminals in the liftgate object sensor connector to the liftgate harness are stable. Any misaligned terminals may cause intermittent electrical contact.

Check the terminals in the liftgate object sensor male in-line connector.

Check for any bent or misaligned terminals in the liftgate object sensor male in-line connector. Straighten any misaligned terminals and reconnect the connectors. Verify proper opening and closing of the power liftgate.

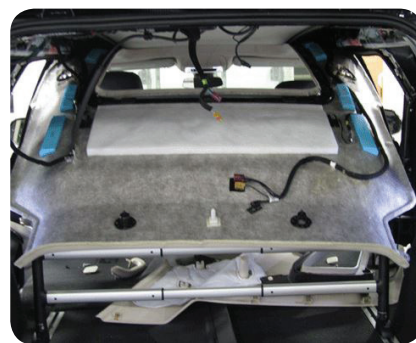
A body creak sound or rattle may be heard near the upper header by the liftgate hinge on some 2018-2019 XT5 models. The sound or rattle may be caused by the two metal structure panels, located in the rear header, rubbing together. The condition is most often found on the left side of the vehicle.

Lower only the rear portion of the headliner.

Pry the two metal structure panels away from each other to eliminate the sound or rattle. Remove both quarter upper trim panels and both center pillar upper trim panels. Lower the rear portion of the headliner only.

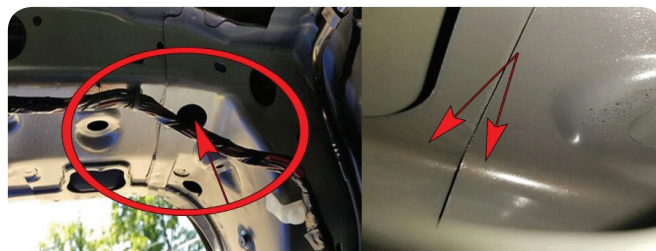
Use the access hole to reach the panels.

To separate the two panels at the seam, go through the access hole using a cotter pin tool or similar tool. The panel seam is located toward the liftgate opening on a 90° angle. It is not directly above the access hole.

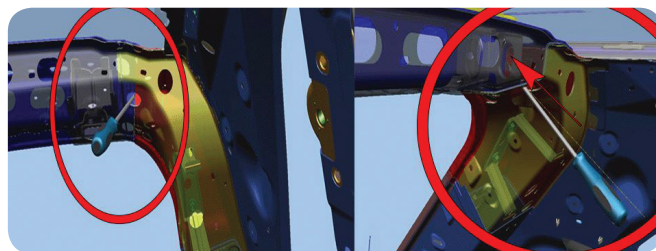
The panel seam is on a 90° angle from the access hole.

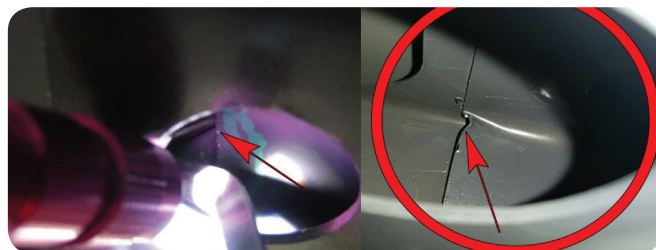
Separate the two panels.

Place the tool between the two panels and twist or apply pressure to separate the panels.

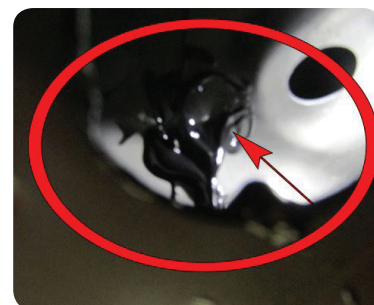
Apply an approved metal panel bonding adhesive.

After the panels are separated, apply any approved metal panel bonding adhesive between the two metal panels. Refer to metal panel bonding in the appropriate Service Information.
