GM Training Programs for Dealership Service Technician Candidates	1
Diagnostic Tips for Battery DTCs	3
Vibration during Hard Acceleration	4
Service Technician Enrollment in the 2019 Mark of Excellence Program	4
Front Roof Wind Noise or Water Leak.	5
Power Liftgate Assist Actuator Replacement	6
Low Oil Light Illuminated on CTS 2.0L Models.	6

Diagnostic Tips for Battery DTCs

TECH LINK

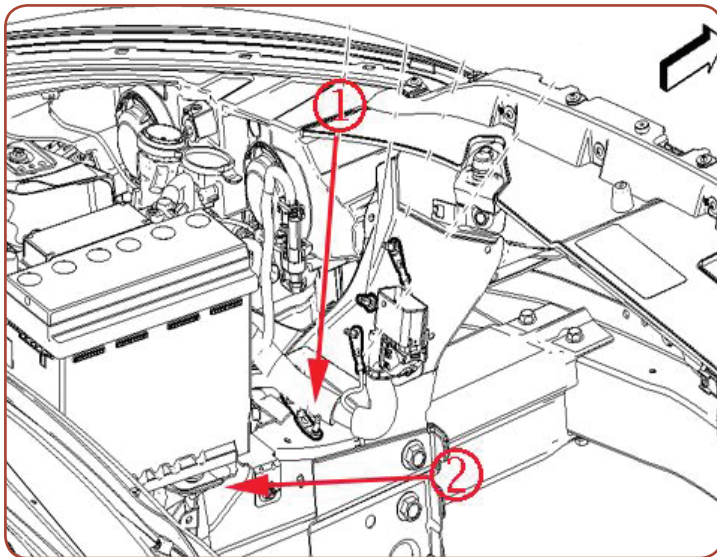
If the state of health of the auxiliary battery is good, check ground resistance from the Dual Battery Isolation Module (DBIM) to G103. Wiggle the harness and negative battery terminal connections to look for varied resistance values.

1. DBIM harness
2. Engine harness under main battery tray

If the resistance is greater than 0.5 ohms, or changes more than 1 ohm, inspect the ground connections and the splice in the harness about 1.5 feet from the connector end. Repair any poor connections.

If the resistance is less than 0.5 ohms, verify that the engine harness is not pinched underneath the main battery tray.

If none of these conditions are found, replace the DBIM. The DBIM is located on the fuse block assembly, which requires replacing the Battery Distribution Fuse Block and wiring harness connector.

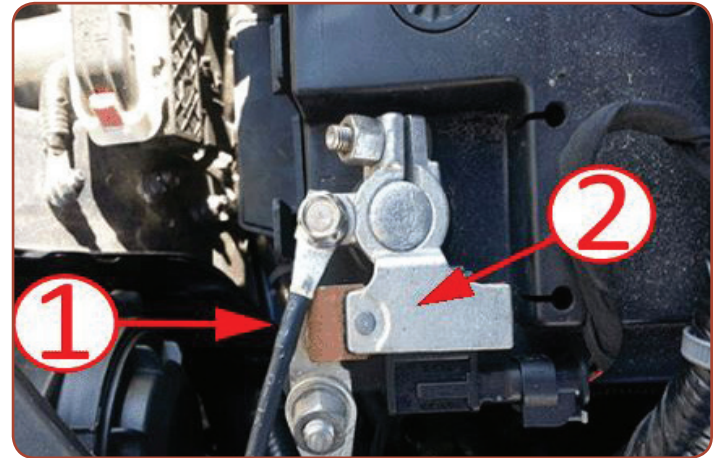
1. Grounding ring for circuit 150
2. Battery Sensor Module

If DTCs P058B and/or P058D are set, check the orientation of the grounding ring for circuit 150 to the B110 Battery Sensor Module.

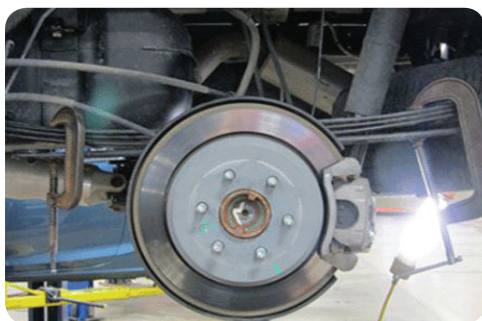
When under acceleration at speeds of 48–52 mph (77–83 km/h), the driveline angles may become extreme during axle wind-up, resulting in a 2nd-order vibration. To adjust the angle, install a tapered shim between the axle and leaf spring.

To install the shim, raise the vehicle and, using a hydraulic jack stand, support the rear axle. Apply tension to each end of the leaf spring using a C-clamp.

C-clamp attached to each end of the leaf spring.

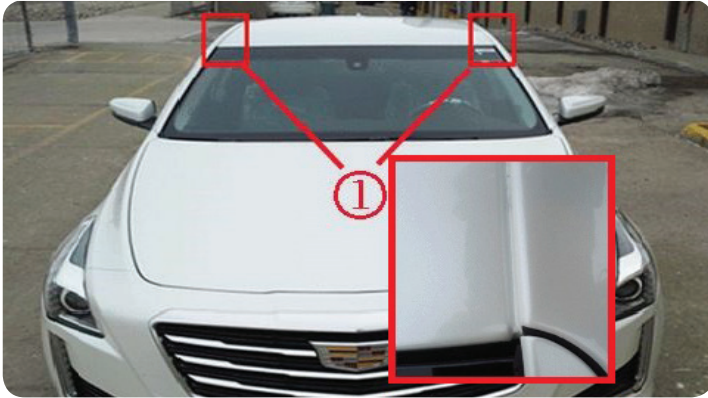
The wind noise or water leak may be due to pinholes, cracks or voids in the forward roof ditch laser braze area, the upper windshield flange seam, or lower corners of the windshield opening.

Possible laser braze water leak areas

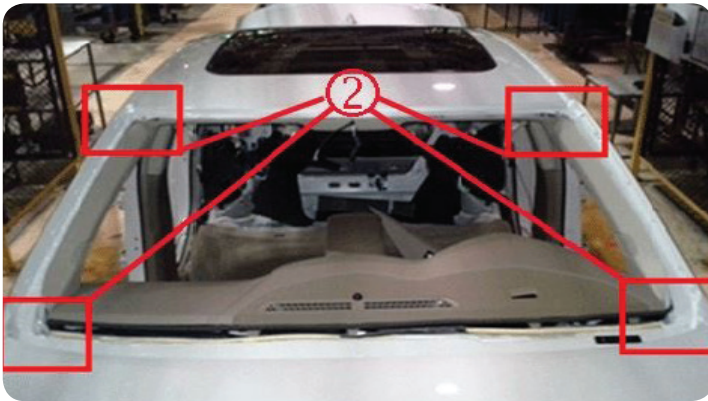
Possible windshield opening flange seam water leak areas

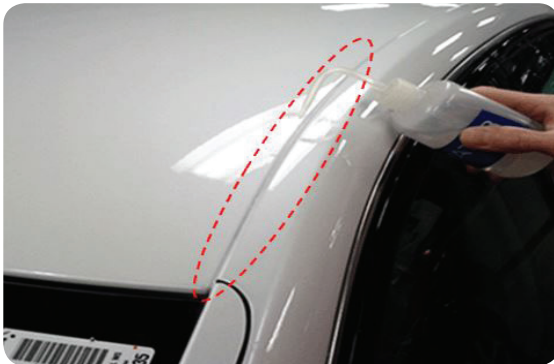
Begin with a clean and dry front laser braze area. Remove the windshield garnish molding and perform a water leak test on the forward laser braze and upper windshield area using a water hose without a nozzle attached.

Flood the area for up to five minutes while observing the interior A-pillar for any evidence of water running along the pillar.

Water leak test on the forward laser braze and upper windshield

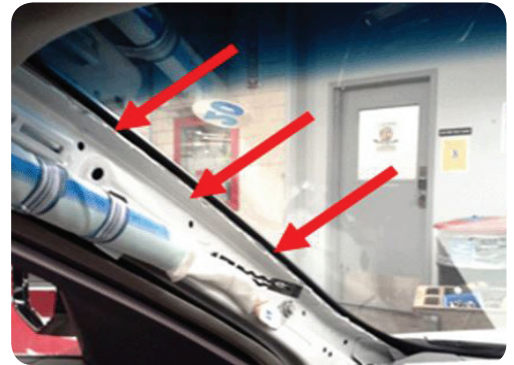
Observe the interior A-pillar for any evidence of water.

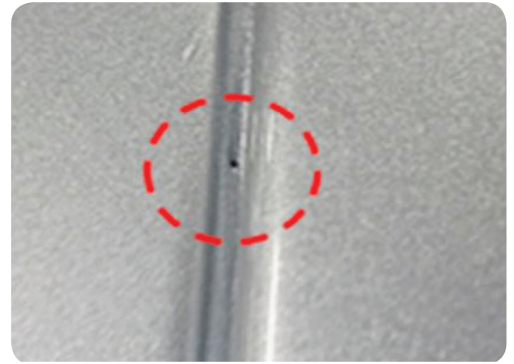
If a water leak is detected, inspect the roof laser braze for any pinholes or cracks. The small pinholes or cracks may be more difficult to see on darker color finishes.

Pinhole in roof laser braze

Seal any holes or cracks using Kent Automotive High-Tech Seam Sealer or equivalent with the proper touch-up paint color. Avoid any build-up of seam sealer within the ditch. Wipe away any excess sealer with a light amount of solvent on a shop rag or paper towel. The solvent will help the sealer flow into the hole or crack. Water test the repaired area again and inspect the interior A-pillar for any visible water leak.

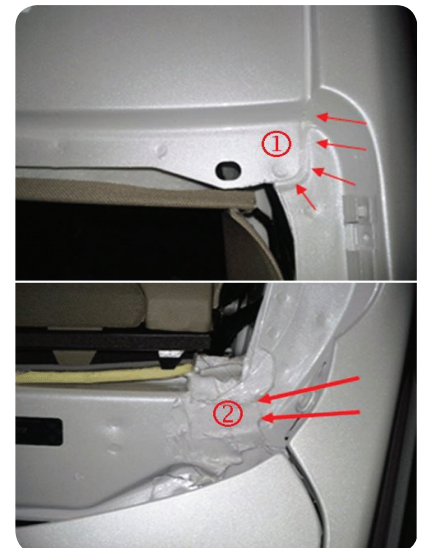
On the affected side, check the upper windshield flange seam at the end of the laser braze as well as the lower corner flange seam for any signs of pinholes, voids or cracks. Seal any holes or seams as needed following the sealing procedure and reinstall the windshield.

1. Upper windshield flange seam at the end of the laser braze
2. Lower corner flange seam

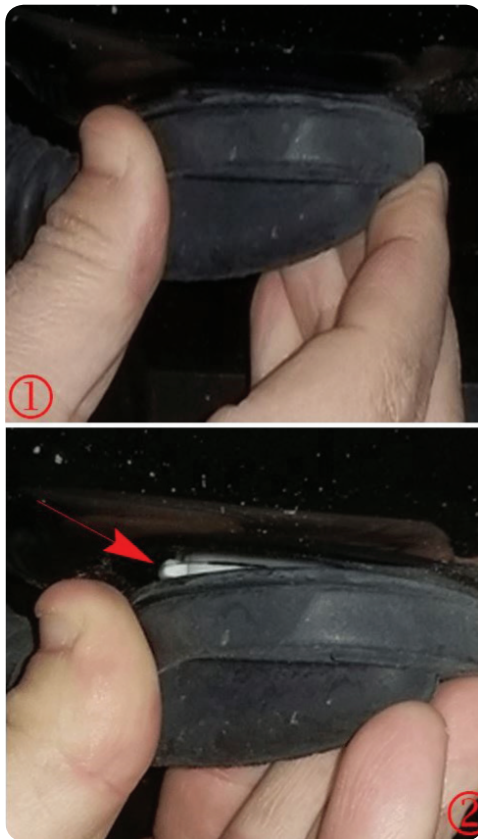
Prior to replacing the power liftgate assist actuator, verify the liftgate actuator grommet is properly seated to the sheet metal with no gaps. Any gap between the grommet and the sheet metal could result in water intrusion into the liftgate.

To check the retention of the liftgate actuator grommet, pull down on each of the four corners of the grommet individually to see if the clip is secured to the sheet metal or if the grommet pulls away easily. Also visually inspect or feel the entire lip seal of the grommet to check for proper seating.

1. Properly seated grommet
2. Gap between the grommet and sheet metal

Any grommet issues that are found that may have resulted in water intrusion should be noted on the job card or a Field Product Report should be submitted.

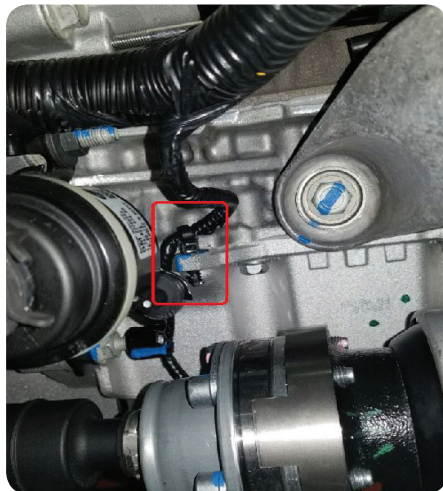
If the Low Oil Light is on, it may be due to the oil level sensor wiring harness clip installed incorrectly, which may cause the harness to become too long and contact the driveshaft.

Check the wiring harness at the point of contact with the driveshaft. Repair the harness if necessary and apply a double layer of Woven Polyester Electrical (PET) tape to all contact points of the harness.

Also check the positioning of the harness clip. The original routing of the harness has the clip installed from the bottom. Reposition the harness clip from the top down. Verify that there is proper clearance between the harness and the driveshaft.

Reposition the harness clip from the top down.
