## All-New 2019 Blazer Arrives with **ATTITUDE**

## TECH LINK

GM TechLink is published for all GM retail technicians and service consultants to provide timely information to help increase knowledge about GM products and improve the performance of the service department.

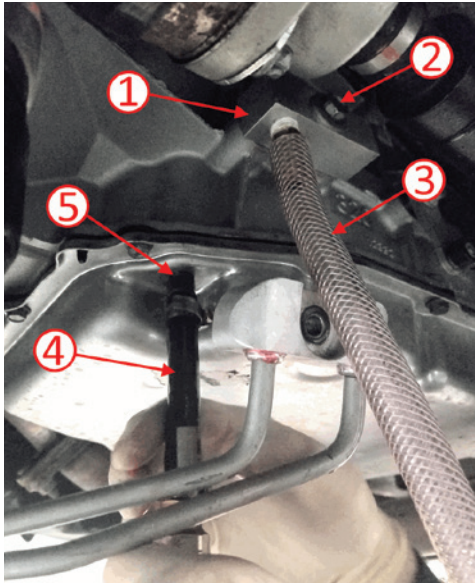
The TCC shudder condition is related to moisture content in the transmission fluid. The current fluid tends to be hygroscopic, or absorbs moisture, which increases the chance of TCC shudder. There are three different fluid exchange procedures to follow,

New fluid exchange procedure using a TransFlow adapter (1), transmission fill adapter (2) and new tool kit components.

The new fluid exchange procedure requires the use of the DT-45096 TransFlow Cooler Flush Machine and DT-52263 Transmission Fluid Exchange Tool Kit. The tool kit began shipping to dealerships at no charge in late January 2019. All GM dealerships should receive the tool kits by the end of March 2019.

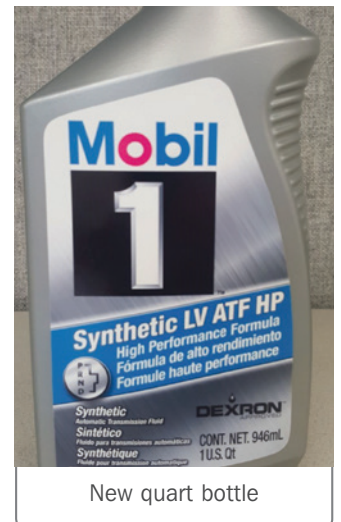
New quart bottle

Quart bottles, which can be identified by a new blue banner across the front of the bottle, will be limited to 20 cases/120 quarts per dealer per week during the initial launch of the new product. The new bottles also feature the HP license number J-62120 on the back label.

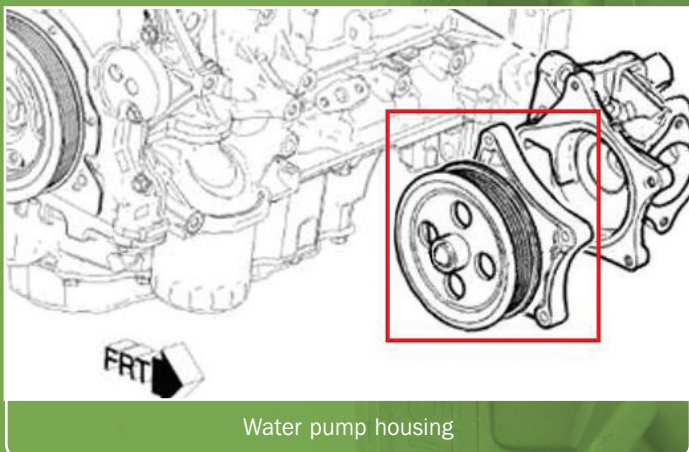
Water pump housing

Some water pumps may have been replaced when the actual failure was the water pump housing on some 2016-2019 Encore, Cruze, Malibu, Spark, Volt, and 2018-2019 Equinox and Terrain models equipped with engine RPOs LE2, LFV, LV7, L3A, and LYX. New water pumps are being returned to the Warranty Parts Center with the old water pump housing installed. These conditions may be due to the description of the parts in the Electronic Parts Catalog (EPC).

If the water pump requires replacement for a noise, leak or poor coolant flow, refer to "Housing w/PMP" in the EPC.

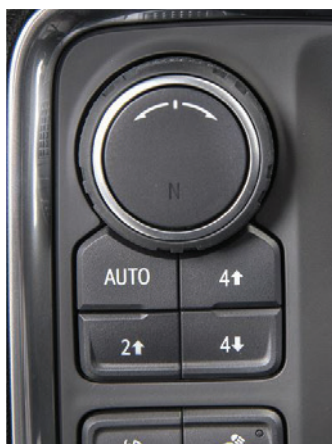
Transfer case controls

If DTC P1899 or P189A are set as current DTCs in the ECM, attempt to shift through all the transfer case ranges using the controls on the left side of the instrument panel. If the transfer case will shift through all ranges, clear the DTCs. If the DTCs do not reset, return the vehicle to the customer. The DTCs may be setting falsely and GM Engineering is currently validating a repair procedure.

If the transfer case will not shift through all ranges, clear the DTCs. If the DTCs cannot be cleared or reset immediately, replace the TCCM.

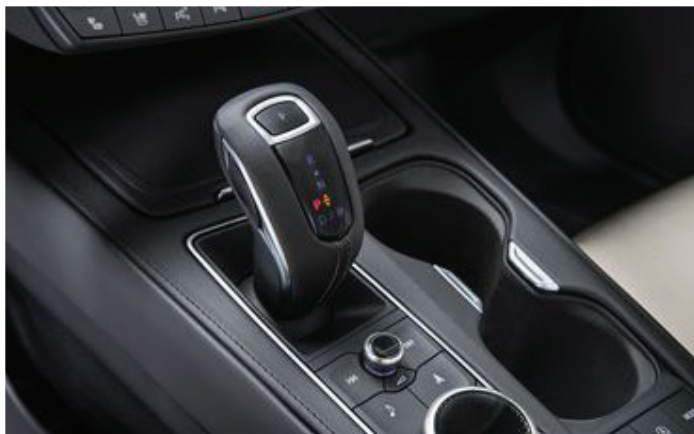
ETRS shift lever

Currently, the vehicle does not properly support KR75 Powertrain Relay functionality for Transmission Surge Accumulator performance, which can lead to a battery drain as the range command is set to undefined. As a result, the ECM gets stuck in a loop waiting for an input signal from the Electronic Transmission Range Select (ETRS). The loop keeps the network awake until there is another start/drive command of the battery discharges.

To avoid discharging the battery and to put the vehicle in the proper state, avoiding the battery drain loop, after remote starting the vehicle press the Park button on the transmission shift lever (ETRS) or press the Engine Start/Stop button to enter Run mode and then select any gear or Park.
