Chevrolet teamed up with premier offroad aftermarket supplier AEV (American Expedition Vehicles) to create the new 2019 Colorado ZR2 Bison (RPO ULV).

Colorado ZR2 Bison Offers Extreme Off-Road Performance

Shift Lever Rattle Sound

New Trailering App Trailer Connection and Lighting Diagnosis

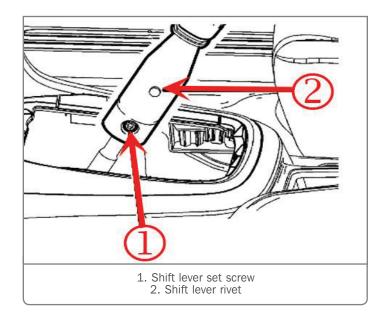
Some 2017-2019 Colorado and Canyon models may have a rattle sound coming from the automatic transmission shift lever. The sound may be due to a loose shift lever set screw or rivet in the shift lever.

Verify that the shift lever set screw is loose or the rivet holding the two-piece shift lever together is loose. If there is a noise from the shift lever, check the torque of the set screw. The torque specification is 80 in.-lbs. If the set screw is loose, remove the screw, clean the threads, and apply blue Loctite. Torque the screw to specification.

If the set screw is at or above the proper torque, tap the end of the rivet and listen for a noise or check for free movement of the rivet. To help isolate the rivet as the source of the rattle sound, wrap tape around the shift lever to cover the rivet. If the wrapped tape eliminates the sound, replace the shift lever.

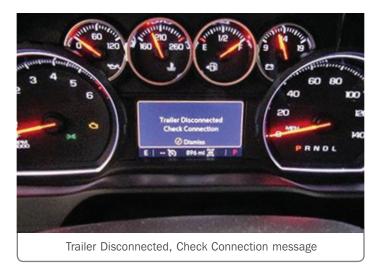
On some trucks, a Trailer Disconnected, Check Connection message may display on the DIC without a trailer being connected. If the Trailer Lighting Control Module detects enough of a load on any of the trailer tail lamps or stop/turn signal circuits, it may determine that a trailer has been connected. However, any moisture or corrosion in the trailer receptacle or Trailer Lighting Control Module connector, of anything left plugged into the trailer receptacle, such as trailer adapters with built-in test LEDs, may cause the module to think that a trailer is connected.

If this condition is found, remove anything plugged into the trailer receptacle and inspect for any moisture or corrosion in the trailer receptacle at the rear bumper, the chassis harness connector that plugs into the trailer receptacle, and the Trailer Lighting Control Module connector. Clean and repair any connection issues.

If the condition is not corrected after performing these checks, do not replace the Trailer Lighting Control Module. GM Engineering is currently evaluating this condition and working on a repair recommendation. For additional information, refer to #PIT5648.
