New Techline Connect Application Brings It All Together for Technicians

TECH LINK

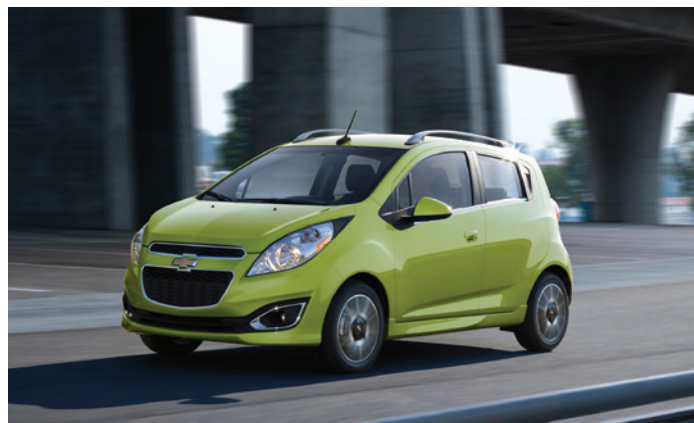
If DTCs P0871 and P2714 are set in the TCM, clear the codes and road test the vehicle. If the codes do not reset, no repairs should be made.

Road test the vehicle.

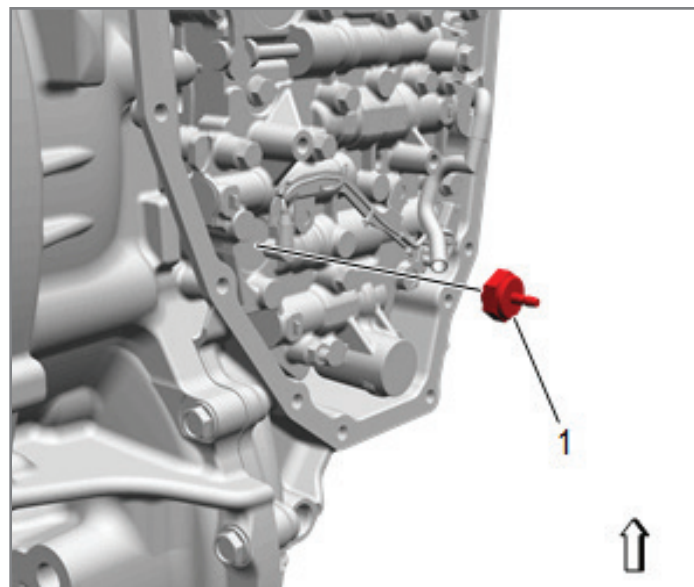
There may be a transmission performance concern on some 2014-2017 Spark models equipped with the CVT7 continuously variable-ratio automatic transmission (RPOs M4M, MR8). The Check Engine MIL may be illuminated and DTCs P0871 (Transmission Fluid Pressure Switch 3 System Performance) and P2714 (Pressure Control Solenoid Valve 4 Stuck Off—Hydraulic/Mechanical Problem) may be set in the Transmission Control Module (TCM).

When either DTC P0871 or P2714 sets, the TCM commands the auxiliary gearbox into 2nd gear. If the codes do reset after the road test, replace the transmission fluid pressure switch. Refer to the appropriate Service Information.

Transmission fluid pressure switch

Two fluid pressure switch harness bracket bolts secure the switch. Disconnect the fluid pressure switch connector to remove the switch from the control valve body.

Currently, the transmission fluid pressure switch must be ordered from the Warranty Parts Center (WPC). Refer to #PIP5521A for the necessary order form and for additional information.

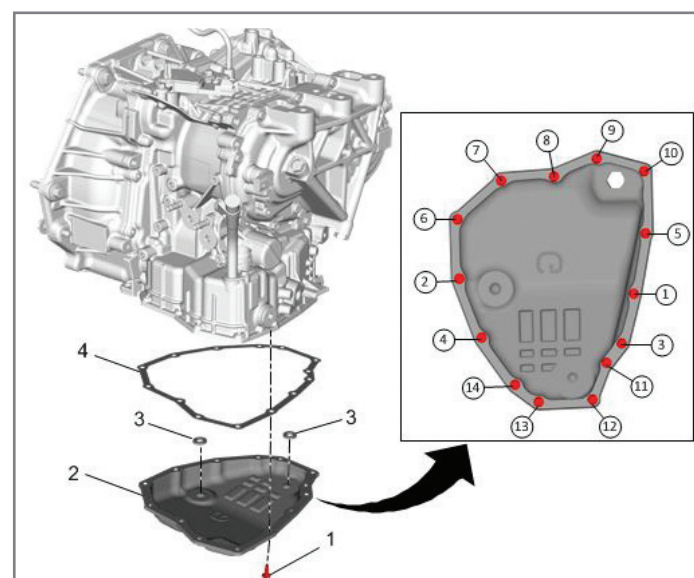
Control valve body cover on the bottom of the transmission

When reinstalling the control valve body cover, do not reuse the gasket. Install the 14 cover bolts by hand and then tighten all bolts to specification in the specified sequence.

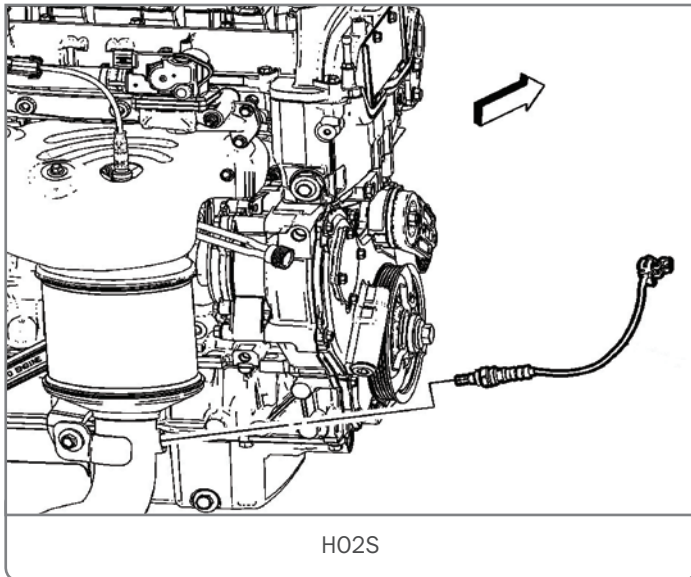
An engine stumble or stall after startup on some 2010-2017 Equinox and Terrain models equipped with the 2.4L 4-cylinder engine (RPO LAF, LEA) may be caused by a faulty aftermarket or incorrect upstream oxygen sensor (HO2S). In most cases, no DTCs will be set.

If an engine stumble or stall condition after a hot or cold start is found, monitor the upstream oxygen sensor voltage. The condition may occur more often when the vehicle is shifted into gear. The voltage may be skewing high, staying at 800mv or higher, which causes the ECM to believe the engine is running rich and results in an unnecessary lean out of the fuel system.

Check if the condition does not occur with the upstream oxygen sensor disconnected, which may confirm that the oxygen sensor is the issue. Do not remove the pigtail from the sensor. Inspect the faulty oxygen sensor to determine if it is an aftermarket part or is the incorrect oxygen sensor, such as a sensor for a different vehicle application or position.
