Generator Conditions Due to Water Leak3

Multiple Electrical Concerns Due to Wiring Harness Contact. . . .5

10-Speed Automatic Transmission Control Valve Body Bolt Kit.9

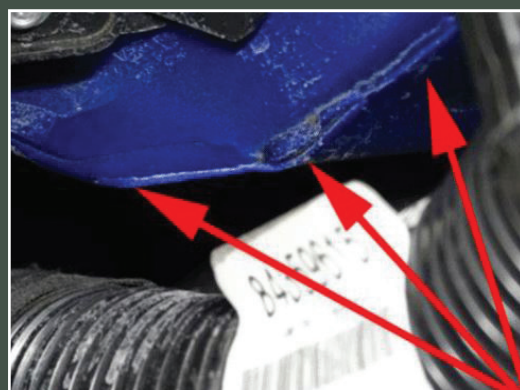
Some 2018-2019 Express and Savana vans equipped with the 4.3L V6 engine (RPO) LV1 may have a hard start condition, broken fan belt, loss of power steering or loss of power brake assist. These conditions may be the result of water leaking from the cowl area into the generator vents. Under certain weather conditions, the water may freeze inside the generator and prevent it from turning.

The common location for the water leak is at the lower cowl of the engine compartment.

Leak location at the lower cowl.

If these conditions are found, replace the generator, fan belt, and any other pulleys that have been contaminated with rubber build-up from the belt heating up.

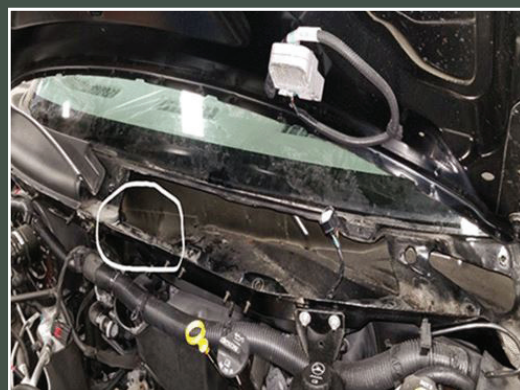
Inner lower right-side cowl seam

Remove the air inlet grille panels and the windshield wiper module to access the inner lower right-side cowl seam.

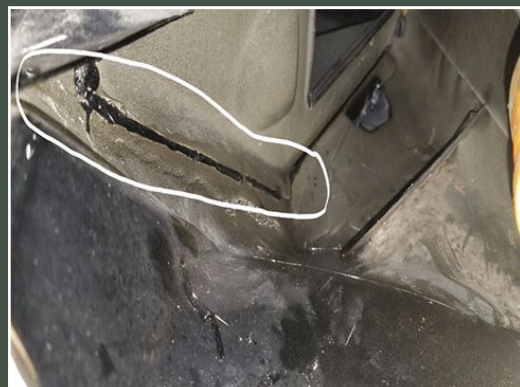
Apply sealer to the entire seam.

Apply Kent Automotive High-Tech Clear Seam Sealer to the seam. Be sure to apply the sealer to the entire inner lower right-side seam.

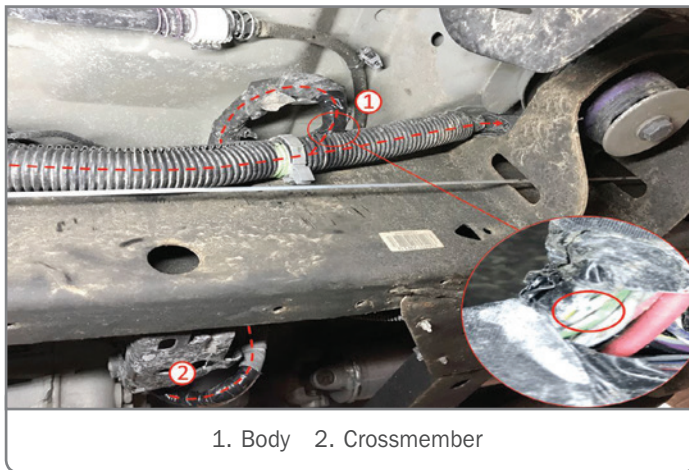
There may be several electrical conditions on some 2017-2018 Silverado and Sierra and 2019 Silverado LD and Sierra Limited models. The conditions may include several illuminated brake and traction control MILs, steering-related Driver Information Center (DIC) messages, inoperative tail lamps or rear turn signals, inoperative rear camera, and intermittent communication issues. These conditions may be due to damage to a multi-wire bundled harness.

Look for any corrosion or contact with the chassis.

Areas to inspect where there may be contact with the wiring harness include at the body and rear crossmember.

Inspect the wiring harness point of contact and repair any damaged wiring as needed. Tape all repaired contact points of the harness using Woven Polyester Electrical Tape (PET) in a double layer. If required, reposition the harness away from the area of contact.

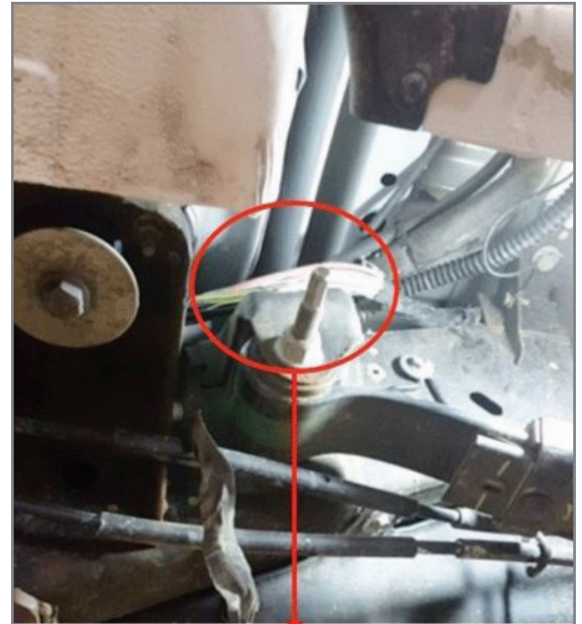
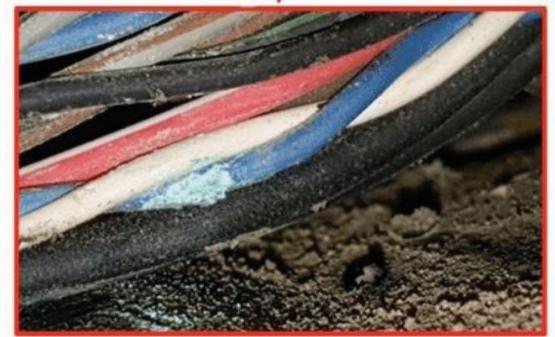
Frame/leaf spring support bracket

Also check the frame/leaf spring support bracket and the cargo box or bed mount.

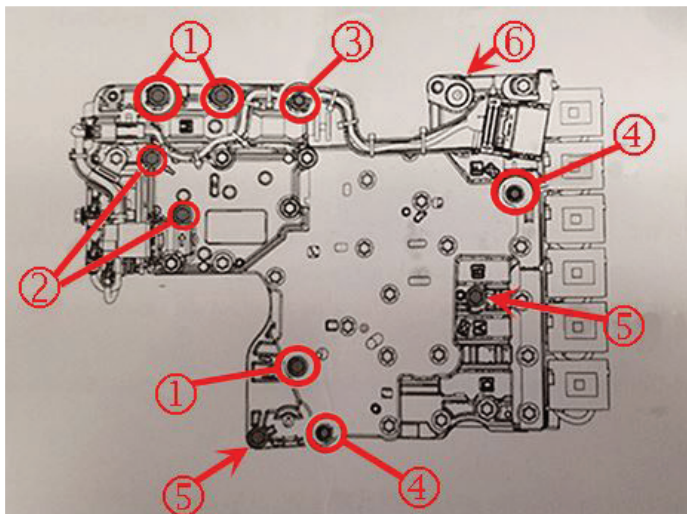
The control valve body bolt kit, part number 24294356, includes bolts that do not need to be replaced. The kit includes seven bolts, but only three bolts require replacement when removed. The instruction sheet indicates that all seven of the identified bolts should be replaced. The bolts are marked by arrows in the valve body casting.

Only 3 bolts require replacement (callout #1)

When replacing the control valve body on the 10-speed automatic transmission (RPO MQB) on 2019 CT6, Silverado 1500 and Sierra 1500 models, some of the bolts are one-time use bolts and should be discarded while other bolts can be reused.

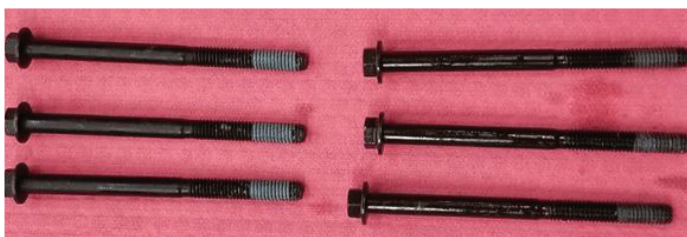
The new bolts in the kit contain a preapplied sealant as shown. The bolts removed from the valve body also are shown.

New bolts (left) and removed bolts (right)
