BOLT EV

Front Seatback Cover Replacement

The front seatback cover on some 2017-2019 Bolt EV models may become detached between the upper seatback cover and the side air bag. An updated seatback cover design has been released to address this condition. The new design features additional J-hooks that secure more tightly to the side air bag in order to keep the seat cover from becoming detached.

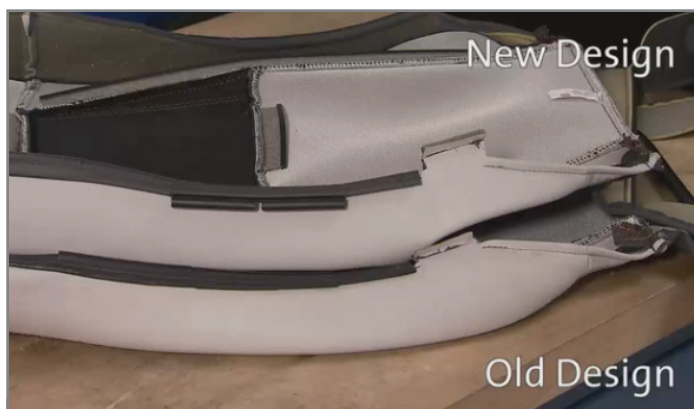
Updated seatback cover design

The 2nd design seatback cover comes with two additional J-hooks in the lower seatback area. It also uses J-hooks around the side air bag, arrow retainers around the edge and bottom of the seatback cover, and a black spline retainer along the inner edge of the cover.

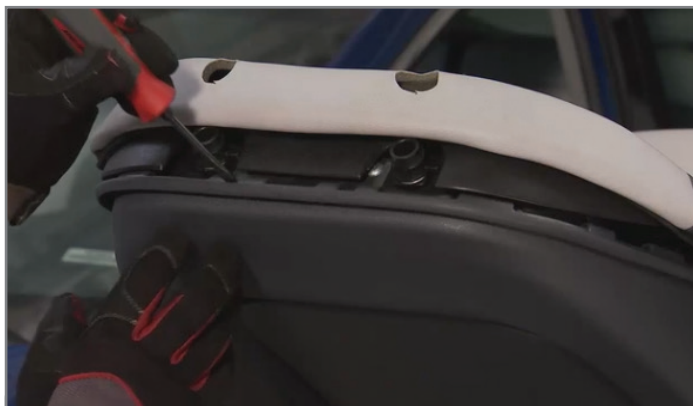
Release the seatback cover retainer

Use a flat-bladed tool to push in and release the seatback cover retainers at the top of the finish cover. With the top of the cover released, reposition the upper support bracket around the side air bag and pivot it upwards.

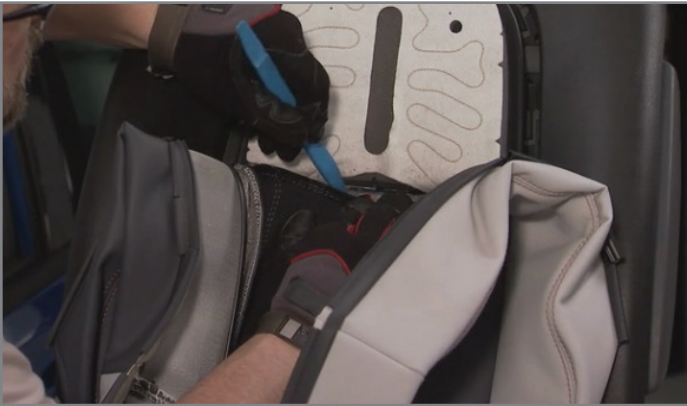
Secure the cover to channel in the middle of the seatback.

Begin the installation of the new cover by aligning the middle section of the seatback cover with the channel in the middle of the seatback. Use a trim stick to seat the retainer into the channel.

Work around the edge of the seatback cover to seat the black spline retainer into the channel.

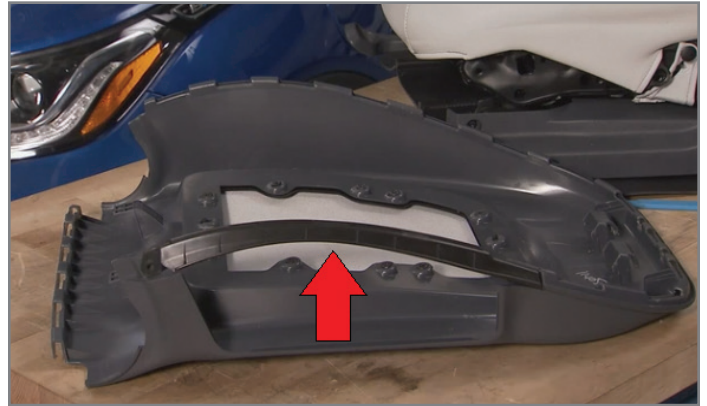
Install a new seatback upper support.

Install a new seatback upper support, which will help hold the seatback cover closer to the air bag cover.

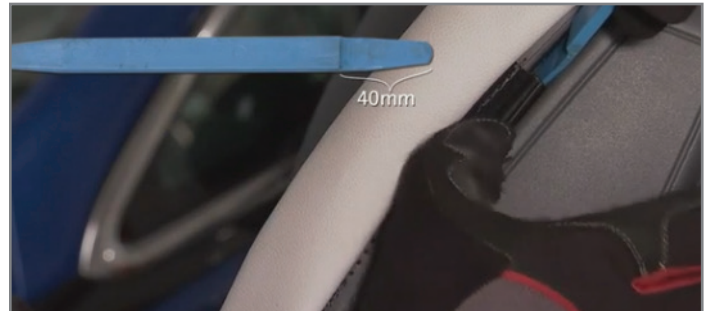
Modify a trim stick so it's thinner 40 mm from the end.

To install the new J-hooks around the rim of the outboard air bag, modify a flat-bladed trim stick by making it thinner approximately 40 mm in length from the end of the tool. The extra clearance is needed to properly install the new J-hooks. Be sure to only push the J-hooks in far enough to hook around the rim of the side air bag.

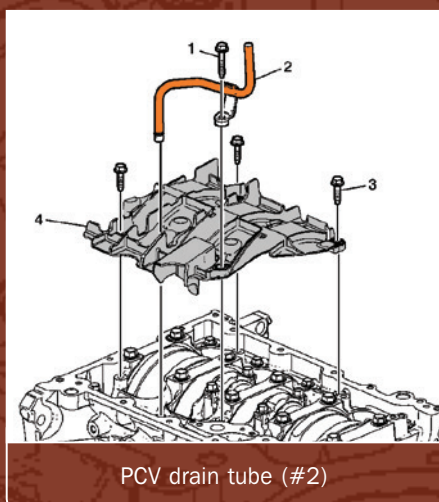
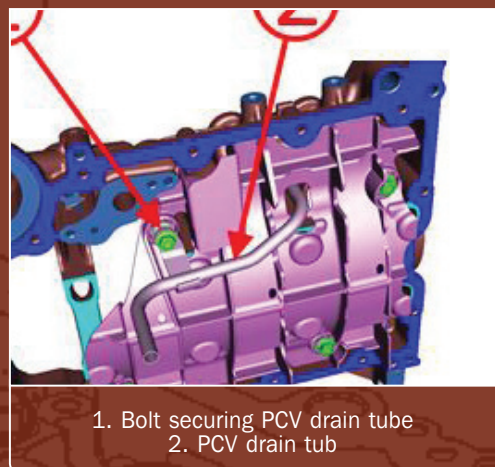
GM has determined that the PCV drain tube is not needed and the drain tube will be deleted in mid-year 2019 production going forward. As a result, the PCV drain tube will no longer be present when performing engine service on these engines nor will it be available as a service part. A replacement for the tube is not required.

If the PCV drain tube needs to be replaced, remove the bolt that secures the tube to the crankshaft oil deflector and bedplate. The crankshaft oil deflector does not need to be removed. Remove the old tube and discard it. Replace the drain tube bolt with a new shorter bolt to retain the crankshaft oil deflector. The shorter bolt must be used if the PCV drain tube is discarded.
