GE-52200-A Powertrain Lift Table . . . . .	1
Coolant Entering Engine Cylinders . . . . .	4
Camshaft Position System Performance DTCs Set in History . . . . .	5
Infotainment Screen Flicker . . . . .	6
Intake Manifold Vacuum Leak . . . . .	7
Dealer Case Management Enhancements . . . . .	8
Click Sound from the Torque Tube . . . . .	9

GM TechLink is published for all GM retail technicians and service consultants to provide timely information to help increase knowledge about GM products and improve the performance of the service department.

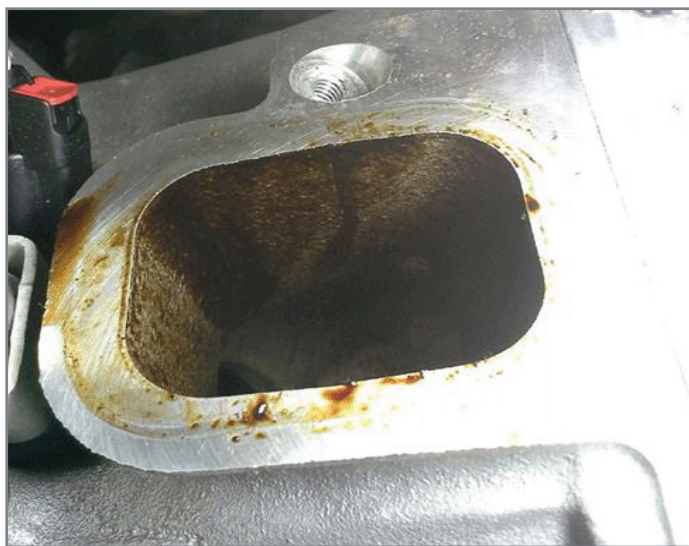
Misfires on start up only, with high rates always on one cylinder, can be suspect for coolant entry at the liner-to-deck face casting or the casting line in the intake port of the cylinder head.

If the head casting line is the issue, the intake port will be wet with a coolant and oil mix. This condition may cause the running rough while warm concern with or without DTCs set. The location where the coolant is running down in the port will look washed down. If this condition is found, the cylinder head will need to be replaced.

Coolant running down in the port will look washed down.

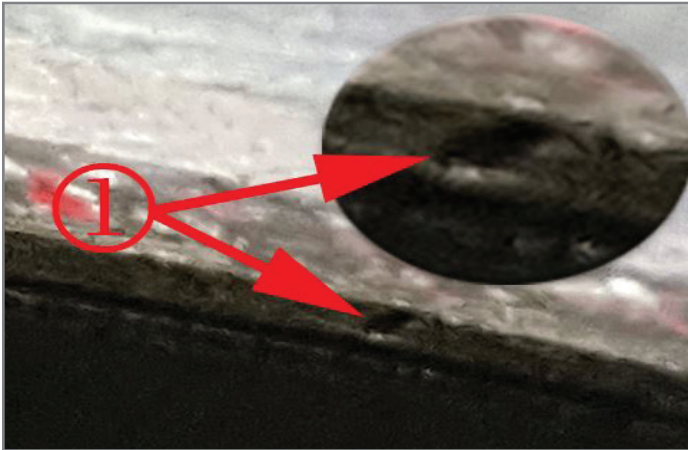
Pin hole

For coolant entry at the liner-to-deck face casting of the cylinder bore, it is hard to see the actual source (pin hole), but it usually streams down the liner so it may be seen with a borescope. The top of the piston will be steam cleaned.

Do not confuse residual fuel on the piston crown/surface as coolant. Some fuel residue may be present and can be mistaken as coolant, which is the reason for the cooling system dye to be added. Use a black light to confirm the liquid is coolant. If fuel residue is present, do not replace the cylinder head. Refer to the latest version of Bulletin #16-NA-338.

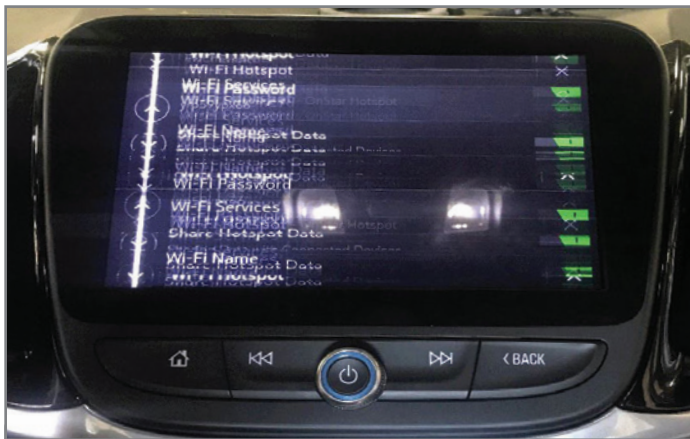
The infotainment screen may flicker occasionally on some 2019 Volt models. The screen flickering may be due to the component packaging inside the instrument panel, which may not provide adequate clearance between the Wi-Fi antenna and the wiring harness, causing electromagnetic interference with the infotainment screen.

Flickering infotainment screen

To eliminate the interference, reposition the wiring harness away from the Wi-Fi antenna.

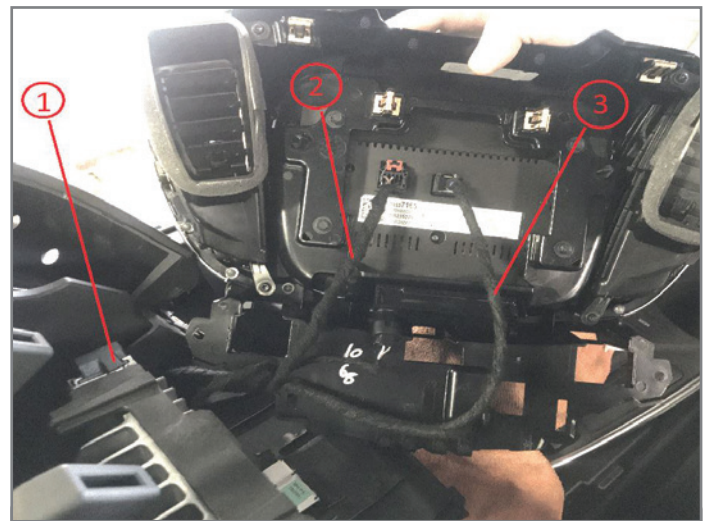
1. Wi-Fi antenna 2. ICS power cable 3. LVDS cable

On the rear of the screen, reroute the wires to prevent covering the Wi-Fi antenna on the instrument panel. The components include the Wi-Fi antenna, Branch Integrated Center Stack (ICS) power cable, and Branch Low Voltage Differential Signaling (LVDS) cable.

Move the ICS power cable toward the LVDS cable and zip-tie the ICS power cable with the LVDS cable near the connection points. Use a small zip tie to secure the LVDS cable to a clip loop created behind the key fob sensor.

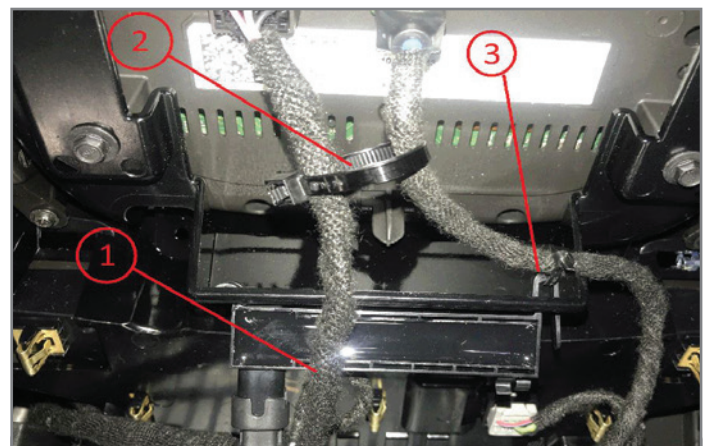
1. ICS power cable  
2. Secured ICS power cable and LVDS cable  
3. Secured LVDS cable

Ensure the new locations of the wires do not cover the Wi-Fi antenna. Cut excess zip tie length and check that any wires are not rubbing, kinked or pulled too tight.

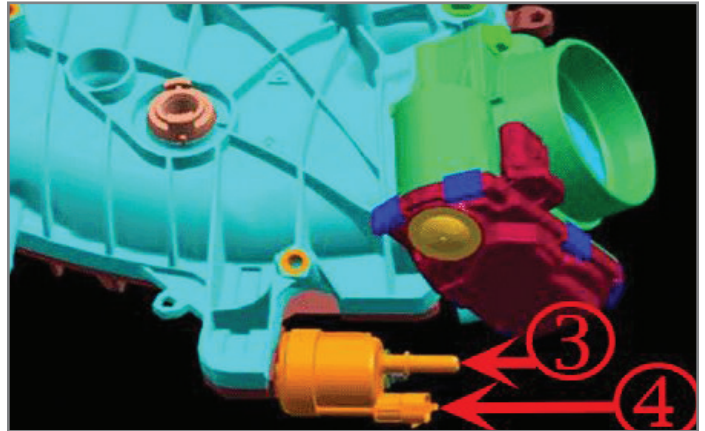
Disconnect the vacuum hose (#3) and power supply (#4) from the purge valve.

Locate the purge valve on the intake manifold and disconnect the vacuum hose and power supply from the purge valve.

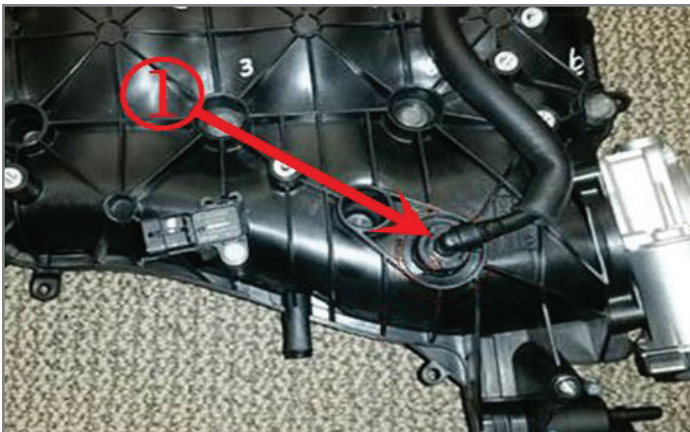
Detach the foul air tube (#1).

If both the first recorded long term and short term fuel trims were at a positive value above 5 and then the second recorded short term fuel trim went to a consistent negative value, replace the foul air tube.

If the first recorded short term fuel trim was at a value above positive 5 and the long term fuel trim was -2 to 2, but the second recorded short term fuel trim went to 0 or a negative value, replace the foul air tube.

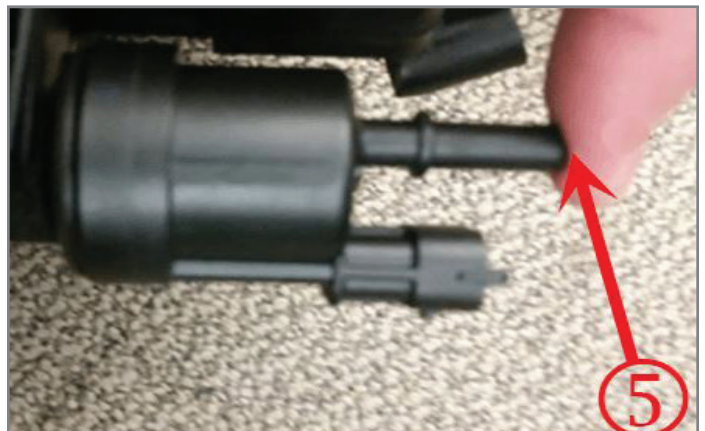
Test for vacuum on the open port of the purge valve.

Restart the engine and place your finger or a vacuum gauge over the open port on the purge valve. If you feel vacuum or read vacuum on the gauge at the port, it will be necessary to replace the purge valve.

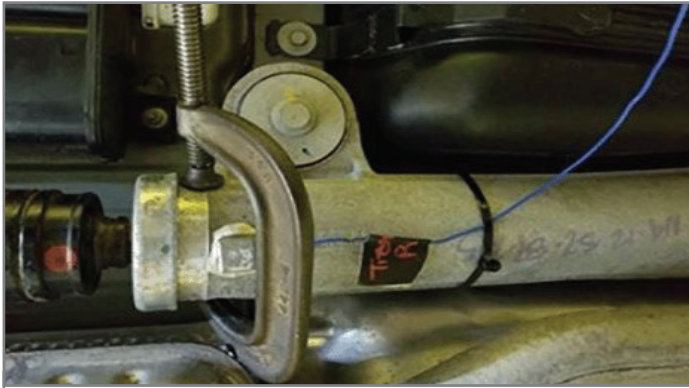
The click sound may be caused by the connection interface of the propeller shaft bearing in the torque tube to the prop shaft.

Place a C-clamp at the end of the torque tube.

With the vehicle securely lifted on a hoist, operate the vehicle to activate the AWD/4WD system. Confirm the sound is present by placing a C-clamp over the torque tube at the end of the tube.
