New GM Service Technical College App	1
Corvette ZR1 Rear Spoiler Adjustment.....	3
Proper GM Accessory Assist Step Installation	6
Whine Sound from Under Center of Vehicle	7
Viewing and Emailing GDS 2 Session Files	8
PCV Crankcase Pressure Control Diaphragm	9
Rattle Sound Near Front of Engine	10

TECH LINK

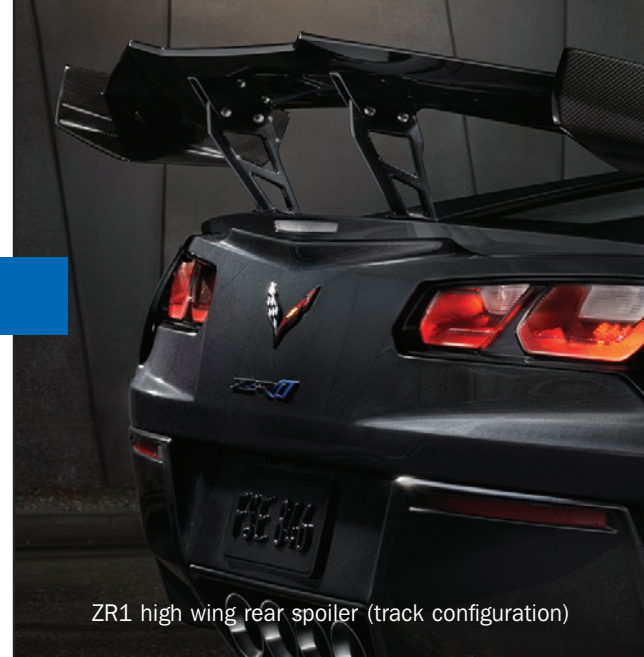
If the mounting piers are not positioned with the minimum 3 mm gap, the fascia paint may be damaged by the spoiler stanchions. Shown is the correct amount of clearance between the stanchions and the rear fascia.

Adjust the spoiler so that the spoiler mounting piers are even left to right and are a minimum of 3 mm above the rear fascia.

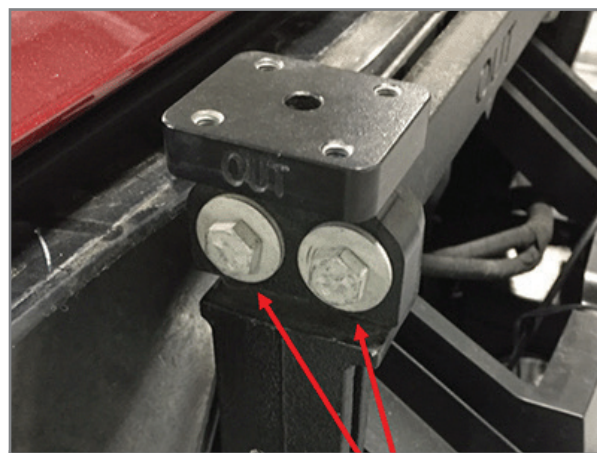
The adjustment bolts are on the left side of the bracket.

To correct the position of the rear spoiler, remove the rear fascia and adjust the Rear End Secondary Spoiler Bracket as needed until the spoiler is level.

The bolts that need to be loosened to perform the adjustment are located on the left side of the bracket.

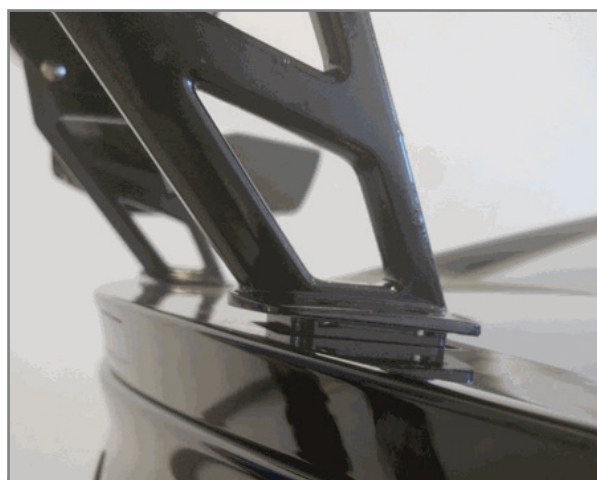
3 mm gap clearance between the stanchions and the rear fascia

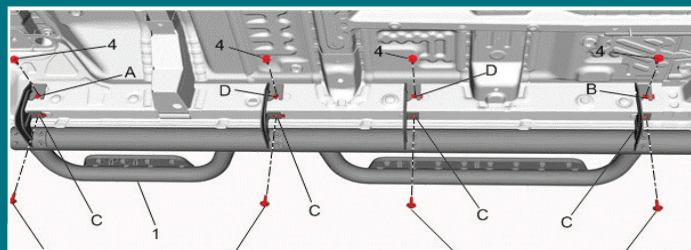
One of the keys to successful installation of the Assist Steps is verifying fastener torque to the proper specification. Warranty claims for the Assist Steps being loose or a noise heard during vehicle operation often will identify that the bracket bolts were not tightened properly or that the brackets were not properly aligned during installation.

Ensure all bolts are properly torqued.

Use the correct fastener in the correct location and ensure that all fasteners are properly torqued to specification. There are a different number of bolts for installation on gasoline and diesel vehicles as well as regular and extended cab or crew cab models.

If power tools are used, it's recommended to verify the proper torque of the fasteners with a torque wrench. It also may be helpful to paint mark M8 bolts to make it easier to visually check that they are properly secured.

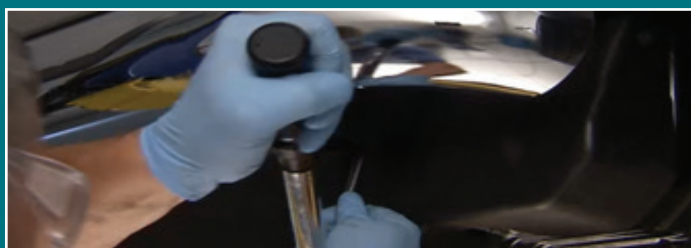
Install and torque the bracket retaining bolt and then remove the bolt to aid Assist Step installation.

To assist in the installation of the bracket near the DEF tank, it may be helpful to install and torque the bracket retaining bolt and then remove the bolt. The bracket should remain in place while securing the Assist Step.

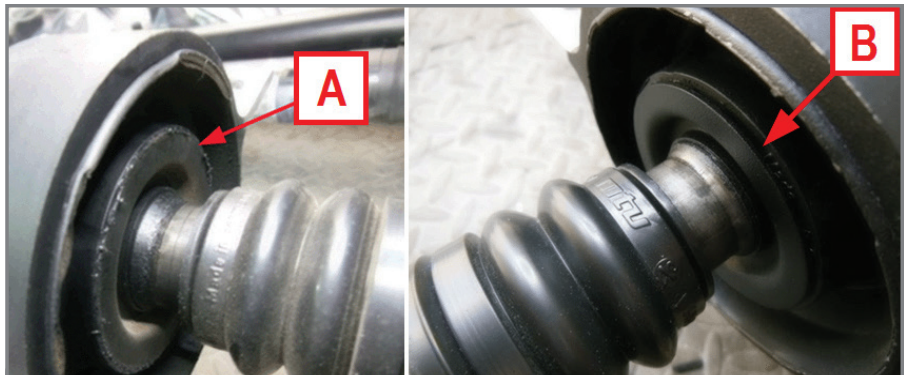
The sound may be caused by contact between the center bearing slinger and the rubber bearing support in the rear driveshaft assembly. Inspect the bearing and slinger for contact between the slinger and the rubber. There should be enough clearance between the slinger and rubber to allow proper movement of the bearing.

A. Contact between the slinger and rubber
B. Proper clearance between the slinger and rubber

If these conditions are found, replace the rear driveshaft assembly. Ensure that when the replacement shaft is installed, the bearing support is installed so it does not load the bearing in the rubber mount.

When properly installed, the clearance between the slinger and rubber support mount should be between 0.7 and 1 mm (0.027 – 0.040 in.).

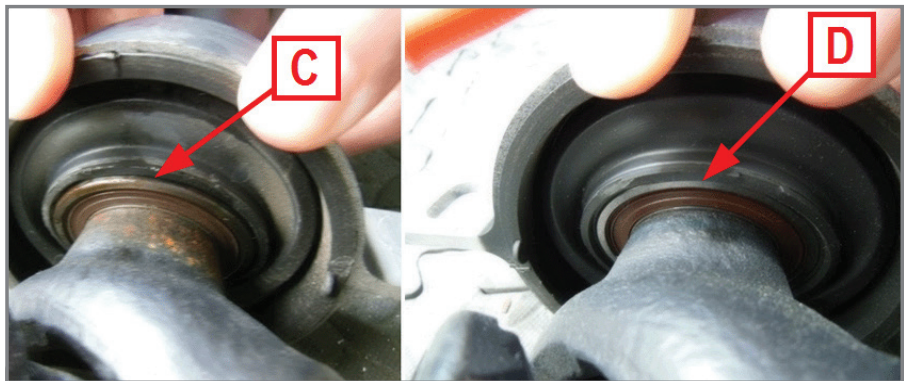
Also check the backside of the bearing. If the bearing is moving rearward, it allows the slinger to also move rearward. If the bearing is installed properly, there will not be any movement rearward.

C. Bearing moving rearward
D. Proper bearing installation

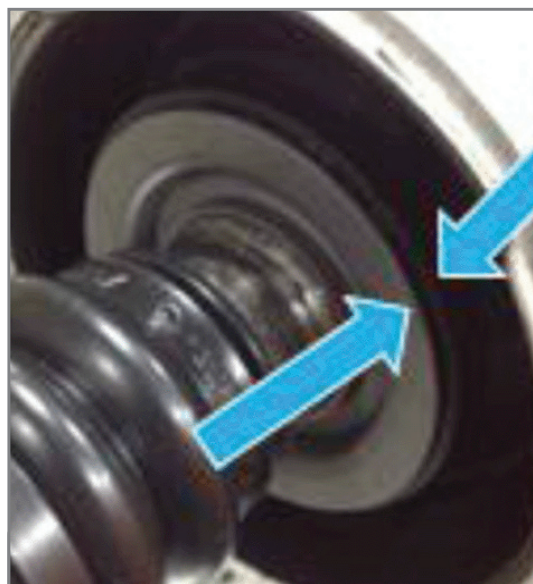
Proper clearance between the slinger and rubber support mount.

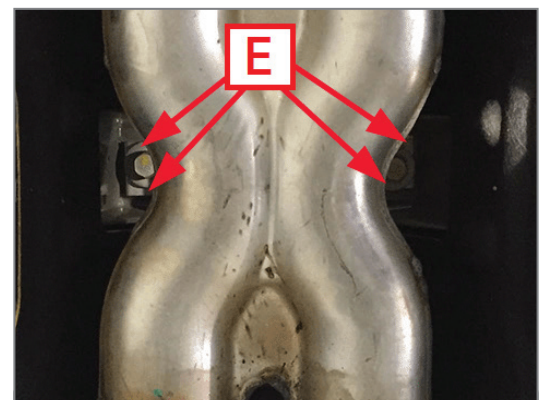
Driveshaft assembly centered in the left and right bolt holes.

When installing the driveshaft assembly, the bearing mount should be in the groove on both sides and centered in the left and right bolt holes.

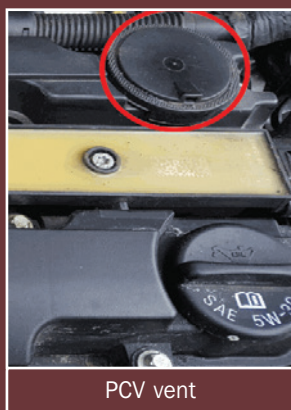
Next, check to see if there is vacuum at the PCV vent at the front of the PCV valve by placing a piece of tissue near it. The tissue will be sucked against the vent and held there if vacuum is present. Smoke also can be used to see if it is drawn into the PCV vent port.

Normal operation of the PCV crankcase pressure control diaphragm would cause a tissue to flutter against the port (smoke would not be continuously drawn into the port). A torn crankcase pressure control diaphragm would cause the tissue to be held against the port (smoke would be continuously drawn in) due to internal engine vacuum leaking through the diaphragm.

If the PCV valve is making noise and there is vacuum present at the PCV valve vent, replace the camshaft cover following the appropriate Service Information.

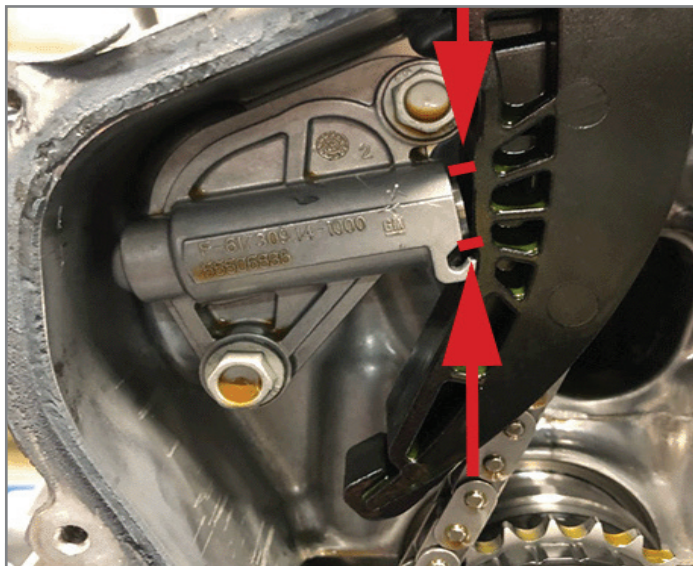
The 2019 XT4 may have a rattle sound heard near the front of the 2.0L 4-cylinder engine (RPO LSY) due to a stuck or collapsed timing chain tensioner and, as a result, a loose timing chain.

If the rattle sound is heard near the front of the engine, remove the lower engine front cover assembly and inspect the timing chain tensioner. A stuck timing chain tensioner plunger will allow an air gap to be present between the tensioner plunger and the timing chain guide.

Air gap between the tensioner plunger and the timing chain guide

If these conditions are found, replace the timing chain tensioner following the appropriate Service Information.

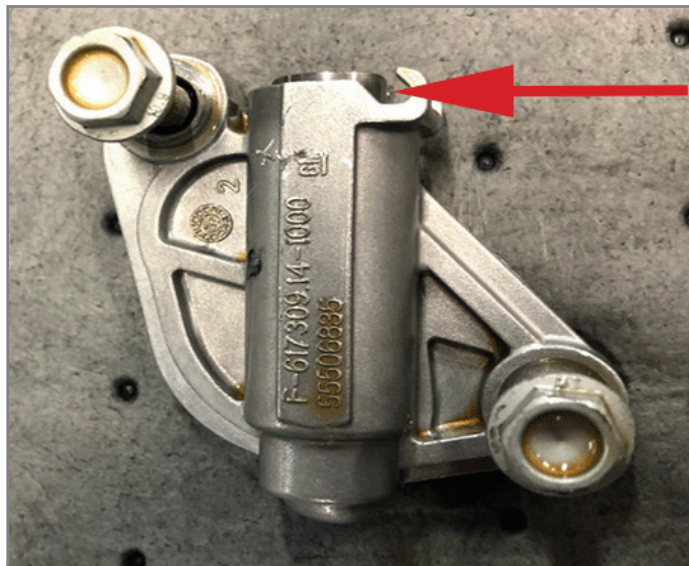
When viewing the timing chain tensioner removed from the engine, the plunger can be seen stuck in the body of the tensioner.

Plunger stuck in the body of the tensioner
