New Turbocharged 2.7L 4-Cylinder Engine

6.6L V8 Gasoline Engine Exchange

Throttle Body Connector Terminal Tension

TECH LINK

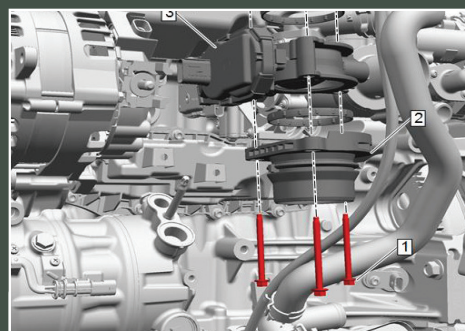
Some 2019 XT4 models equipped with the 2.0L 4-cylinder engine (RPO LSY) and 2019 Silverado 1500 and Sierra 1500 models equipped with the 2.7L 4-cylinder engine (RPO L3B) may have a Reduced Engine Power message displayed on the Driver Information Center and DTCs P2101 (Throttle Actuator Position Performance) and/or P1516 (Throttle Actuator Control (TAC) Module Throttle Actuator Position Performance) set as current or history in the Engine Control Module (ECM). These conditions may be caused by a possible throttle body internal gel contamination issue.

First, inspect the terminal tension at the ECM and throttle body. Verify there are no wiring-related issues present between the ECM and throttle body.

Inspect the connector (#3) terminal tension at the throttle body (LSY engine)

If there are not any wiring- or terminal-related issues found, replace the throttle body assembly and re-evaluate the condition.

If the diagnosis leads to ECM replacement and the vehicle was built after February 2019, complete the ECM replacement procedure following the appropriate Service Information and re-evaluate the condition.

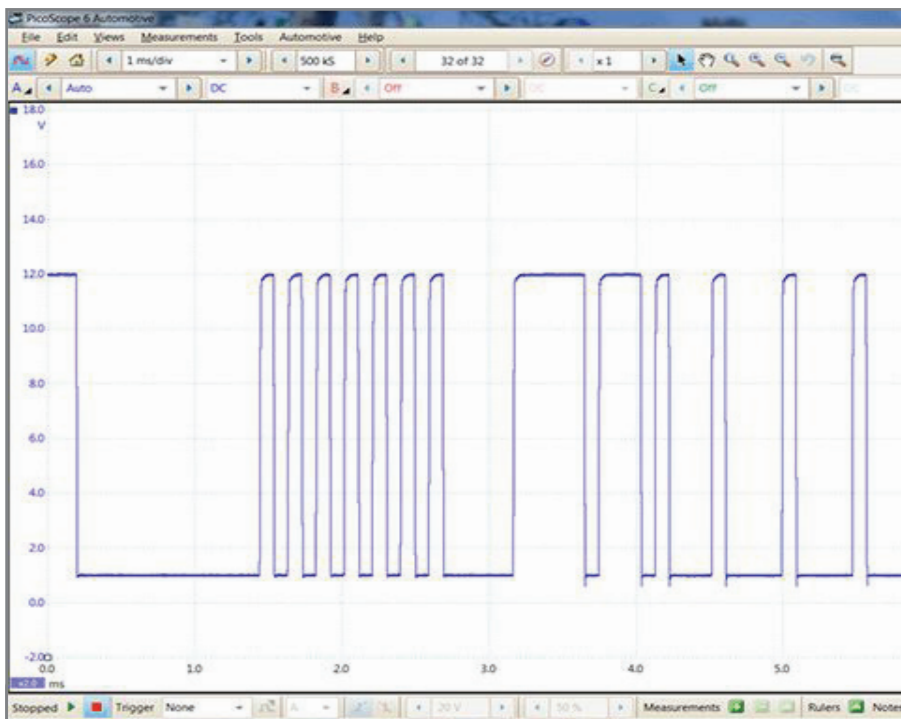
Each component on the LIN bus will send out approximately 11-12 volts and then toggle that voltage low when communicating.

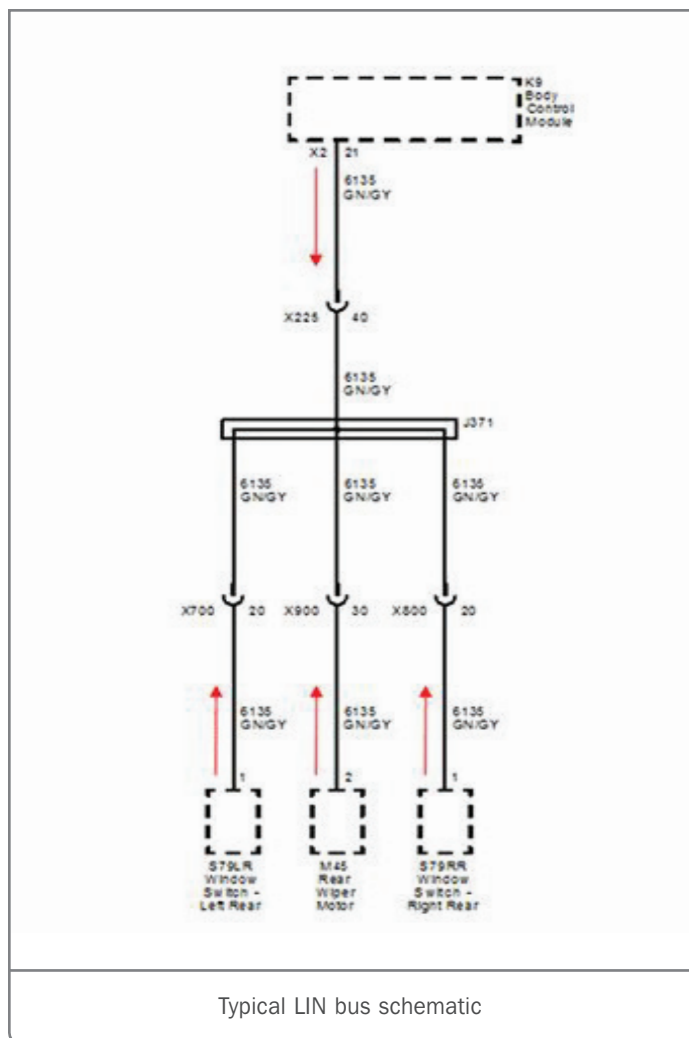
Typical LIN bus schematic

- If a LIN bus has more than one slave device, check to see if the other devices are working. Looking at the schematic, if the customer's concern was that the rear wiper was not operating, check to see if the rear power windows operate. This can help in narrowing down the area of concern.
- The LIN bus is a single wire and many faults are basic failures, such as opens, high resistance, shorts to ground/power, poor terminal drag, or connectors not fully seated. Use the proper terminal test probes to inspect for these types of failures.
- Testing/monitoring the voltage of the LIN bus can help determine what type of failure may have occurred.
- Check the output voltage from the master control module: With the master control module connected, disconnect the slave device and turn on the ignition. At the slave device, inspect for the toggling voltage from the master control module

If no voltage is found coming from the slave device, it could indicate poor terminal tension at the LIN bus terminal, the slave device was not powered on (missing power or ground), or the slave device

If the voltage is present, check that the correct part number slave device is installed. Slave device part numbers change from year to year yet the different devices may look similar.

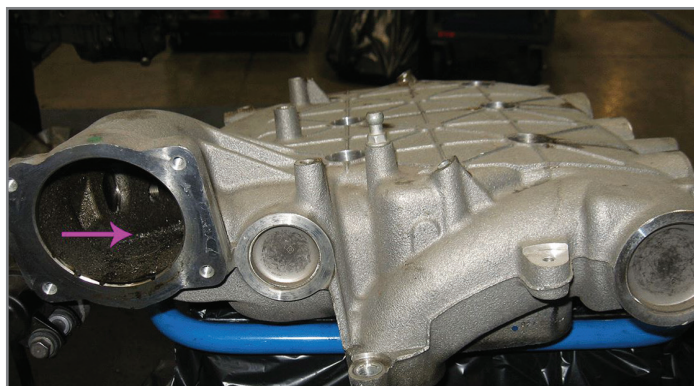
Internal engine damage may have resulted in the potential discharge of internal engine component debris into the intake manifold from any broken pistons or bent, broken, or missing intake valves. Broken valves and pistons as well as piston-to-cylinder head damage all create material debris that scatters throughout the induction system.

Debris in Aluminum Intake Manifold — Throttle Body Opening

After removing the intake manifold from the damaged engine, inspect all of the cylinder head intake ports to see if the valve heads are still present and not bent. Usually when the valve heads are missing or sufficiently bent, internal engine component debris will be present to varying degrees in the intake port of the cylinder head. If there is any debris present in the throttle body opening or any of the cylinder head intake ports, the intake manifold should be replaced.

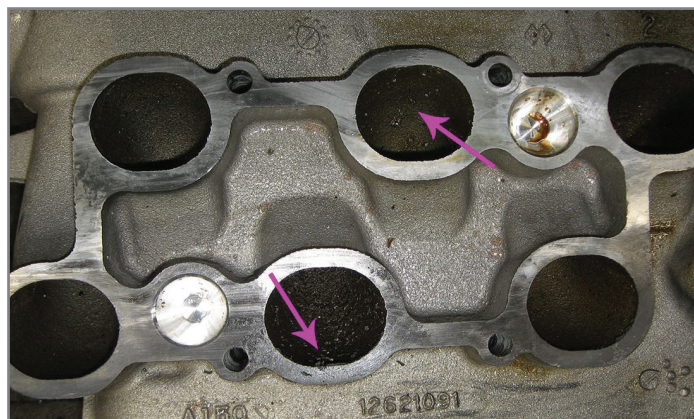
Debris in Aluminum Intake Manifold — Ports to Cylinder Heads

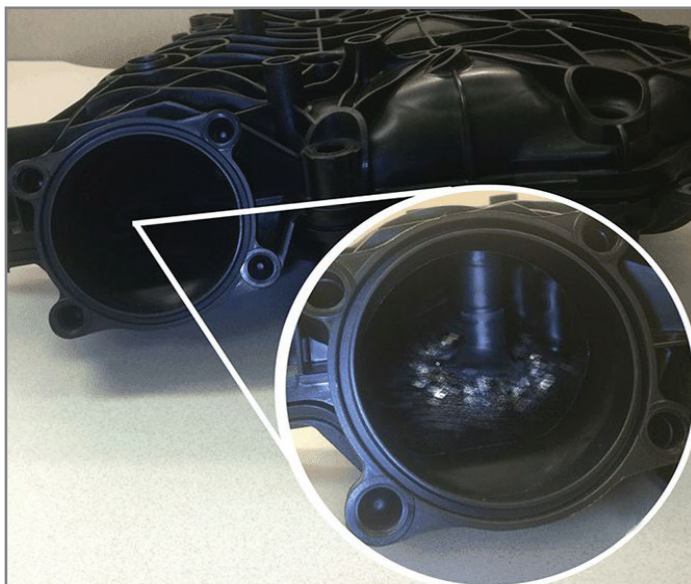
Debris in Plastic Intake Manifold — Throttle Body Opening

The complex inlet runner and plenum configuration of most of the intake manifolds make thorough and complete component cleaning difficult. In addition, it is nearly impossible to verify the complete removal of debris due to the complex configuration, making replacement a requirement if any debris is present.

Reinstallation of an intake manifold removed from an engine with deposits of internal engine component debris may result in the ingestion of any remaining debris into the new service engine, which will lead to damage or potential failure of the new service engine long block.

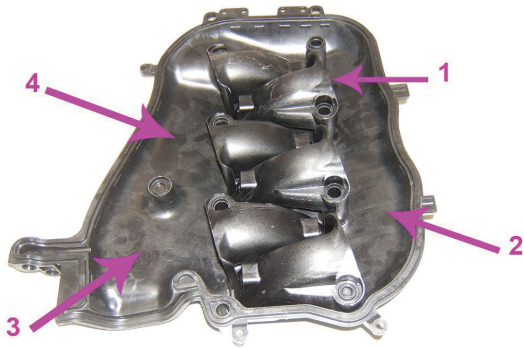
Looking at an internal view of the plastic intake manifold lower half (the plastic intake manifold cannot be disassembled), the intake port to cylinder head opening is just one of several areas where debris can collect.

1. Intake port to cylinder head opening
2., 3., 4. Areas where debris can collect

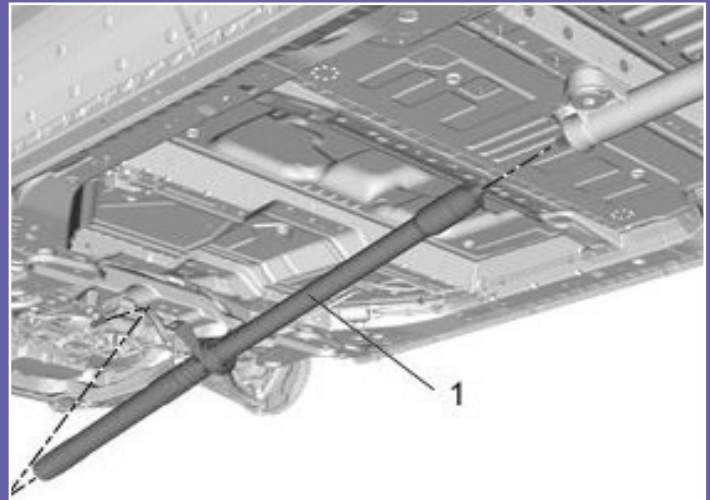
Propeller shaft

A whine sound may be heard coming from under the vehicle on some 2019-2020 Envision models equipped with the 2.0L 4-cylinder engine (RPO LTG) and the 9T60 automatic transmission (RPO M3T). The sound may be radiating from the driveline while at cruising speeds with light throttle input or while coasting at 30-60 mph (48-60 km/h). The sound may be found more prominent when the transmission is cold and slowly diminishes as the transmission warms up.

If this sound is heard, it may be caused by a drive chain internal to the 9-speed transmission. The sound radiates through the propeller shaft.

Replace the propeller shaft with a newly designed propeller shaft that has been released. The new propeller shaft has an integrated tuned vibration absorber designed to mitigate the whine sound.

Refer to two-piece propeller shaft replacement in the appropriate Service Information.

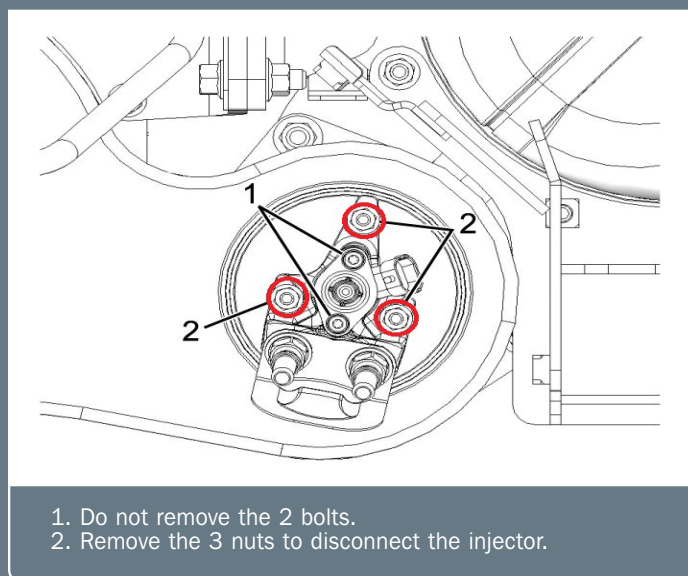
The DEF injector is attached to the mixer chamber located between the Diesel Particulate Filter (DPF) housing and the Selective Catalytic Reduction (SCR) housing.

When removing the DEF injector, do not disassemble the DEF injector by removing the two central bolts on the injector. Disconnect the injector by remove the three nuts on the outer edges of the injector. If the two bolts are removed instead, the resin portion may be damaged and the sealing performance may be lost, resulting in an exhaust gas leak. Also, do not reuse the gasket.

During installation, use a clean cloth to wipe off any foreign matter attached to the DEF injector. Using air to blow off any foreign matter may cause it to enter in the urea passage, resulting in a failure.

Once the DEF injector has been installed, perform the DEF injector data reset procedure for the DEF control module using SPS.
