# Multiple Electrical Conditions, Illuminated Instrument Cluster Warning Lamps, and DIC Messages

# Lack of A/C Performance in High Ambient Temperatures

# Bluetooth Microphone Poor Performance

# Rear Brake Squeal Sound

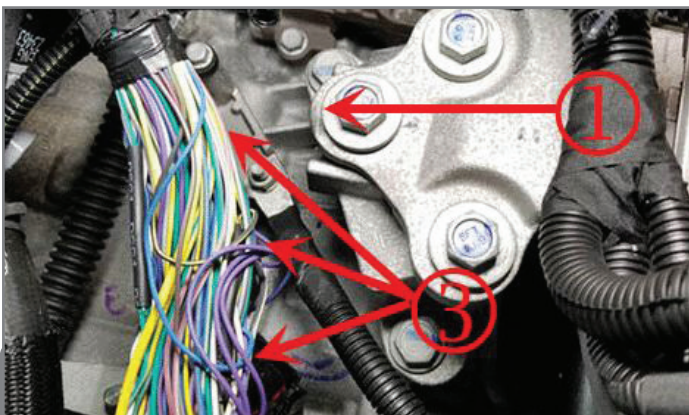
Check the harness for any damage.

Damage may be found at circuit 6387 TCM high side driver.

Repair any damaged wires according to the proper Service Information wiring repair procedures.

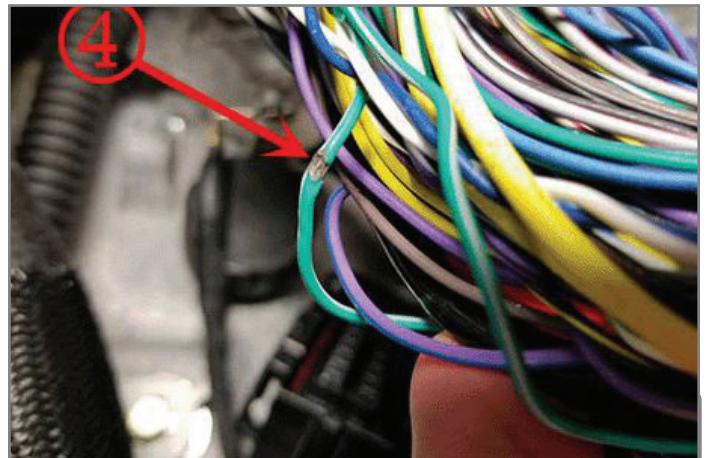
Damage may be found at circuit 6387.

In addition, check that the wiring harness retainer is properly installed into the bracket (shown not installed).

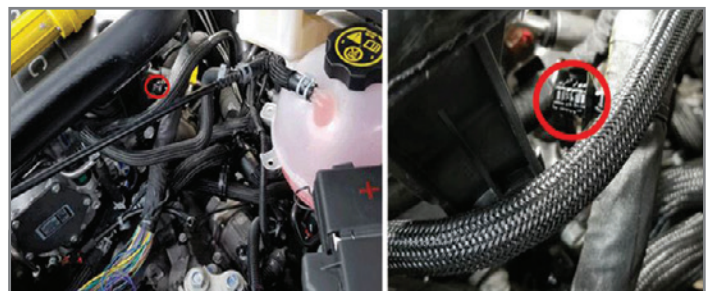
Wiring harness retainer not installed in bracket

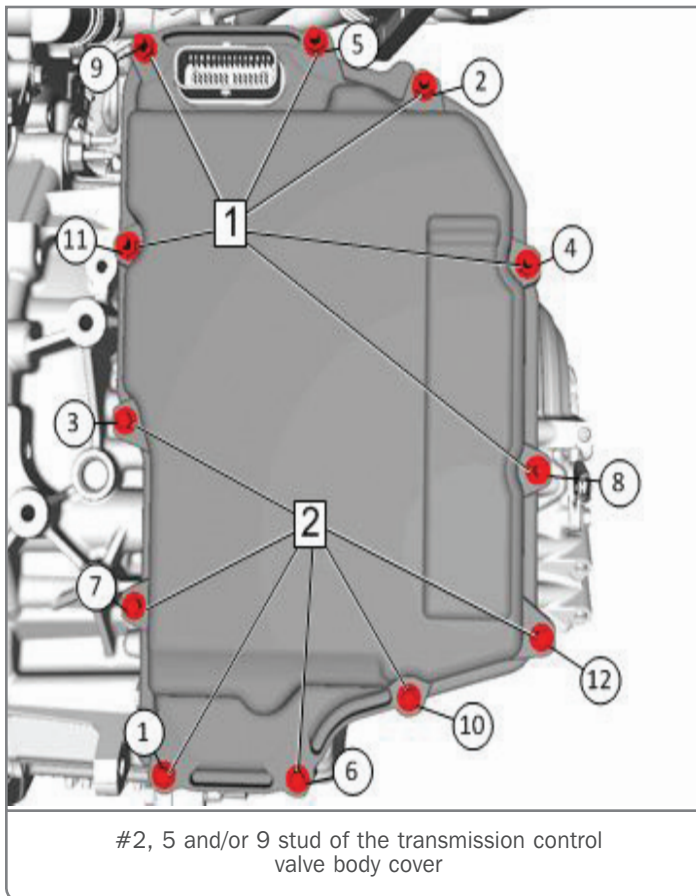
Inspect the wiring harness conduit and wires for chafing around the #2, 5 and/or 9 stud of the transmission control valve body cover.

At the point of contact, remove the wrap to check for any damaged wiring. Repair the damaged wires according to the proper Service Information wiring repair procedures.

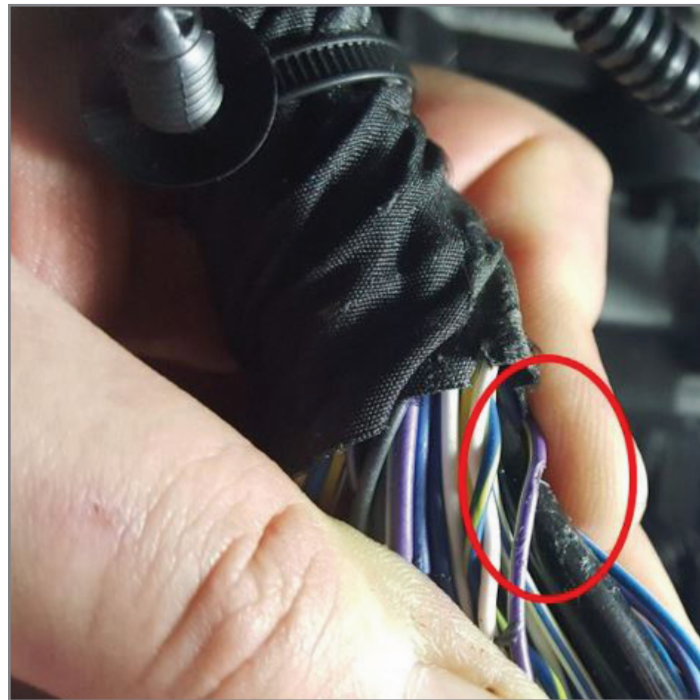
Check for damaged wires near the studs.

Use Woven Polyester Electrical Tape (PET) to tape all contact points of the engine wiring harness, ensuring that the tape is applied in a double layer extending along the harness past the splice sleeves

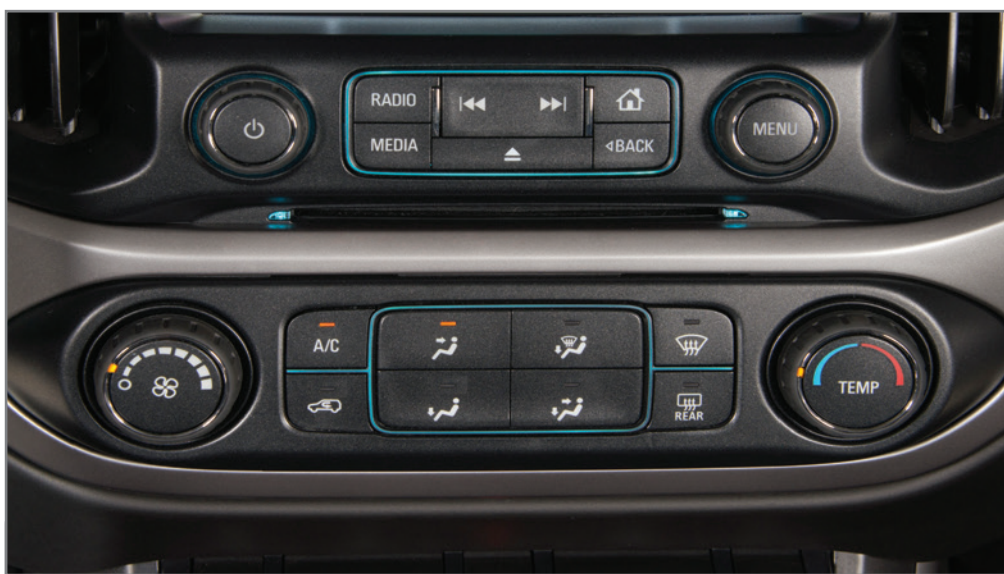
The air conditioning system may be blowing warm air on some 2017-2019 Colorado and Canyon models. In some cases, the A/C evaporator may be freezing up. There also may be a lack of air flow from some of the vents.

The lack of A/C performance may be due to the A/C system being used on the coldest temperature setting with the fan control set to the lowest speed setting. These conditions typically occur in climates with a high ambient temperature (over 85°F or 29°C) and humidity over 80 percent.

Lack of A/C performance may occur when the coldest temperature setting and lowest fan setting are used.

If it's determined that reprogramming is necessary, reprogram the H33 HVAC Control Module with the calibration available in TIS2Web with the SPS description: "Refer to TSB #19-NA-177 – Special Use Only. To reduce evaporator freeze-up in hot, extreme humid environments, such as gulf coast states. Not to be used in any other condition or environment due to some negative effects on cabin comfort."

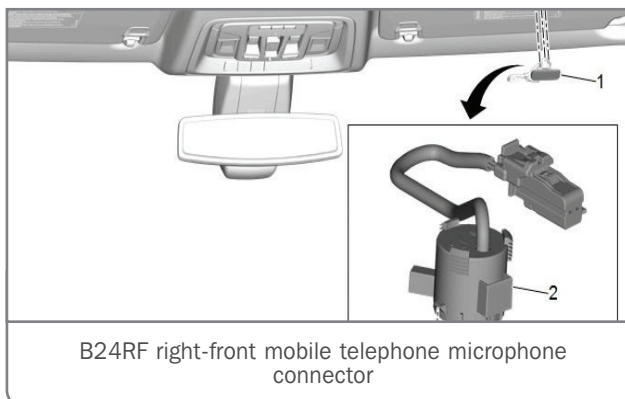
The sound may be due to poor terminal tension, or deformed or bent terminals in the passenger-side wiring harness at the B24RF

right-front mobile telephone microphone connector.

Inspect the B24RF microphone connector for any damaged terminals. Also check the mated bodies for any unseated terminals.

If any damaged terminals are found, replace the connector with leads. If no damage is found, follow the appropriate Service Information for additional diagnostic procedures.

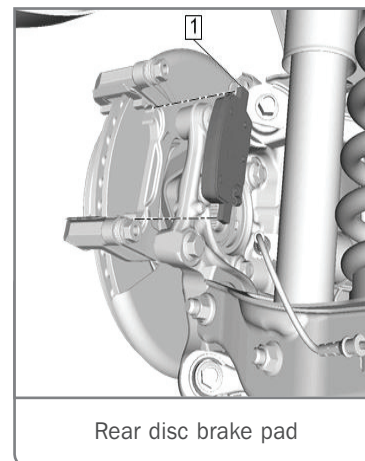
A rear brake squeal sound may be heard on some 2017-2019 XT5, Acadia (VIN N); 2018 Enclave, Traverse, Acadia; and 2019 Blazer models. The sound may be caused by

the current material used on the rear disc brake pad shims. The brake pads are now available with a shim material designed to eliminate the squeal sound.

If the rear brake squeal sound is found, replace the rear disc brake pads with the new design pads following the appropriate Service Information procedure.
