All-New Cadillac CT5 Debuts

UPDATE:

Rattle Sound near Front of Engine

TECH LINK

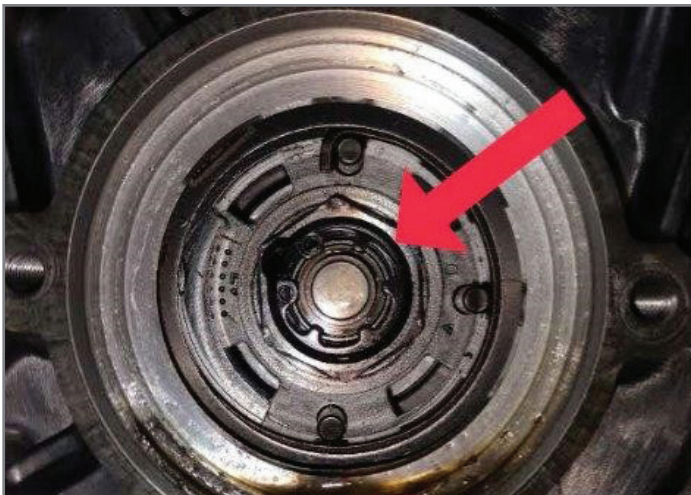
SNAP RING

A stuck or collapsed timing chain tensioner may cause damage to the oil control valve assemblies in either camshaft sprocket bolt. If a rattle sound is heard near the front of the engine, remove the camshaft position actuator valve solenoids and check for a missing, out of position, or damaged camshaft position actuator valve snap ring.

Inspect the camshaft position actuator valve snap rings.

If the snap ring for either camshaft sprocket bolt is missing, out of position or damaged, replace both camshaft sprocket bolts and perform the timing chain tensioner/guide inspections listed below.

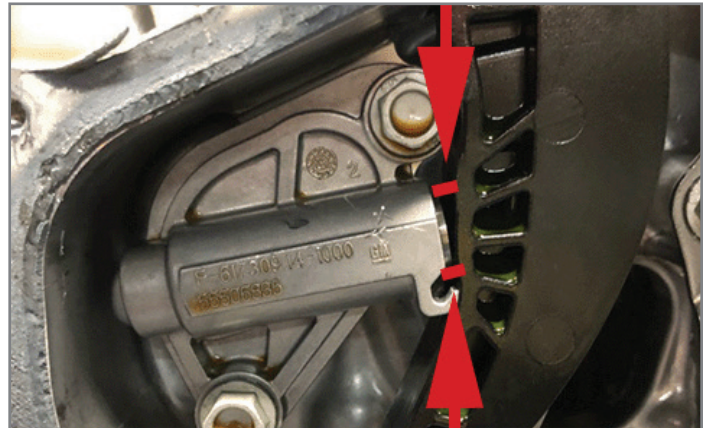
If the rattle sound is heard near the front of the engine, remove the lower engine front cover assembly and inspect the timing chain tensioner. A stuck timing chain tensioner plunger will allow an air gap to be present between the tensioner plunger and the timing chain guide.

Air gap between the tensioner plunger and the timing chain guide

If these conditions are found, replace the timing chain

tensioner following the appropriate Service Information. Also inspect the three timing chain guides for any excessive wear or damage. Replace any damaged timing chain guides if necessary.

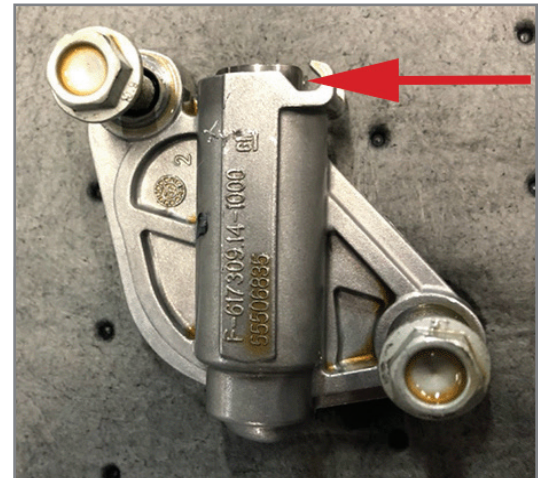
When viewing the timing chain tensioner removed from the engine, the plunger can be seen stuck in the body of the tensioner.

Plunger stuck in the body of the tensioner

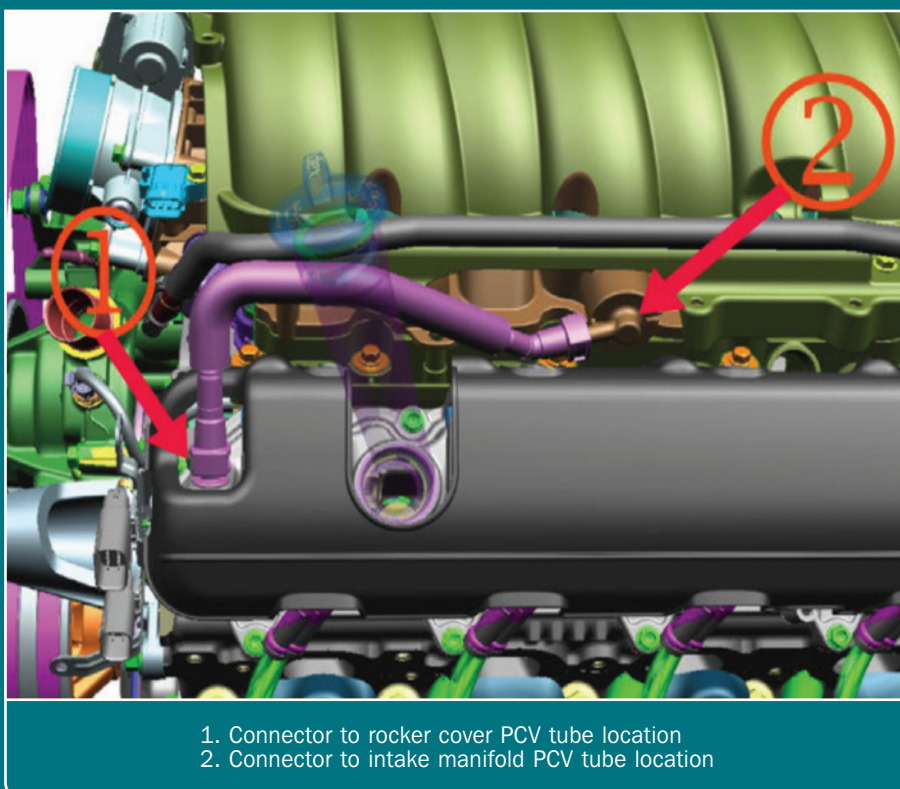
Some 2019-2020 Silverado 1500 and Sierra 1500 models equipped with the 5.3L V8 engine (RPO L84) may have a rough idle, lean running concern, or an air leak sound from the Positive Crankcase Ventilation (PCV) system. DTCs P0171 (Fuel Trim System Lean Bank 1) and/or P0174 (Fuel Trim System Lean Bank 2) may be set. These conditions may be caused by an incorrectly installed or damaged foul air PCV tube.

1. Connector to rocker cover PCV tube location
2. Connector to intake manifold PCV tube location

If no smoke is detected, pull on the PCV tube ends at the rocker cover or intake manifold to ensure each tube is seated. If a tube is not fully seated, secure the connection by pressing the tube in until it clicks.

If smoke is detected at the rocker cover or intake manifold, remove and reinstall the same PCV tube, ensuring that both latches click to that the tube is fully seated. Repeat the smoke test to verify the condition. If the leak is still present, remove the tube and inspect the O-ring seals. Look for any damage or missing O-ring seals. Replace the tube if any damage is found.

If the tube is cracked, or there is damage at any other location other than at the rocker cover or intake manifold, remove and replace the damaged tube with a new tube.

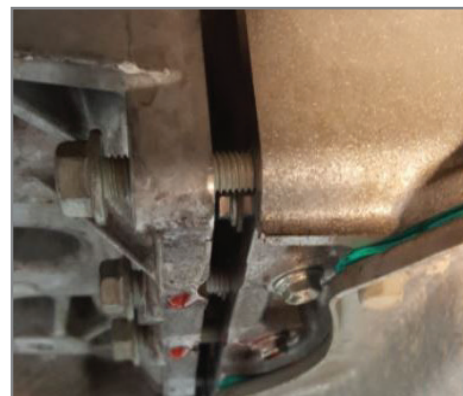
The NVH condition may be the result of a misalignment between the transmission output shaft and the transfer case input. The misalignment could cause the transfer case shift collar to slip out of engagement.

Slide the transfer case rearward and then forward until it is contacting the transmission again.

With the bolts loosened, slide the transfer case rearward so there is a minimum gap of 1/2 inch (13 mm), but not more than 1 inch (25 mm). Next, slide the transfer case forward until it is contacting the transmission again.

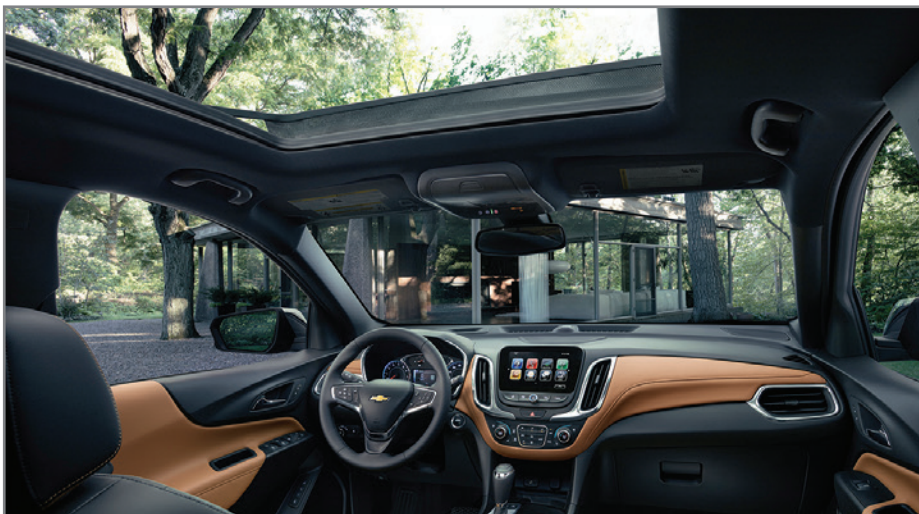
An inoperative sunroof and/or sunshade (RPO C3U) may be found on some 2018-2020 Equinox and Terrain models. The inoperative condition may be the result of the sunroof programming losing initialization.

Use the sunroof switches to perform the initialization procedure.

Before replacing any parts or making any repairs to the sunroof, perform the Sunroof Motor/Actuator Initialization/Tech Process using the sunroof/sunshade open and close switches. Refer to Sunroof/Sunshade Motor Initialization in the appropriate Service Information.
