Mid-November 2019, Volume 21, No. 22

New TechPRO Diagnostic App for Non-GM Vehicles 2
Unable to Deactivate Brake Boost System in GDS 2 5
Unwanted Power Door Unlock Command 6
Lane Keep Assist Icon Missing from Instrument Cluster 6
Parking Brake Cable Squeak Sound 7
Your Thoughts? Tell Us in the TechLink Survey8

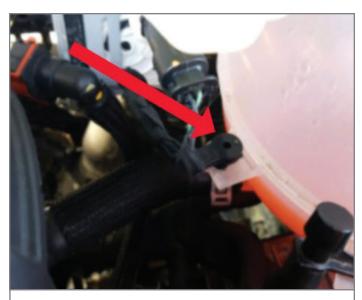
Engine Coolant Temperature Sensor 4 (#1)

Being unable to deactivate the brake boost system may be caused by the B20 Brake Fluid Level Switch and the B34D Engine Coolant Temperature Sensor 4 Connector being swapped during reassembly. If these connectors are swapped, DTCs C0049 SYM05 (Low Brake Fluid Indicated) will be stored in the Electronic Brake Control Module (EBCM) and a P2AFF SYM (Engine Coolant Temperature Sensor 4 Circuit High Voltage) will be stored in the Engine Control Module (ECM).

The Brake Fluid Level Switch Connector and the Engine Coolant Temperature Sensor 4 Connector are identical and can be easily swapped. The harness retainers and the wire colors are different.

Shown are the correct connections of the Engine Coolant Temperature Sensor 4 (Fig. 1) and Brake Fluid Level Sensor. (Fig. 2)

If the GDS 2 error message is displayed, verify that the connectors are in the correct location.

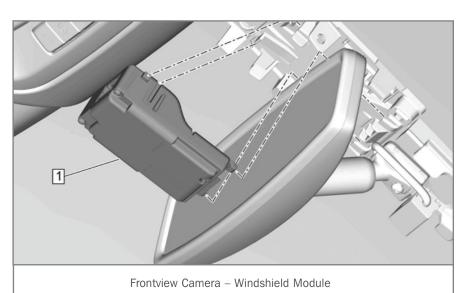
The Lane Keep Assist icon may not appear on the instrument cluster on some 2019-2020 Silverado 1500 and Sierra 1500 models. In addition, the Lane Keep Assist switch LED indicator always stays illuminated, the Forward Collision Alert Gap switch is inoperative. The Forward Collision Alert and Forward Automatic Braking Alert icon (green car) will illuminate properly on the instrument cluster when a vehicle is detected ahead.

The incorrect icon operation and inoperative Forward Collision Alert Gap switch may be caused by the B174W Frontview Camera – Windshield Module not being configured properly after a Service Programming System (SPS) programming event.

Perform all programming and configuration procedures in the appropriate Service Information using SPS. Also perform the Frontview Camera Module Learn procedure in order to calibrate the Frontview Camera Module.

**TIP:** Anytime the Frontview Camera – Windshield Module is removed from its mount on the windshield, including replacement of the module as well as any time the module is removed for diagnosis or windshield replacement, the Frontview Camera Module Learn procedure must be performed.

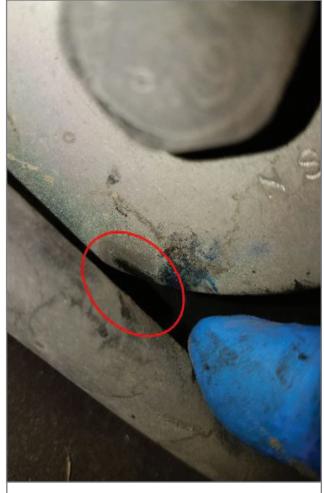
Some 2015-2020 Tahoe, Suburban, Yukon and Escalade models may have a squeak sound heard from under the vehicle while driving at slow speeds. The sound may be caused by the parking brake cables rubbing against each other or alongside the body.

<sup>2.</sup> Tape both cables

Check for contact between the cable and the body.

If the squeak sound is heard, inspect the location of the parking brake cables near the parking brake cable bracket. Apply woven Polyester Electrical Tape (PET) to both cables in a double layer extending along the cable. Ensure that the tape extends at least 25 mm (1 inch) above and below the rubbing point at the parking brake cable bracket or body.

Follow the parking brake cables alongside the body, checking for any contact with the body. If the cables are contacting the body, apply PET to the cable. Make sure the tape is applied in a double layer extending along the cable.
