Use Dielectric Grease to Prevent SPARK PLUG Carbon Tracking

Broken or Loose Engine Ground Cable

Extended Engine Crank Time

Cooling Fans Running for an Extended Period

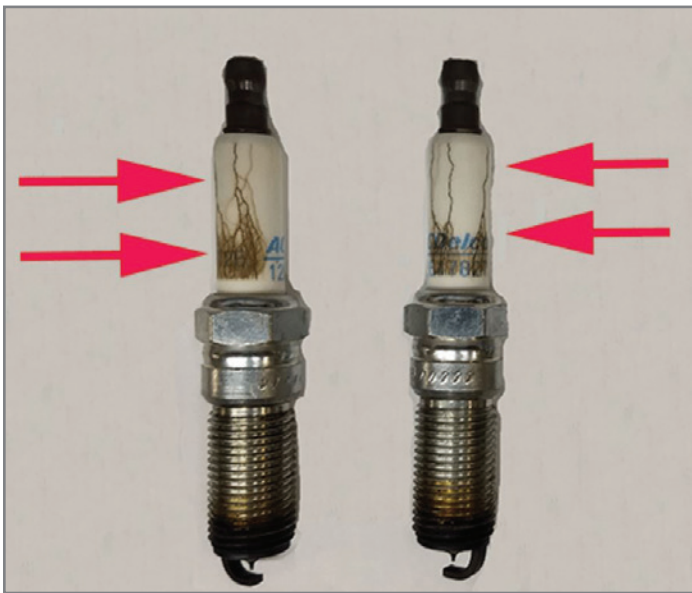
Talc powder was applied to prevent the rubber boot from sticking to the porcelain insulator of the spark plug. However, the talc powder has a lower insulating strength than dielectric grease, which may lead to possible arcing, eventual carbon tracking and, ultimately, a misfire condition. A prolonged misfire condition can result in piston damage.

Inspect the spark plugs for carbon tracking.

If a misfire condition is present on the 2.0L engine, inspect all spark plugs for signs of carbon tracking and inspect the pistons and cylinder walls for damage.

If there is no high cylinder leakage found, replace all four spark plugs and all four coils if any carbon tracking is seen on any of the spark plugs. All spark plug boots also will require an application of Molykote G-5008 Dielectric Grease.

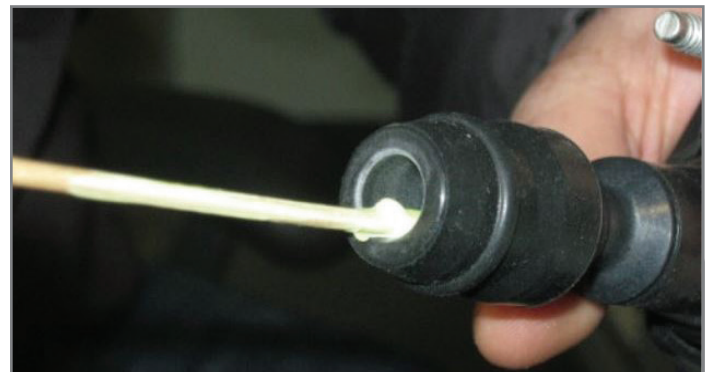
Apply a thin coating of grease in the rubber boot.

Inspect all the ignition coils and apply additional dielectric grease if required. Using an applicator stick or equivalent, apply a thin coating of grease in the rubber boot of the coil, up to a depth of 15 mm. Remove any extra grease from around the end of the boot. Do not use an excessive amount of grease in the boot.

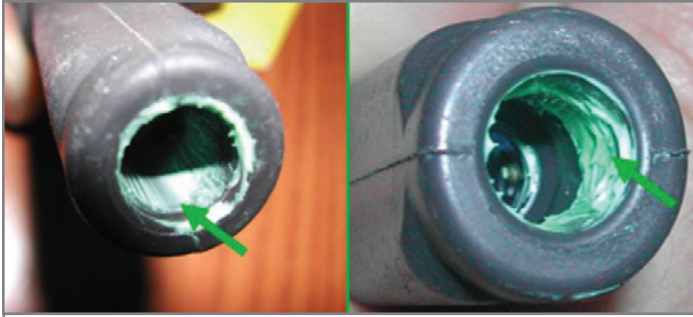
The dielectric grease should be applied evenly inside the boot.

The dielectric grease should be applied evenly inside the boot, from the end of the terminal to the edge of the boot.

TIP: Be sure to only use the specified dielectric grease (U.S. – 19260901; Canada – 19260902) and apply it correctly or the engine conditions/damage may reoccur.

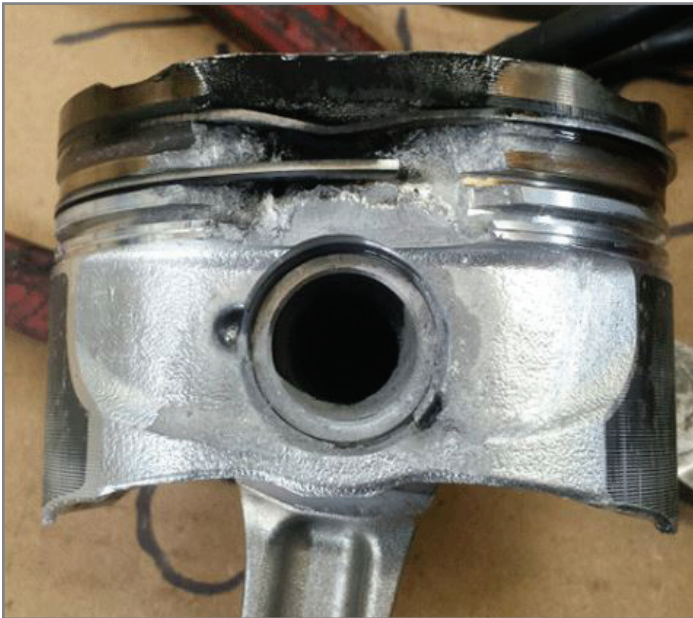
Fractured piston

If the cylinder walls are not damaged, remove the pistons and inspect for a fractured piston between the top and second rings.

If the cylinder walls are not damaged and one or more of the pistons are found fractured, replace all four spark plugs, all four ignition coils (apply dielectric grease to the spark plug boots as previously described), the fuel injector of the cylinder(s) that had damaged pistons, all four piston kits, all ring sets for all four pistons, all rod bearings, all four connecting rod assemblies, and other components necessary when pistons are replaced.

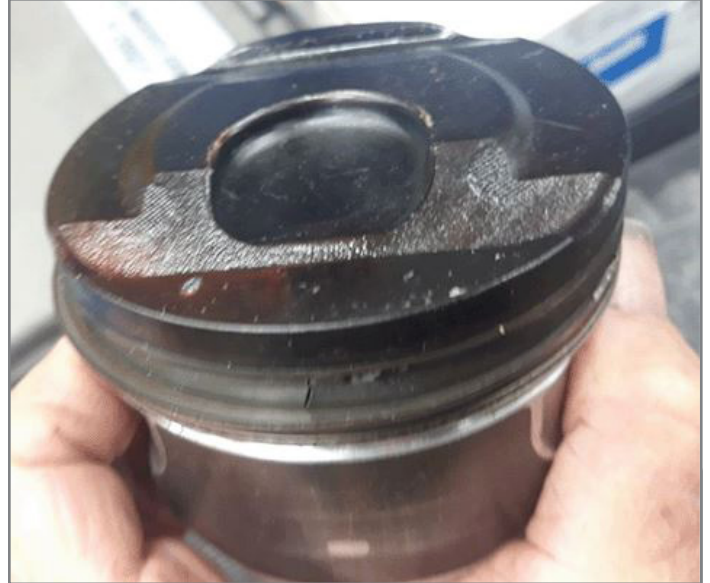
Damaged piston

When installing the pistons, use the J-43953 tapered ring compressor special tool. Use care when installing the piston assemblies into the cylinder so the rings are not damaged.

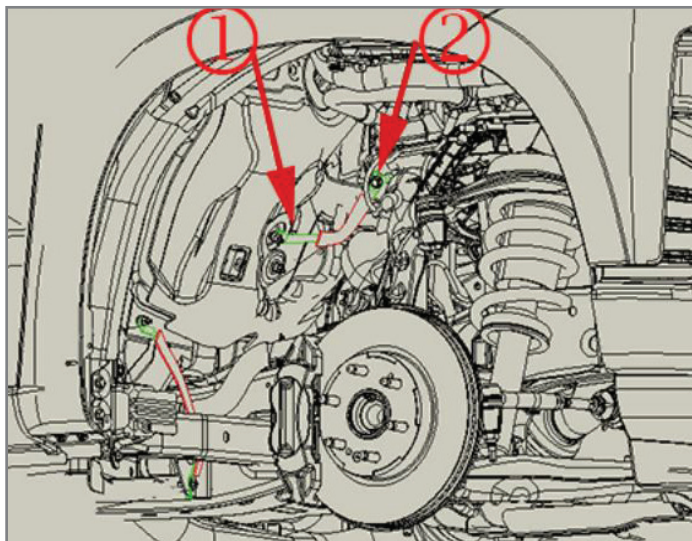
1. G132 2. G134

Inspect the engine to body ground cable/strap, G132 and G134 for any damage or loose connections.

Tighten any ground connections that are loose or replace the ground cable/strap if it is damaged. Ensure that the ground cable/strap is properly orientated to prevent future damage to the ground cable/strap that may be caused by powertrain movement.

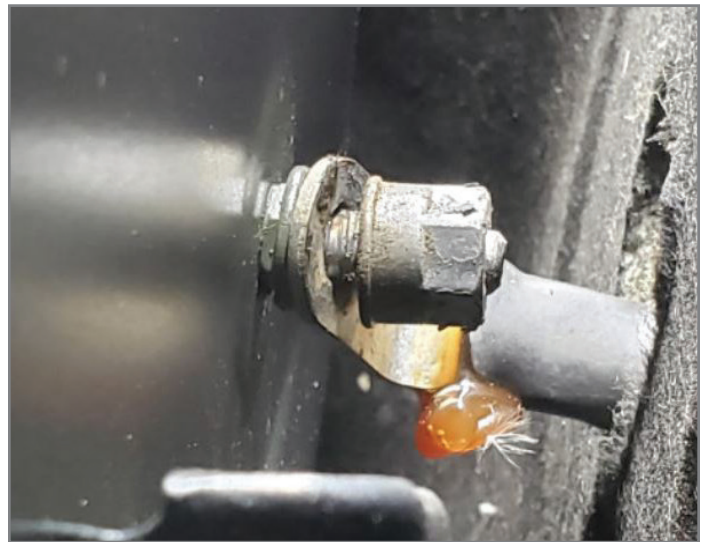
Loose G132 cable/strap

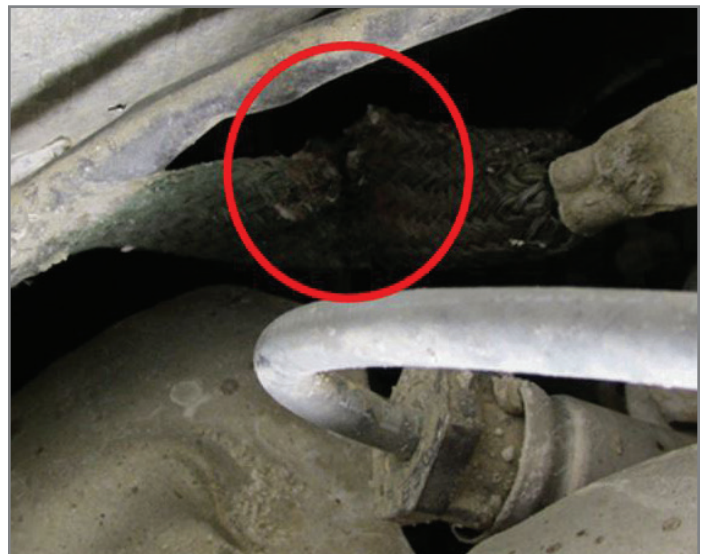
Broken G132 cable/strap

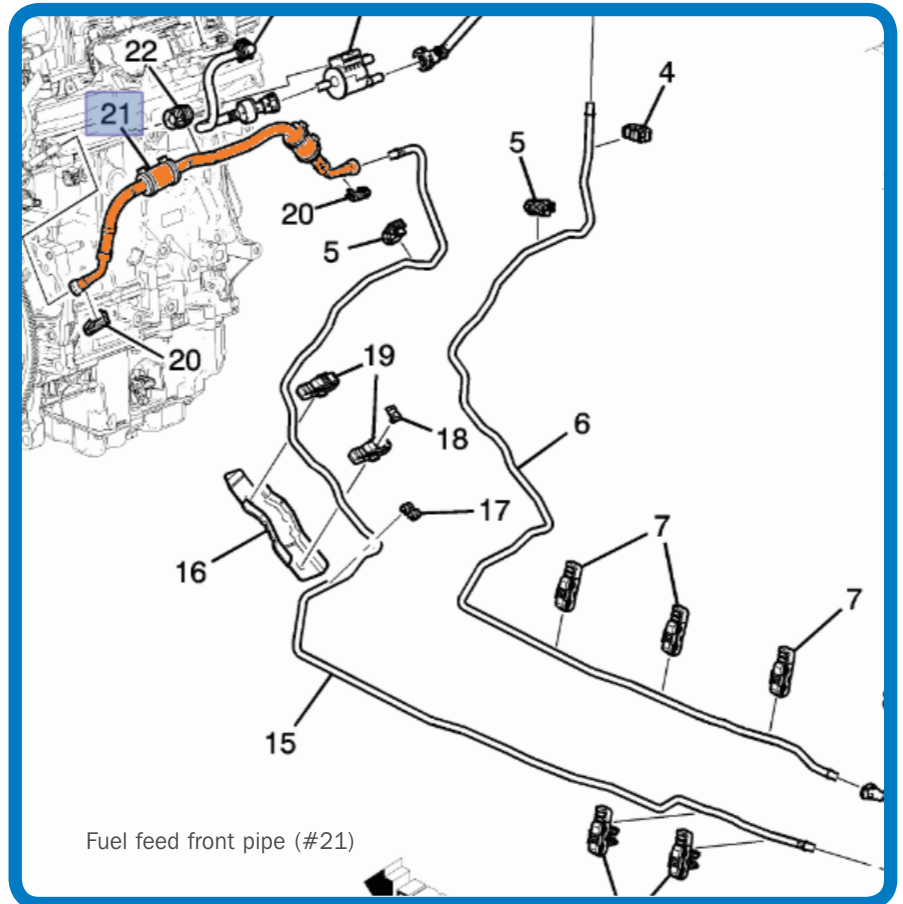
Fuel feed front pipe (#21)

If there is an extended crank time condition, it may be caused by the check valves stuck open in the fuel feed front pipe and the fuel tank fuel pump module. After verifying the extended crank time, replace both the fuel feed front pipe and the fuel tank fuel pump module.

For the fuel feed front pipe, there are different part numbers for vehicles equipped with the 1.5L engine (RPO LYX) and the 2.0L engine (RPO LTG).
