Mid-December 2019, Volume 21, No. 24

Unavailable Driver Assistance Features Messages

Engine Harness

Air Conditioning Blows Warm Air

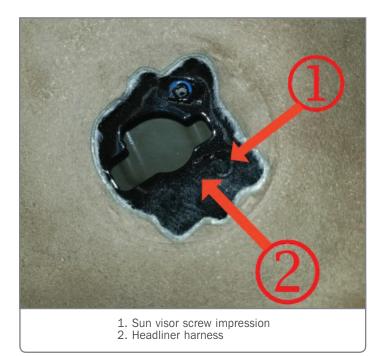
Service Drivers Assist and Service Side Object Detection messages and/or a Super Cruise Temporarily Unavailable message may display on the Driver Information Center of some 2019-2020 CT6 models. DTC U0075 (Control Module Communication Object Detection CAN Bus Off) may be set.

If these conditions are found, there may be a short to ground on Object bus circuits 3811 and 3813 at the driver's sun visor mounting screws. Remove the driver's sun visor and lower the harness

Unwrap the harness to expose the wiring. The Object High Speed GM LAN circuits 3811 and 3813 may be damaged by the sun visor mounting screw.

If any damage is evident, repair the wiring following the appropriate Service Information for wiring repairs.

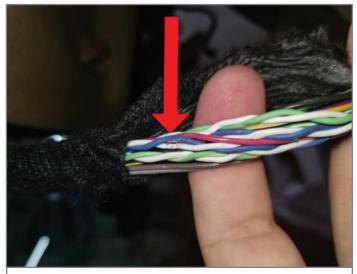
Check for damage to the wiring.
