Mid-February 2020, Volume 22, No. 4

Use the Pre-Repair Authorization Process for Quick Warranty Approval
Torque Converter Fluid Seal Leak 3
Loss of Audio or Abnormal Speaker Operation5
Trailering App Trailer Connection and Lighting Diagnosis Update 8
Safety Alert Seat Lane Departure Warning Inoperative 10
Flex Plate and Starter Motor Damage12

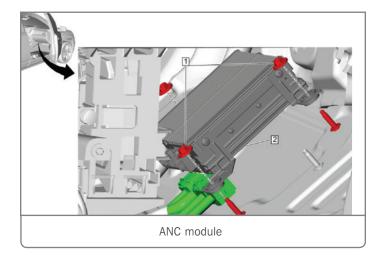
ANC module (#2) and ANC module secondary shield (#3)

from a speaker channel, or abnormal speaker noises, on some 2018-2019 Enclave and Traverse models equipped with the standard audio speaker system (RPO UQF). These conditions may be caused by condensation from the HVAC system entering the Active Noise Cancelation (ANC) module through the module vents.

ANC module secondary shield to prevent additional moisture from entering the module vents.

If audio is present at a lower level, or abnormal speaker noise is no longer present, replace the ANC module and install the ANC module secondary shield. The shield should be installed on the studs first before installing the new module.

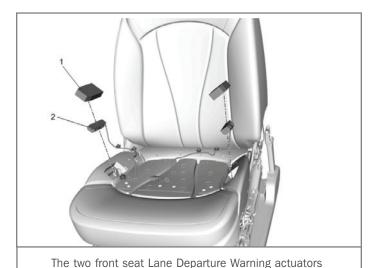
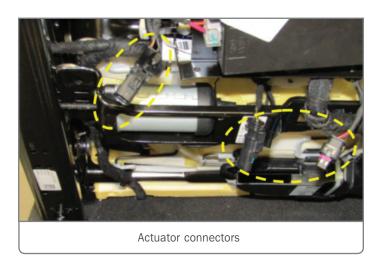
Some 2016-2019 Envision models may have a Service Driver Assist message displayed on the Driver Information Center along with an inoperative Lane Departure Warning actuator in the Safety Alert Seat (driver's seat). DTC B172E (Driver Seat Cushion Left Rear Haptic Movement) also may be set.

These conditions may be due to negative inductance energy driven to the actuator, overheating the Memory Seat Module chip and causing the Memory Seat Module to shut off the port for the actuator. If these conditions are found, replace the two front seat Lane Departure Warning actuators following the procedures in the appropriate Service Information.

In addition, rework the actuator harness to swap the terminal polarity on the actuator connectors. Be sure to complete the harness rework before reassembling the seat.

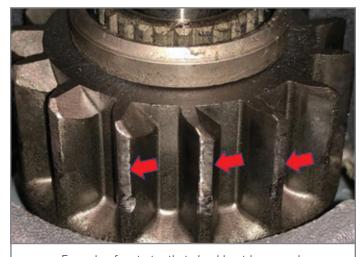
If the starter pinion drive teeth or housing have pieces chunks missing, replace the starter motor assembly.

Example of a starter that should not be reused.
