Duramax Diesel Warm  
Engine Idle Knock Sound . . . . . 3

Unable to Deactivate  
Brake Boost System . . . . . 5

Poor Heater Performance Due to  
Coolant Hose Restriction . . . . . 6

### TECH LINK

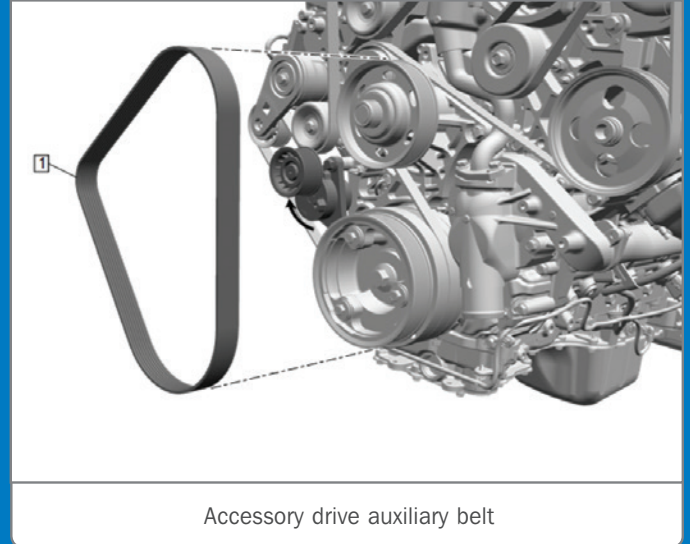
Some 2020 Silverado 2500HD/3500HD and Sierra 2500HD/3500HD trucks equipped with the 6.6L Duramax diesel engine (RPO L5P) may have a thumping or knocking sound coming from the rear of the engine. The sound is often more pronounced in the interior of the truck as it's amplified by the transmission bell housing.

If the noise level is significantly reduced, it should be considered a normal characteristic of the 2020 model year truck. No additional repairs are necessary.

Accessory drive auxiliary belt

The engine sound has no short- or long-term effects on the engine.

1. Remove the air cleaner housing.
2. Remove intake air duct.
3. Separate the charge air cooler (CAC) tube and position aside.
4. Remove the belt and position aside.
5. Install the CAC tube.
6. Loosely place the air box and intake duct back in place. (So a DTC is not set for the sensor when starting.)
7. Start the engine and verify the sound is gone.

8. Remove the loosely installed air box and intake duct.
9. Separate the CAC tube.
10. Install the belt.
11. Install the CAC tube.
12. Install the air box and duct.

**TIP:** Do not run the vehicle more than three minutes without the auxiliary belt installed. Do not raise the RPM higher than idle with the belt removed.

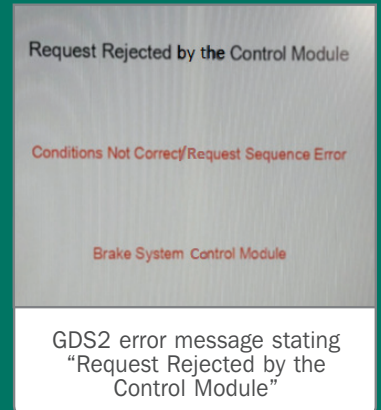
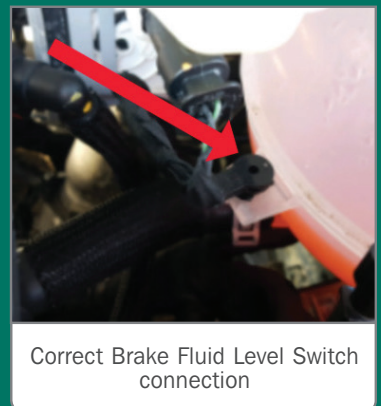
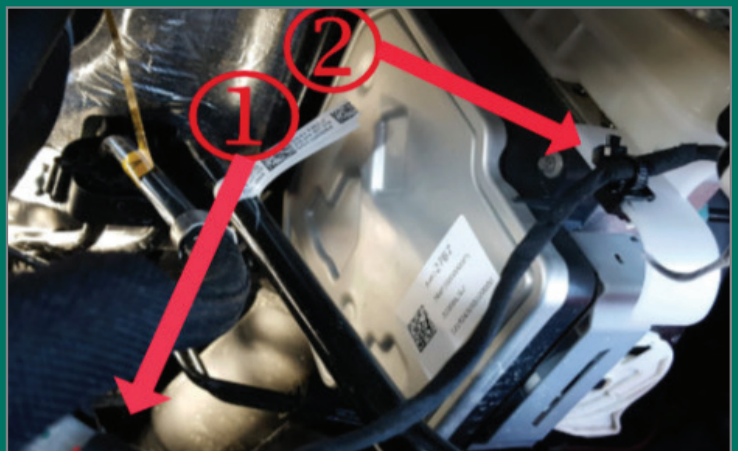
A GDS2 error message stating "Request Rejected by the Control Module" may occur when trying to deactivate the brake boost system while performing the hydraulic brake system bleeding procedure on some 2019-2021 XT4 models.

The error message may be caused by the B20 Brake Fluid Level Switch Connector and the B34D Engine Coolant Temperature Sensor 4 Connector being swapped during reassembly.

If these connectors are swapped, DTC C0049 (Low Brake Fluid Indicated) SYM05 (High Voltage/Open) will be stored in the Electronic Brake Control Module (EBCM) and P2AFF (Engine Coolant Temperature Sensor 4 Circuit High Voltage) will be stored in the Engine Control Module (ECM).

When connecting the Brake Fluid Level Switch and Engine Coolant Temperature Sensor 4, be sure to verify that the connectors are in the correct location. Reverse the connections if necessary.

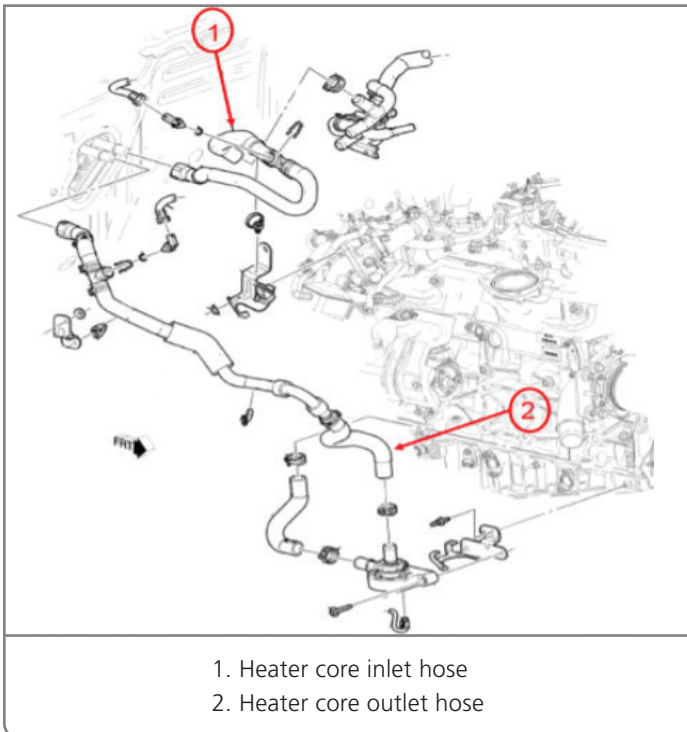
Poor heater performance may be experienced on some 2020 Silverado and Sierra models equipped with the 3.0L diesel engine (RPO LM2). The poor performance may be caused by the heater core inlet or outlet hoses becoming twisted or kinked, which may restrict coolant flow.

If there is a hose restriction, there will be a significant difference between the temperatures; for example, the inlet temperature may be 147°F (64°C) and the outlet temper may be 82°F (28°C). Typically, the temperatures will be within 10–20°F (5.5–11°C).

Use GDS2 to compare the heater core inlet temperature sensor 3 to the heater core outlet temperature sensor 4. When comparing the difference in the heater core temperature sensors, make sure the blower motor is on high with the HVAC temperature set to full hot.

Follow the appropriate Service Information for poor heater performance. If diagnostics do not lead to a correction, inspect the heater core inlet and/or outlet hoses for any twists or kinks.

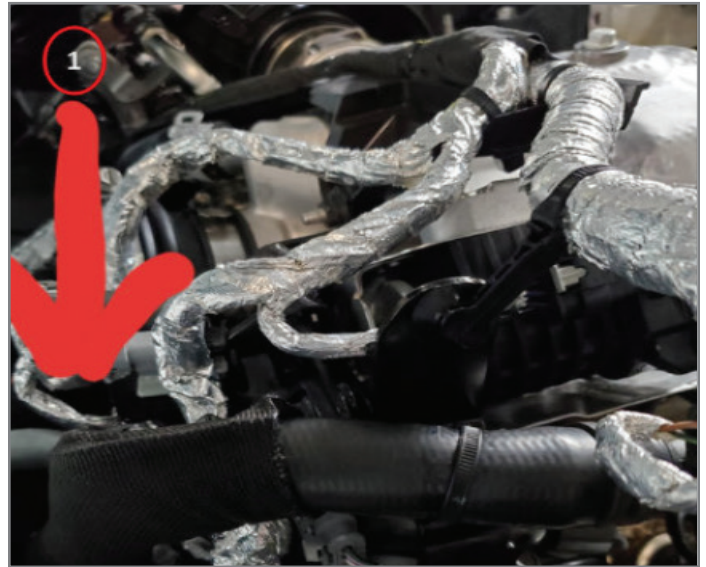
In some cases, it may be difficult to see the twist or kink in the hose due to the conduit that covers the hoses.

Heater core inlet hose on vehicle (#1)

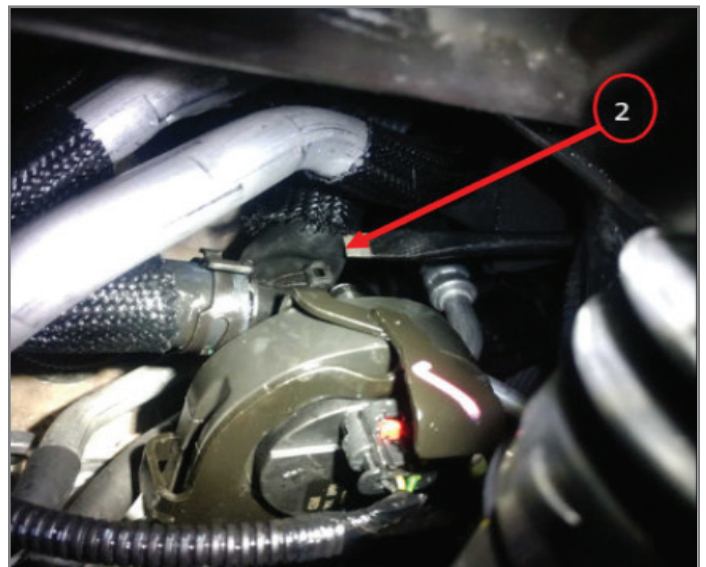
Heater core outlet hose on vehicle (#2)

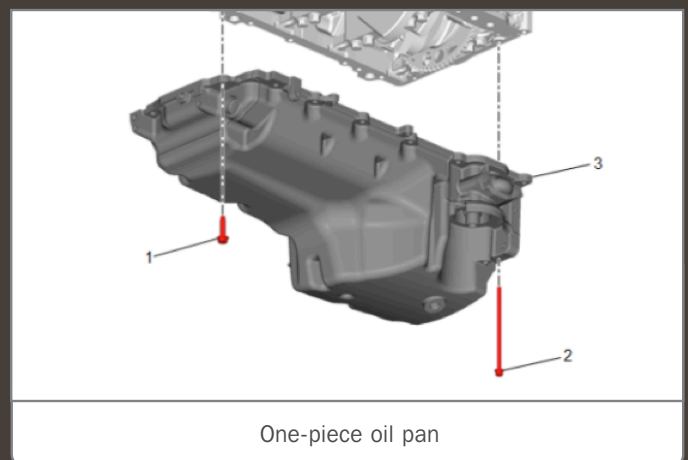
The oil level condition may be caused by new engine RTV sealant leaching silicone into the engine oil.

When the silicone leaches into the oil, it can contribute to aeration of the oil and cause an erroneous oil level switch response. During normal engine operation, the Engine Control Module (ECM) checks the oil level dynamically between the RPM range of 1,000-1,400 RPM. Other Small Block engine RPOs check the oil level at idle.

The oil condition will most likely occur before the first scheduled oil change or after the recent addition of new RTV sealant, for example, during an oil pan replacement. In addition, the new one-piece oil pan design used on these engines may also increase the occurrence of this condition.

One-piece oil pan

If this condition is found, verify the engine oil level is full. Also check that there are not any oil level switch-related DTCs set and that the oil switch reads OK using GDS 2 (engine off/ignition on).

If DTCs are not present, perform an oil and filter change and then re-evaluate vehicle.

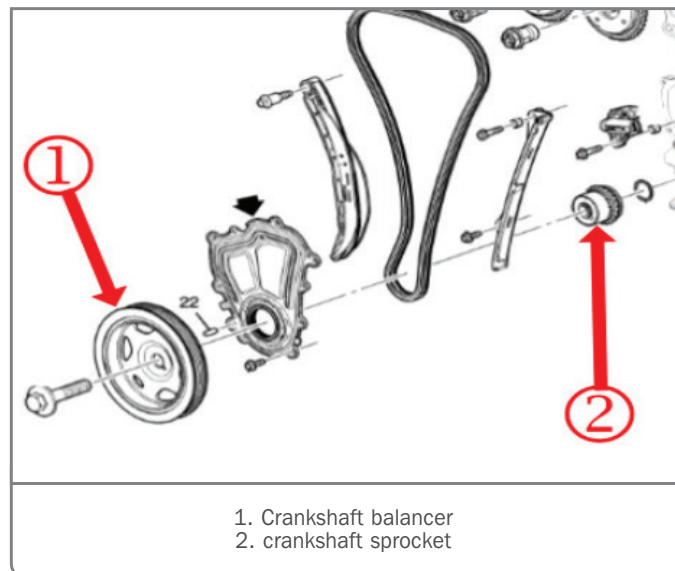
On some 2019 CT6; 2019-2020 XT4, Silverado, Sierra; 2020 CT4, CT5, XT5, XT6, Blazer, and Acadia models equipped with the 2.0L engine (RPO LSY) or 2.7L engine (RPO L3B), the crankshaft sprocket may disengage from the crankshaft during crankshaft balancer removal.

Anytime that the crankshaft balancer is removed for service, ensure that the crankshaft sprocket is not sticking to the crankshaft balancer; otherwise, the sprocket will pull off the end of the crankshaft.

To separate the crankshaft balancer from the crankshaft sprocket during service, first loosen the crankshaft balancer bolt a few turns and then strike the crankshaft balancer with a rubber mallet.

**TIP:** Do not rotate the crankshaft on these engines with the crankshaft balancer removed. The crankshaft balancer and bolt must be reinstalled to avoid damage to the crankshaft sprocket, crankshaft and valvetrain.
