## Corvette Competition Sport Seat Bolster Pad Support

Corvette Competition Sport  
Seat Bolster Pad Support . . . . . 2

Front Suspension Rattle at  
Slow Speeds . . . . . 3

## TECH LINK

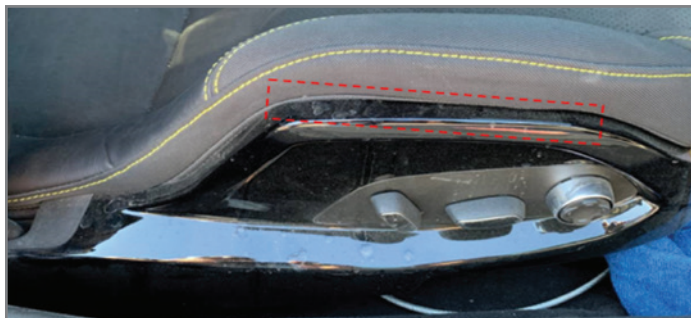
The fit and appearance condition is due to an incorrect seat foam-to-side shield interface that causes the foam to be unsupported. As a result, the unsupported seat foam can create a poor appearance as the driver enters and exits the vehicle over time.

Incorrect seat foam-to-side shield interface

If this condition is found, check that the foam and bottom felt of the foam pad (A) are not caught on the edge of the side shield (B), which may cause the poor trim appearance. The felt on the bottom of the foam pad should extend over the edge of the side shield, allowing the foam to be proud to the side shield. (C)

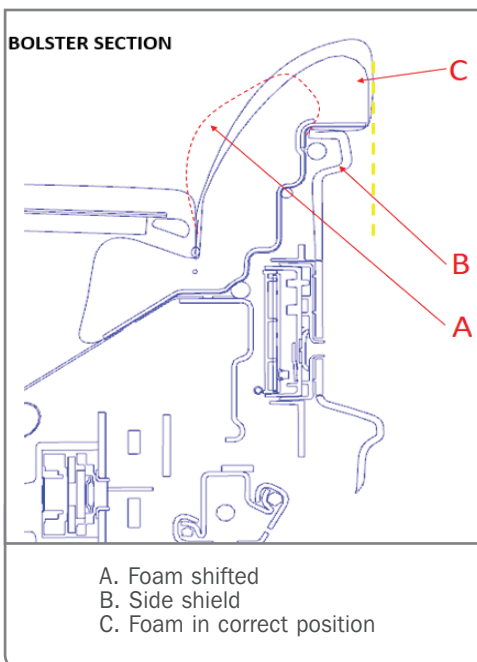
When properly fitted, the bolster will be flush with the vertical surface of the side shield.

To correct the fit and appearance condition, remove side shield and massage the foam pad back into position. The pad must be pulled up vertically. Make sure it is not folded or collapsed.

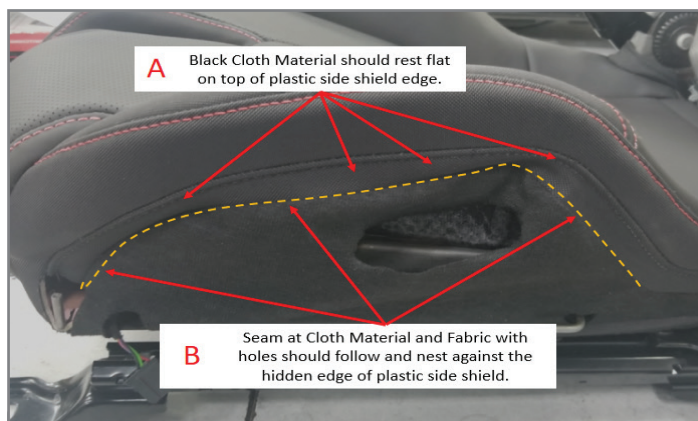
A. Black cloth should rest flat on top of side shield.  
B. Seam should follow hidden edge of side shield.

When in proper position, the pad will fit into the cushion cover of the bolster with the black cloth material of the bolster cover resting flat on the top of the side shield edge. In addition, the seam of the cloth material and perforated fabric should follow along the hidden edge of the side shield.

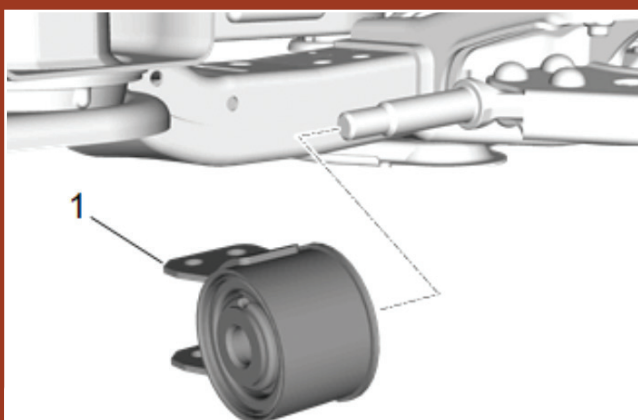
A rattle or creak noise at slow speeds over bumps or broken pavement on some 2013-2016 Acadia; 2013-2017 Enclave, Traverse; and 2017 Acadia Limited models may be originating from the front lower control arm front bushing.

Front lower control arm front bushing

If the rattle sound cannot be determined after a thorough visual inspection of all front suspension components and the use of the J39570 Chassis Ear tool, it may be necessary to replace the front lower control arm front bushing. Only replace the front lower control arm front bushing on the side that is making the rattle sound.

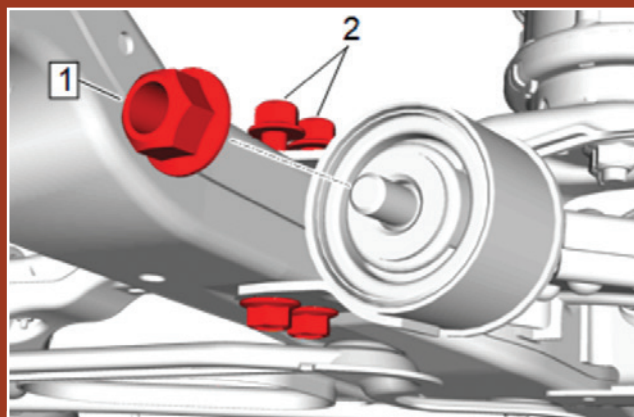
1. Front lower control arm front bushing nut
2. Front lower control arm front bushing bolt

The torque sequence of the bushing is critical to resolving the rattle condition. Ensure that the front lower control arm front nut is fully tightened to properly seat the front lower control arm front bushing before tightening the front lower control arm front bushing nuts.

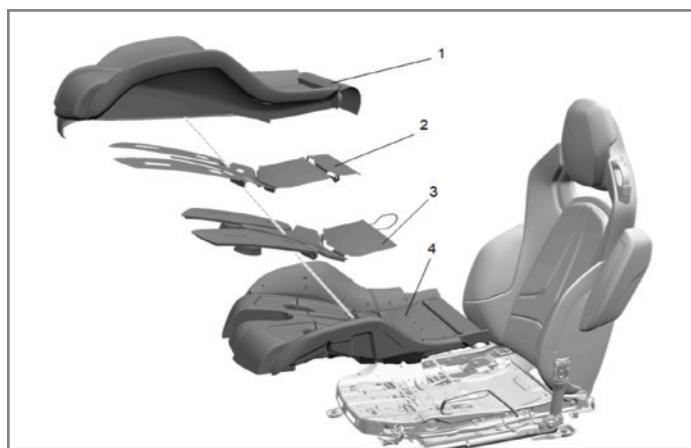
Cushion cover and pad replacement

If the foam pad is folded or collapsed, replace the pad. The cushion cover and pad are removed from the seat frame as an assembly. Refer to Seat Cushion Cover and Pad Replacement in the appropriate Service Information.

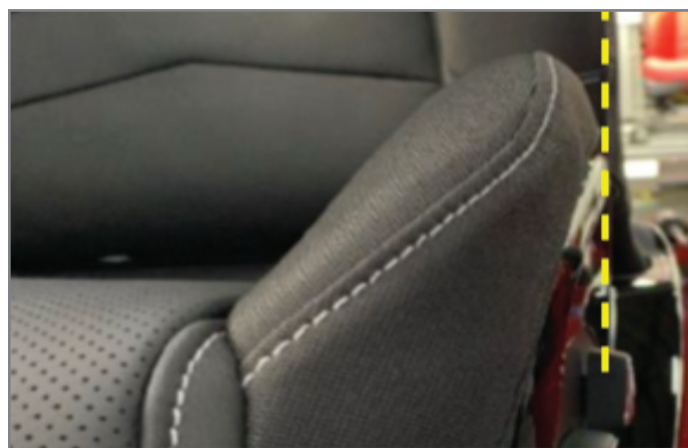
Bolster flush with the side shield.

After properly positioning the foam pad, reinstall the side shield so the bolster sits on top of the shield and is flush with it. The trim should not be under any tension that would pull the bolster foam off the side shield.

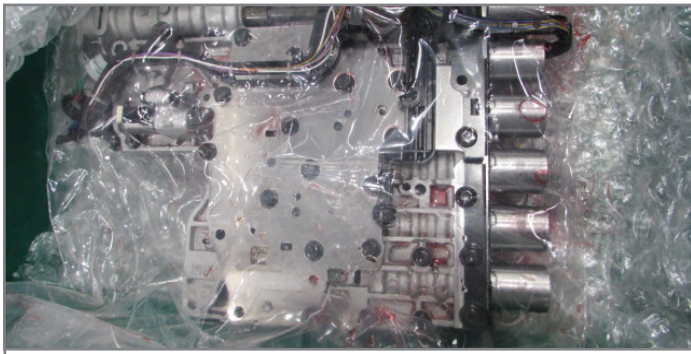
Valve body wet from testing.

The new parts should not be returned because they are wet with fluid from testing, which is a normal condition.

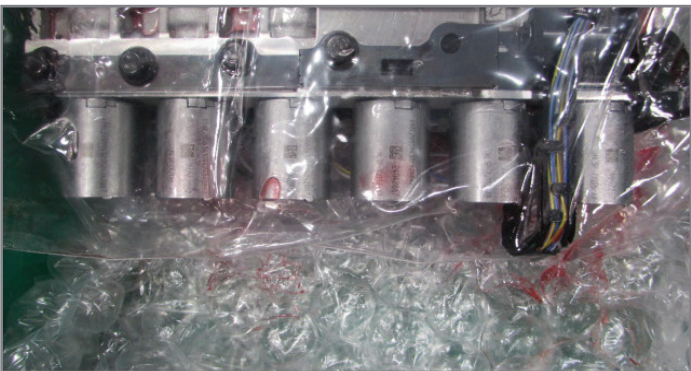
The components go through a function testing procedure before being shipped. The solenoids are characterized through a wet test and, as a result, transmission fluid may collect in the shipping package.

Solenoids wet after testing.

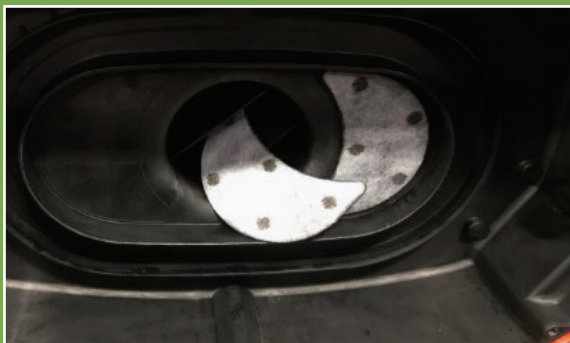
Loose carbon patch in air cleaner housing.

If a carbon patch is not secure and positioned properly, the air cleaner housing assembly will need to be replaced.

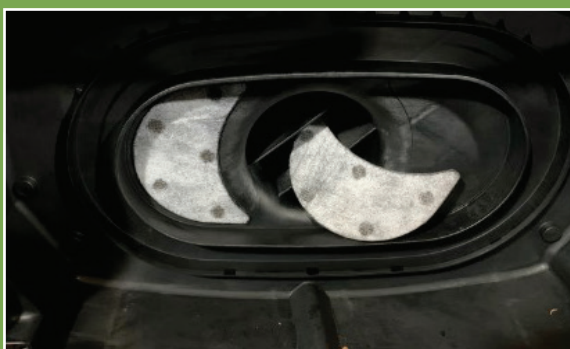
## Out of position carbon patch

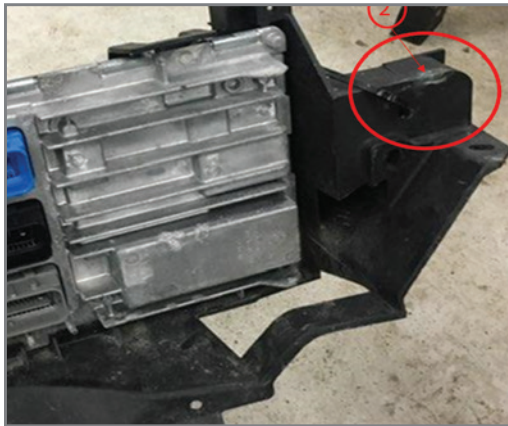
The engine performance conditions may be caused by the engine wiring harness chafing on the Engine Control Module (ECM) mounting bracket.

The contact with the edge of the ECM mounting bracket may be causing damage to a number of circuits in the wiring harness, resulting in the wide variety of different symptoms that may occur.

Harness contact area

Inspect the engine harness in the area around the ECM mounting bracket. If harness damage is found, repair the damaged wiring following the appropriate Service Information wire to wire repair procedures. Once repaired, protect the engine wiring harness using Woven Polyester (PET) Electrical/Anti-Abrasive Tape.
