Diesel Exhaust Fluid Consumption

Rushing Air Sound in PCV Tube

Fuel Injector Replacement Guidelines

TECH LINK

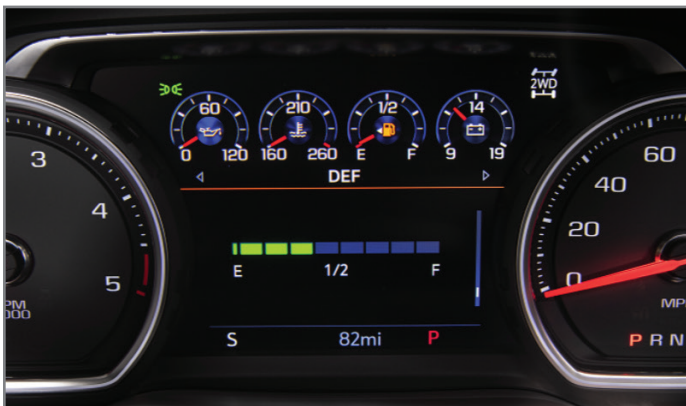
The current 2020 Silverado 1500 and Sierra 1500 models have a DEF level gauge on the instrument cluster that provides drivers with a representation of how much DEF is in the DEF tank up. The DEF level gauge does not operate like a typical float-style gauge that is used in a fuel tank. The Engine Control Module (ECM) monitors the DEF level and consumption rate in order to calculate an estimated range. DEF levels are detected by the DEF level sensor.

There may be some fluctuation in the amount of DEF represented on the DEF level gauge. After filling the DEF tank, it may take a few key cycles to register the correct amount in the DEF tank. With the new segmented DEF level gauge, it is possible that after adding 5 gallons (18.9 L) of DEF that the gauge reads as a full tank after the fill event. However, if the actual level of DEF is just entering the last segment on the gauge, the gauge is likely to drop by one segment shortly after driving after the fill event. As a result, a driver could have an initial impression that the vehicle

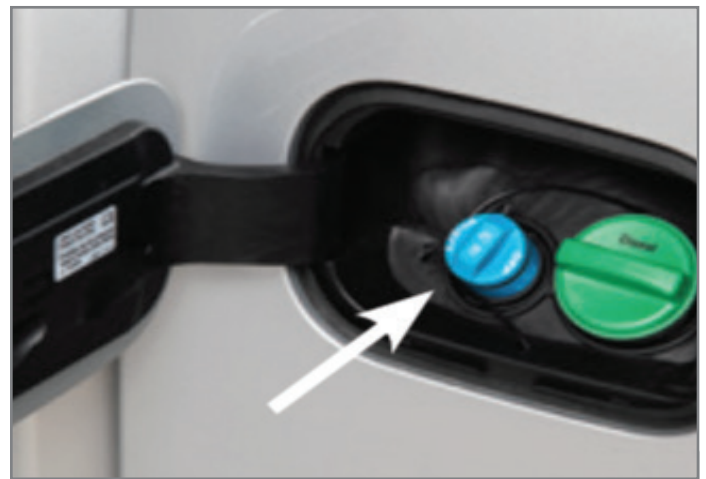
DEF fill

The amount of DEF consumed also is a function of how hard the engine is working, or engine load. Due to engine use, it is more representative to compare DEF consumption to the amount of fuel consumed – also a function of engine load – instead of miles traveled. In addition to engine load, other factors that affect the DEF usage rate are the humidity, temperature, and altitude where the vehicle is operating.

Under certain conditions, the ECM will increase or decrease the amount of DEF used based on learning or adaptive algorithms. In the event of a malfunction and Check Engine light, the ECM may double or even eliminate the amount of DEF that is being used. An improper amount of DEF use will continue until the vehicle is repaired and the learned value in the ECM is reset.

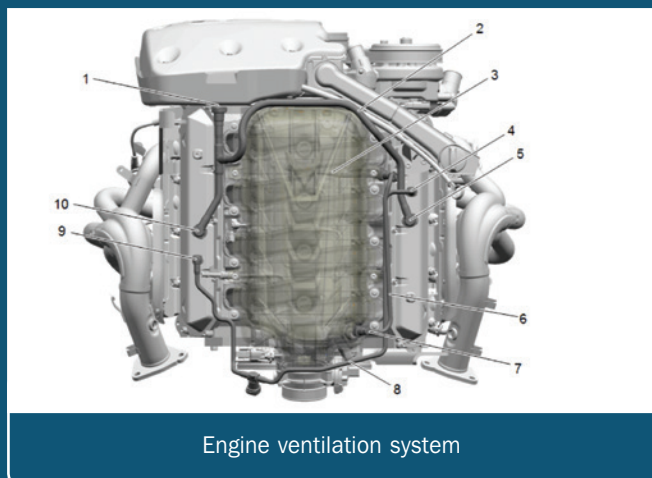
In the LT2 engine, filtered fresh air is routed from upstream of the throttle plate through a formed nylon fresh air tube(8) to a PCV fitting(9) in the left-side rocker arm cover and a PCV fitting(4) in the right-side rocker arm cover. The design of the rocker arm covers shields rocker arm oil spray, reducing the potential for oil being drawn back into the fresh air PCV tube during any backflow of the ventilation system. Separated foul vapor from the engine oil tank(1) is routed to a PCV fitting(10) in the left-side rocker arm cover and a PCV fitting(5) in the right-side rocker arm cover via a formed nylon recirculation tube(2). Foul crankcase vapor is routed through a formed nylon foul air tube(6) from a

PCV connection(3) on the engine oil separator in the engine valley to right side rear of the intake manifold(7).

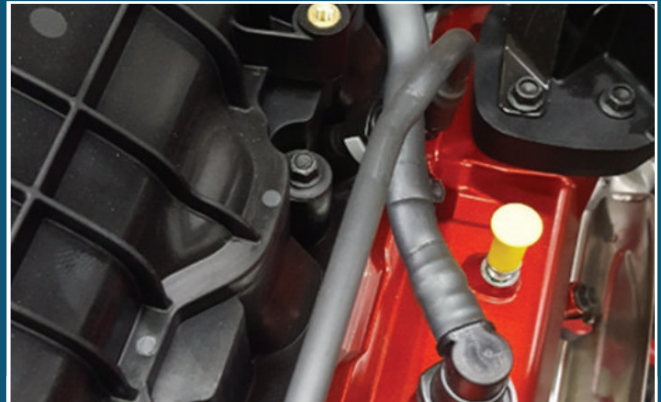
When diagnosing the hissing sound, first verify the correct PCV tube routing. The following photo shows a PCV tube that is incorrectly routed.

Incorrectly routed PCV tube

The sound may change when moving the PCV tube, which is normal. However, if the PCV tube is routed incorrectly, the sound may be magnified.

If a leak is suspected, perform a smoke test to check the induction system. If tests show that the PCV tube is not leaking, it should not be replaced due to the rushing air or hissing sound only.

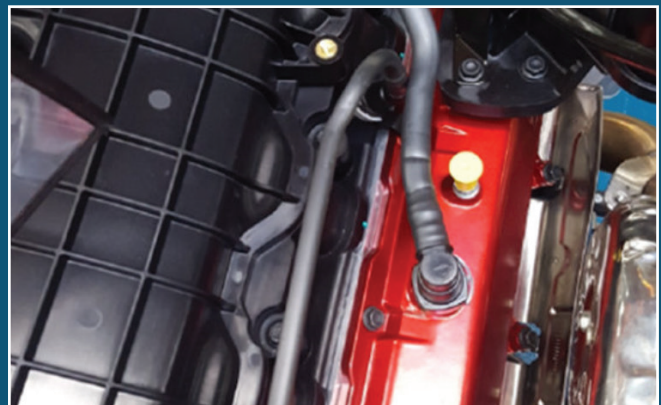
The PCV tube is routed correct in the following photo.

Correctly routed PCV tube

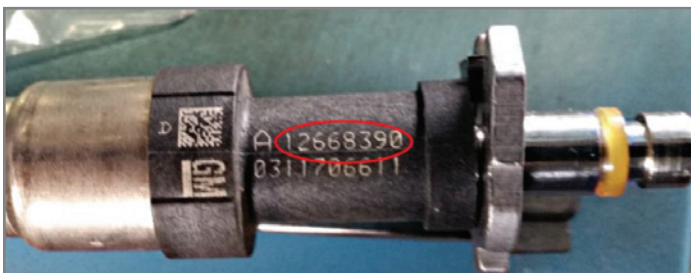
8-digit injector part number

For the Silverado with the 5.3L V8 engine in this example, the original fuel injector part number is 12668390, highlighted in the Description column. The part number to order is 12698484.

1. Identify the 8-digit injector part number found on the injector body.
2. Enter the VIN in the parts catalog; go to the fuel injector rail parts section.
3. After the injector part number has been identified in the Description column, the part number that needs to be ordered will be in the Part # column.

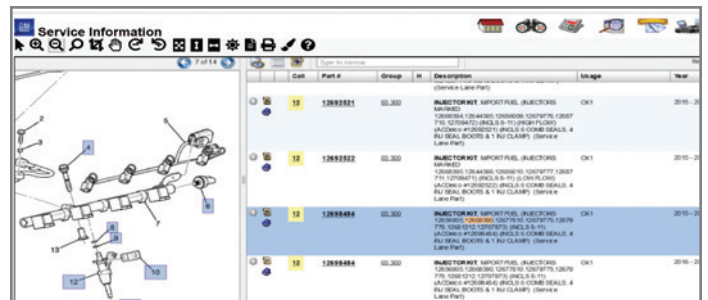
When fuel rails are assembled at the supplier, each injector installed in the fuel rail can be a nominal, low or high flow injector. The different injectors in the rail is done to get an even balance or flow across the fuel rail for emission requirements. Replacement injector kits will be a different part number than the injectors, and a kit may contain one of several different injector part numbers.

Check the Description column and Part # column.

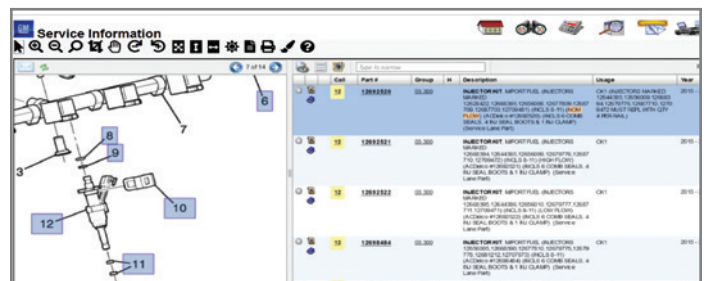
NOM FLOW injector

If an injector has been removed and discarded or if all injectors are on the bench and it can't be determined which one goes where, the best thing to do is order the "NOM FLOW" injector part number in the quantity needed.

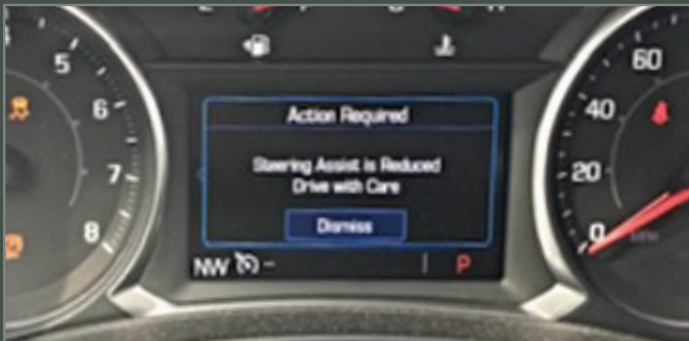
Steering Assist is Reduced message

Some 2018 Equinox and Terrain models may have several Driver Information Center (DIC) messages display on the instrument cluster after an Auto Stop (when the automatic engine stop/start system turns off the engine when the vehicle is at a stop). The DIC messages may include Steering Assist is Reduced, Service StabiliTrak, and/or Park Brake Released. In addition, DTCs C0800:03 (Device Power 1 Circuit Voltage – Electronic Brake Control Module), C0800:03 or C0800:12 (Device Power 1 Circuit Voltage – Power Steering Control Module), and U0121 (Lost Communication with Brake System Control Module – Body Control Module) may be set.

There may be a steering assist reduction for a few seconds when the messages display. All of these symptoms occur most commonly after the engine restarts after an auto stop event.

The steering assist condition and DIC messages may be caused by low voltage being received by the Electronic Brake Control Module or Power Steering Control Module. If these conditions are present, test the battery using the EL-52800 Diagnostic Charge Battery Station (DCBS) or EL-50313 Midtronics GR8 Battery Tester/Charger (GR8).

If the battery test result shows Replace Battery (GR8) or Bad Battery (DCBS), replace the battery. Use the standard labor code for battery replacement.

If the battery test result indicates the battery is good but the capacity is diminished with a CCA rating of 575 or below, the battery also should be replaced. Use the special labor code for battery replacement with a diminished CCA rating.

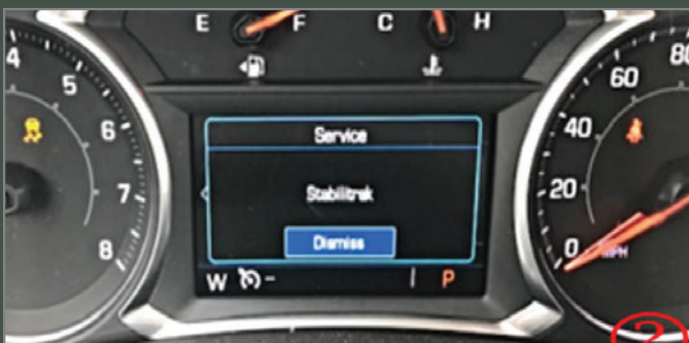
Service StabiliTrak DIC message

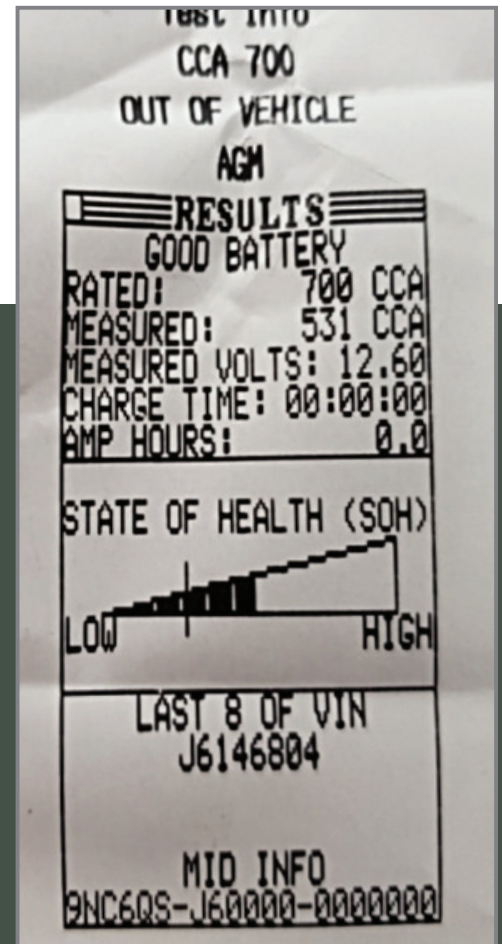
Good battery test result showing diminished CCA rating

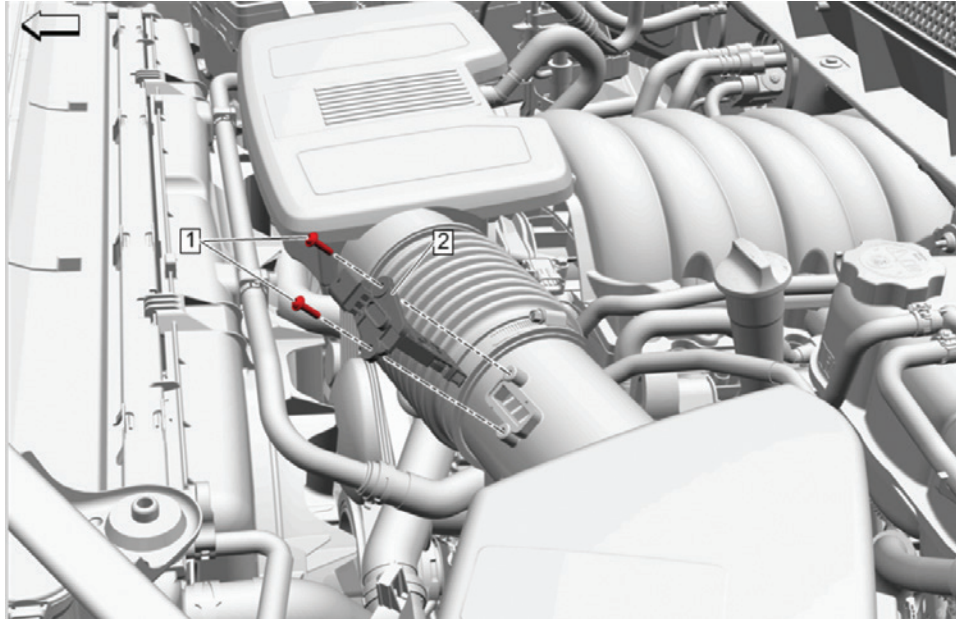
Some 2019-2020 Escalade, Silverado 1500, Silverado 2500/3500, Tahoe, Suburban, Sierra 1500, Sierra 2500/3500, and Yukon models equipped with the 5.3L V8 engine (RPO L82, L83, L84), 6.2L V8 engine (RPO L86, L87), or 6.6L V8 engine (RPO L8T) may have an illuminated Check Engine MIL and DTC P1682 (Ignition 1 Switch Circuit 2) set. DTCs P0101 (Mass Air Flow Sensor Performance), P0689 (Engine Controls Ignition Relay Feedback Circuit Low Voltage), P16A7 (Engine Controls Ignition Relay Feedback Circuit 2), or P16BC (Engine Controls Ignition Relay Feedback Circuit 3) also may be set. In addition, the vehicle may have had the Mass Air Flow (MAF) sensor replaced recently for DTC P0101.

If these conditions are found, there may be a faulty ignition relay or underhood fuse block terminal concern.

Before replacing the MAF sensor for DTC P0101, inspect the underhood fuse block ignition relay circuits. Replace the underhood ignition relay if required.

Also diagnose any applicable DTCs before replacing the MAF sensor. Refer to the appropriate Service Information for diagnosing each DTC.

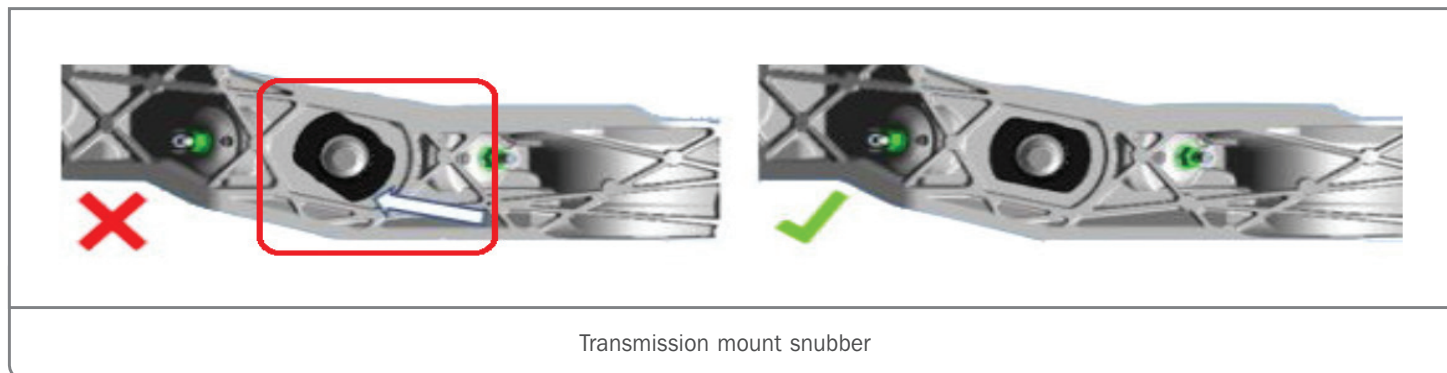
Some 2020 CT5 models may have a low-frequency noise and vibration under wide open throttle that sounds like the muffler is grounding out against the body. The noise and vibration may get progressively worse as more miles are driven.

If the noise and vibration are present and can be heard inside the passenger compartment, check the transmission mount snubber. It may be out of position and rubbing against the inside pocket of the crossmember.

Raise the vehicle and inspect the position of the transmission mount and snubber. If out of position, loosen the bolt and rotate the snubber until the anti-rotation feature engages. Tighten the bolt to specification (100 N·m or 74 lb.-ft.). Lower the vehicle and perform a test drive to confirm the noise has been eliminated.
