## Corvette Stingray

### TRACK PREPARATION

## TECH LINK

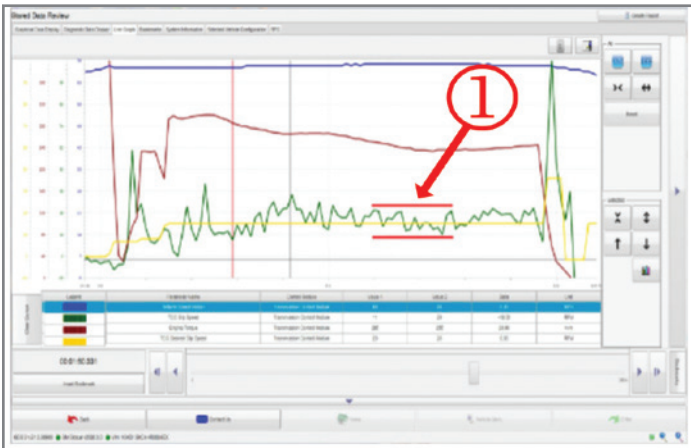
GDS2 data showing TCC slip peak-to-peak below 20 RPM is an example of normal TCC operation.

GDS2 data showing TCC slip peak-to-peak below 20 RPM.

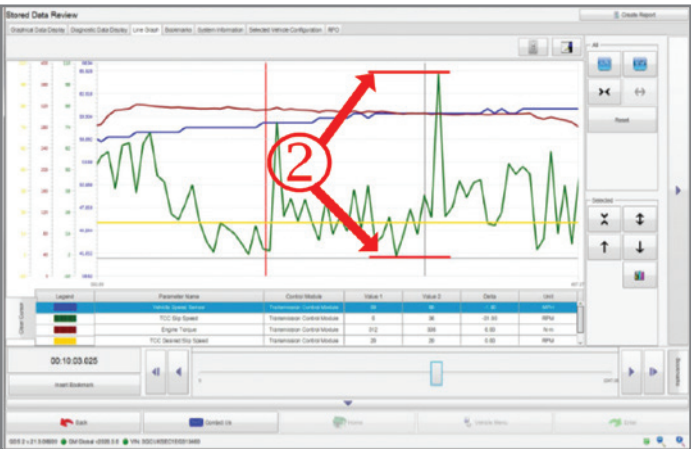
GDS2 data showing TCC slip peak-to-peak erratic near 0 RPM to over 100 RPM in a short time is an example of a damaged torque converter clutch.

GDS2 data showing TCC slip peak-to-peak erratic near 0 RPM to over 100 RPM in a short time.

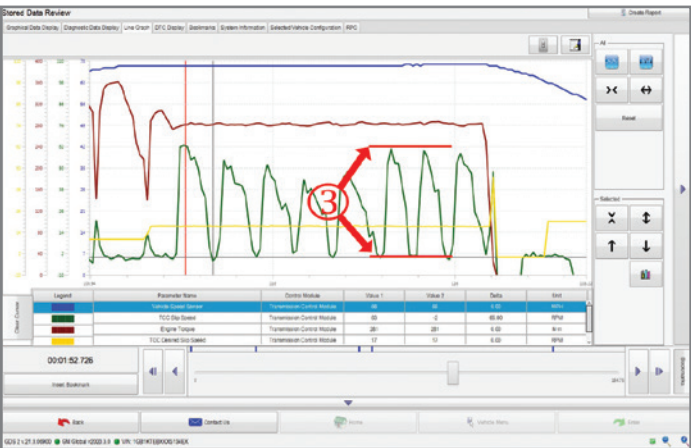
GDS2 data showing TCC slip peak-to-peak repeating near 60 RPM or less is an example of degraded fluid. Perform the TCC slip control test within this procedure and compare service tool-collected data results to normal, damaged and degraded operation.

GDS2 data showing TCC slip peak-to-peak repeating near 60 RPM or less.

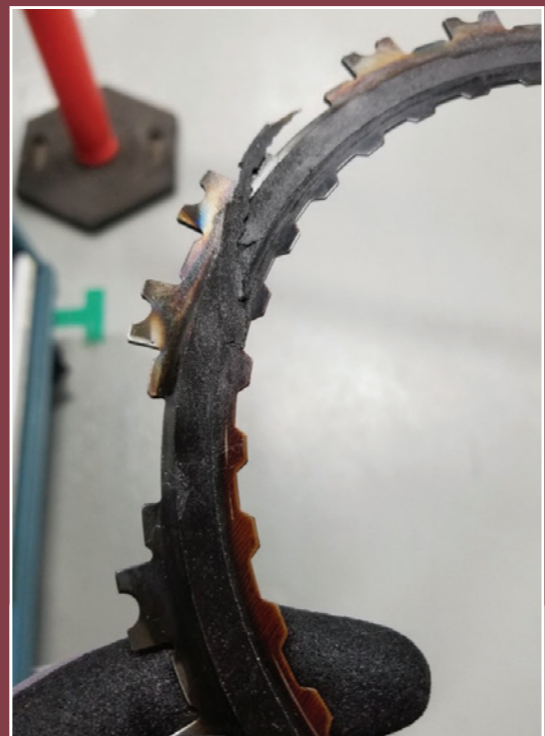
When servicing these transmissions with these particular DTCs set, be aware that the vehicle could move forward if it is started in Neutral. In some failure modes, the friction and steel plates for the first gear clutch may be burned so badly that they have been welded together, which may result in possible vehicle movement.

Burned clutch plates

Regardless of the service procedure, it's recommended to keep the brake pedal applied any time the vehicle is started.

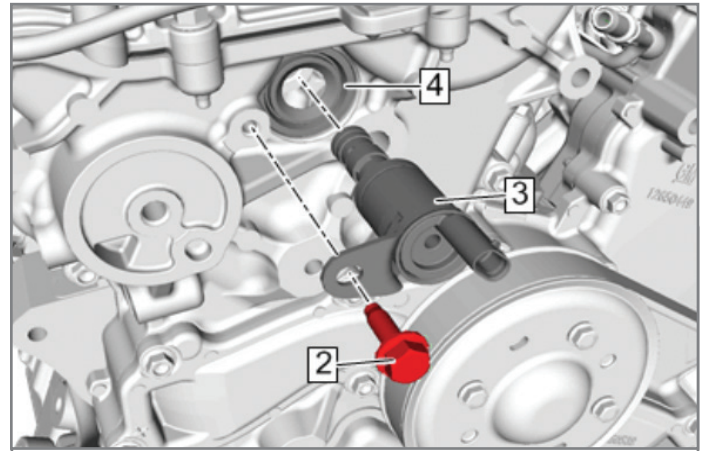
Intake Camshaft Position Actuator Park Lock Solenoid Valve

The DTCs may be caused by the Intake Camshaft Position Actuator Park Lock Solenoid Valves (or Camshaft Position Actuator Locating Pin Control Valves) sticking in the actuator or coming apart and leaving a portion of the valve stuck in the actuator. Remove the Intake Camshaft Position Actuator Park Lock Solenoid Valves and inspect them for any damage or sticking conditions. Replace both solenoid valves if there are any performance issues or

damage found. Refer to Camshaft Position Actuator Locating Pin Control Valve Replacement in the appropriate Service Information.

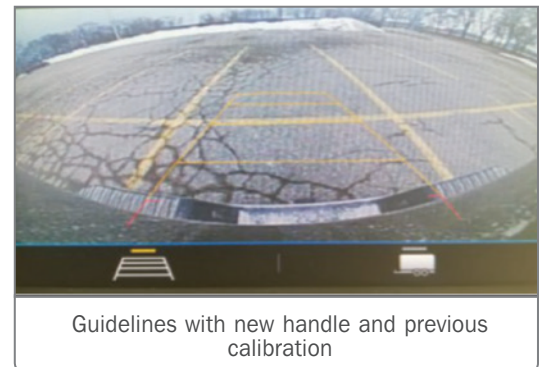
The incorrect guidelines may be caused by a different rear camera angle in the replacement tailgate handle compared with the original tailgate handle. The new rear camera angle requires the infotainment system (radio) software to be updated when the tailgate handle/tailgate is replaced.

Guidelines with new handle and previous calibration

To update the infotainment system software, contact the Techline Customer Support Center (TCSC) for the correct calibration. Follow all programming guidelines when updating the software. Refer to A11 Radio: Programming and Setup in the appropriate Service Information.

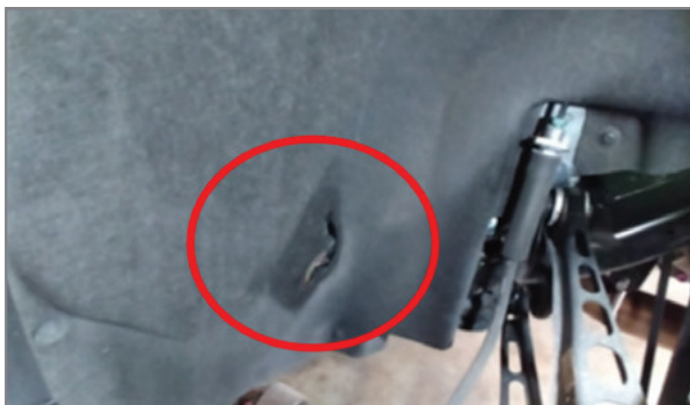
If these conditions are found, inspect the left rear wheelhouse liner for a rub-through condition due to incorrect tire size, which may result in a damaged body-to-fuel pump harness

Rub-through on the left rear wheelhouse liner

If the concern is caused by a rub-through condition and the vehicle is not equipped with the original equipment (OE) tires, advise the customer of the importance to use the same tire size and manufacturer with which the vehicle was originally equipped. The repair is not covered as a warranty claim.

If the concern is caused by a rub-through condition and the vehicle is equipped with the OE tires, repair the harness and submit a field product report, including photos and tire information.

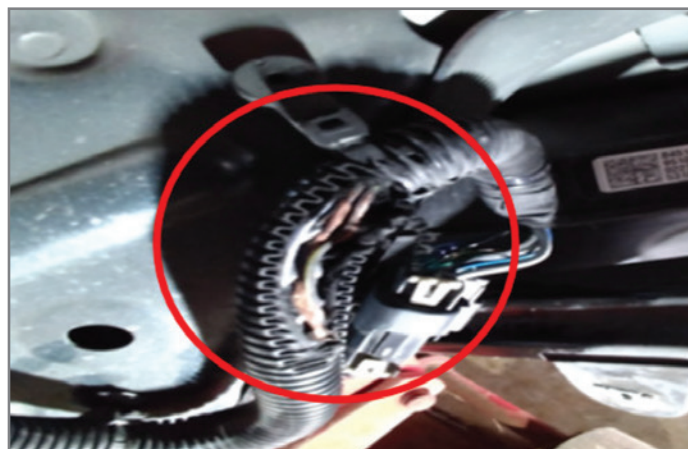
Body harness damage
