# Proactive Alerts

# Proactive Alerts – Updated Service Procedures and Warranty Information

# Intermittent Parasitic Battery Draw Below 40° F/4° C

# Front Fender and Fascia Realignment

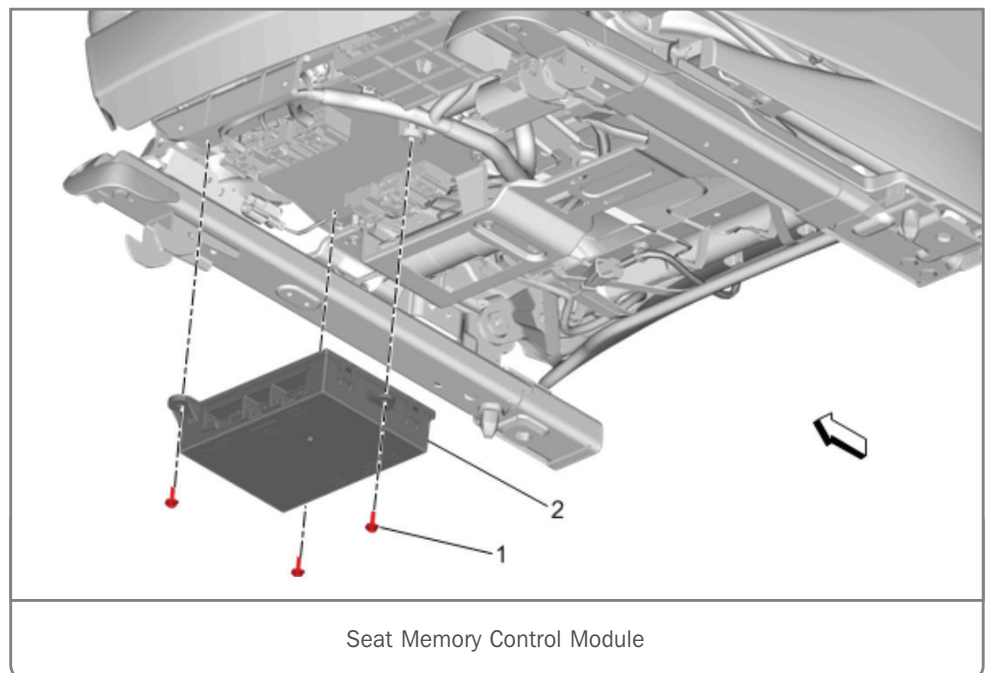
These conditions may be due to a low battery state of charge that is being caused by one or more modules waking up the Low Speed GM LAN Bus. When the ambient air temperature is below 40° F/4° C, the Seat Memory Control Module (SMCM) could inadvertently wake up the Low Speed GM LAN Bus. All SMCM's on a vehicle, including the Driver K40, Passenger K40P, Left Rear K40LR and/or Right Rear K40RR module, may apply.

Follow the Battery Electrical Drain/Parasitic Load Test procedure in the appropriate Service Information. If an excessive battery draw is duplicated, as part of the Circuit/System Testing procedure, remove the fuse(s) that powers the SMCM. The SMCM may be powered by more than one fuse. Wait several minutes to see if the vehicle will return to an acceptable battery draw level. If so, replace the appropriate SMCM.

If the battery draw does not return to an acceptable level with the SMCM fuse(s) removed, then continue with the diagnostic procedures in the Service Information.

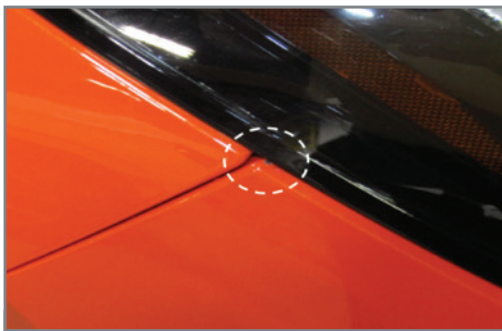
Some 2020 Corvettes may have a small paint chip in the front fascia below the headlamp on one or both sides of the vehicle. The paint chip may be caused by a mis-positioned fender-to-fascia gap joint.

Paint chip in the front fascia

The fender and fascia joint fit should be re-aligned. The realignment will reposition the fender and fascia downward and inboard so that the fascia is flush with the fender. After realignment, the paint chip will no longer be visible.

Follow the realignment procedure in Bulletin #20-NA-124. The front tire and wheel assembly, front wheelhouse

liner and front wheel opening molding must be removed on the affected side of the vehicle.

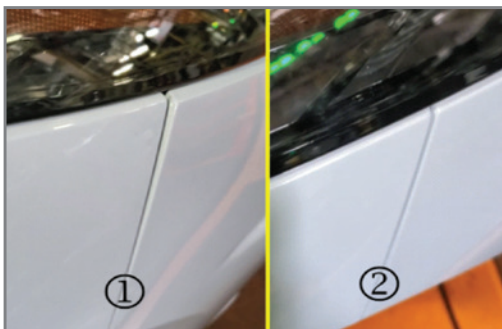
Fender-to-fascia gap joint before (#1) and after (#2) realignment.

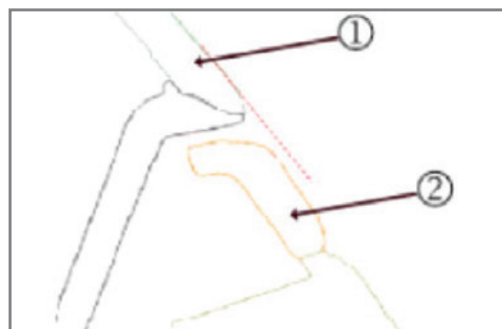
After adjusting the fender inboard, the headlamp lens will be proud of the fender and the fascia tip will be below the headlamp lens.

Dashed red line shows where the headlamp (#1) is proud of the fender (#2).

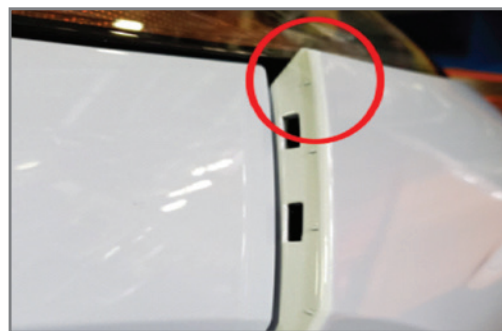
The fascia tip installs below the headlamp lens.
