## Repair or Replace?

### NEW PROGRAM IDENTIFIES 9T65 TRANSMISSION REPLACEMENTS

GM TechLink is published for all GM retail technicians and service consultants to provide timely information to help increase knowledge about GM products and improve the performance of the service department.

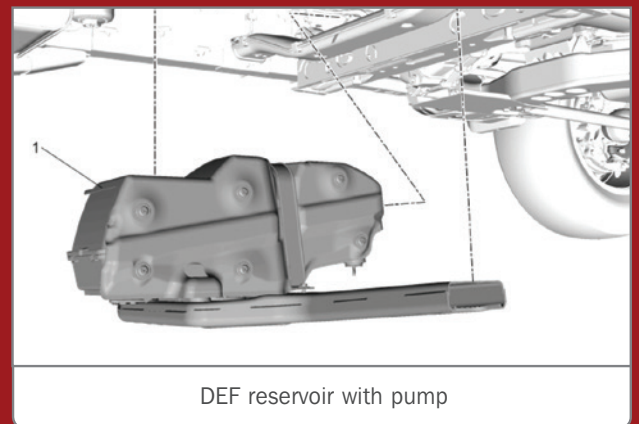
After replacing the Diesel Exhaust Fluid (DEF) pump on some 2017-2020 Colorado, Cruze, Express, Silverado 1500, Silverado 2500/3500, Canyon, Sierra 1500, Sierra 2500/3500; 2017-2019 Savana; 2018-2019 Equinox, Terrain; and 2019-2020 Silverado 4500/5500/6500 models equipped with the 2.8L diesel engine (RPO LWN), 1.6L diesel engine (RPO LH7), 3.0L diesel engine (RPO LM2), or 6.6L diesel engine (RPO L5P, L5D), the pump may not build pressure. DTCs P20E8 (Reductant Low Pressure) and P249C (Excessive Time To Enter Closed Loop Reductant Injection Control) may be set.

DEF reservoir with pump

After replacing the DEF pump and confirming that the system is unable to build pressure, inspect for any leaks, loose connections or kinks in the supply line.

Also perform an initial leak test three times using a scan tool. If low pressure is present, the DEF pump filter may have dried out.

Allow the vehicle to sit overnight with the new pump and DEF fluid in order to re-saturate the DEF pump filter. In the morning, perform the leak test three additional times. The pump should now be able to build pressure.

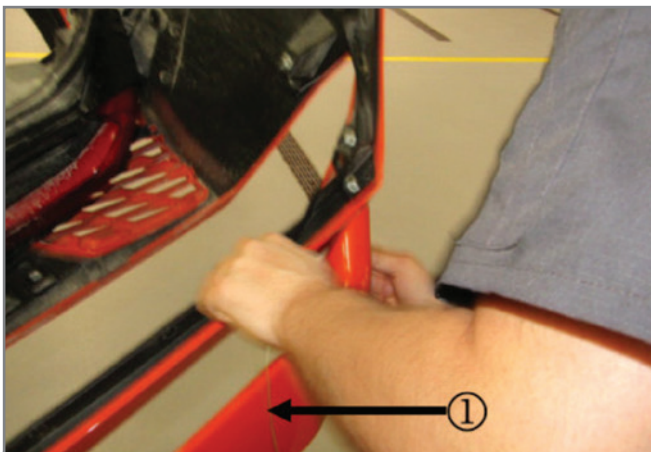
2020 Corvette Stingray models equipped with the Z51 Performance Package feature a rear spoiler that adds downforce to improve high-speed stability. If the Z51 spoiler is to be replaced with the high wing accessory spoiler, there may be some concern about applying heat to soften the two-way tape retaining the spoiler without damaging the rear fascia paint. The fascia paint may not be able to withstand high heat generated by a heat gun.

To remove the Z51 rear spoiler, it's recommended to use 50 lb. test monofilament fishing line. Position the line between the spoiler and fascia and, with a sawing motion, move the fishing line through the two-way tape to remove the spoiler. Using the fishing line method will eliminate any possibility of damage to the painted fascia surface.

Use 50 lb. test monofilament fishing line (#1) to remove the spoiler.

Do not use a heat gun, or attempt to pry the spoiler off the fascia with a plastic, metal or wood trim removal tool, in order to loosen the adhesive tape.

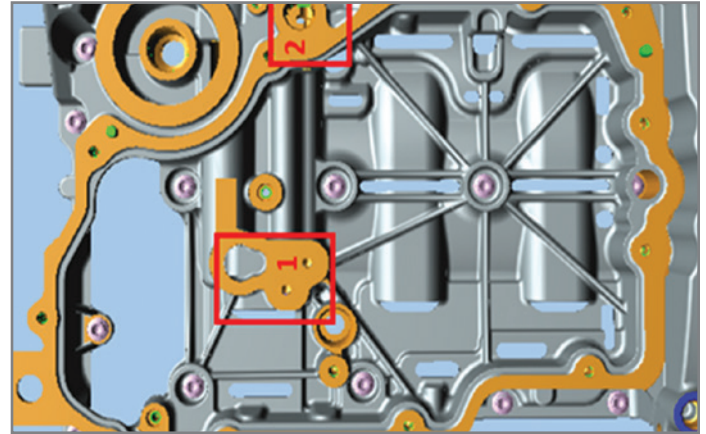
1. Oil pump ports
2. Engine oil pressure control solenoid valve port

With the engine oil pan, engine oil pressure control solenoid valve, and oil pump removed, inspect the three oil pump ports and the engine oil pressure control solenoid valve port for any debris.

Remove any debris from the ports. Do not scratch or damage any surfaces or use brush-type tools or cloth materials that may leave debris in the oiling circuit ports.

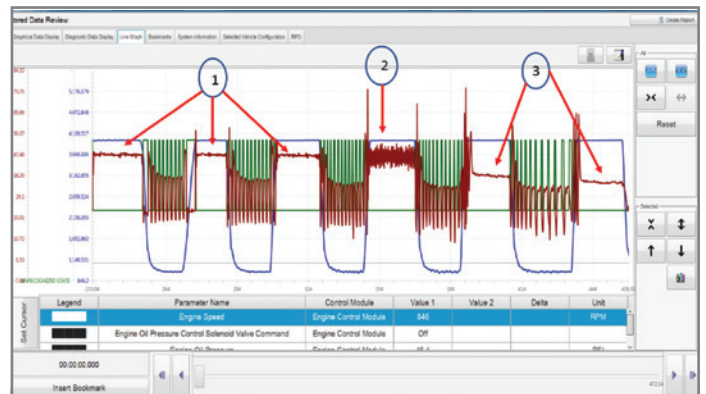
in a normal pattern. Look for an abnormal pattern that indicates normal pressure is not being achieved. In the following example, there is a normal pressure pattern (#1), and then abnormal pressure (#2) followed by failures to achieve normal pressure (#3), which indicates a failed engine oil pump.

Normal pressure pattern (1), and abnormal pressure (2) followed by failures to achieve normal pressure (3).

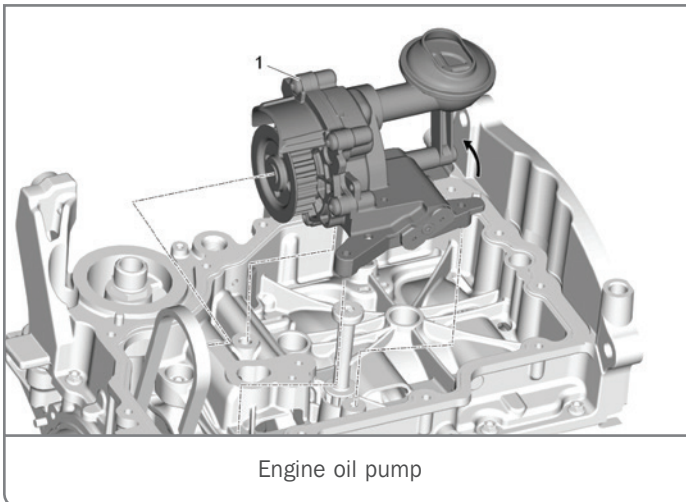
Engine oil pump

Some 2020 Encore GX and 2021 Trailblazer models equipped with the 1.2L engine (RPO LIH) may have an illuminated Check Engine MIL and DTCs P0521 (Engine Oil Pressure Sensor Performance) and/or P06DE (Engine Oil Pressure Control Solenoid Valve Stuck On) and P06DD (Engine Oil Pressure Control Solenoid Valve Stuck Off) set. If these conditions are found, perform the engine oil pump failure screening test using GDS 2.

If DTCs P0521, P06DE, and/or P06DD set, engine oil pump replacement and lower crankcase extension port inspections are required. Refer to the appropriate Service Information for oil pump replacement.

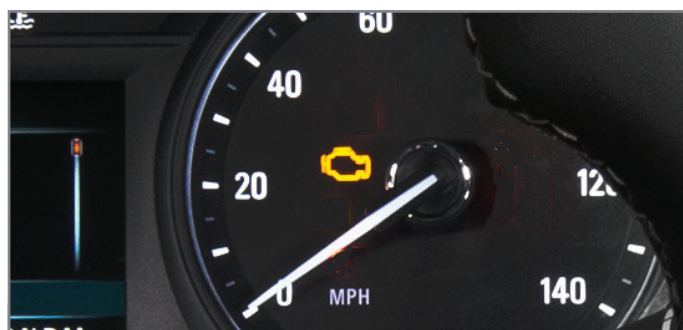
Illuminated Check Engine MIL
