Techline App Enhancements

TECH LINK

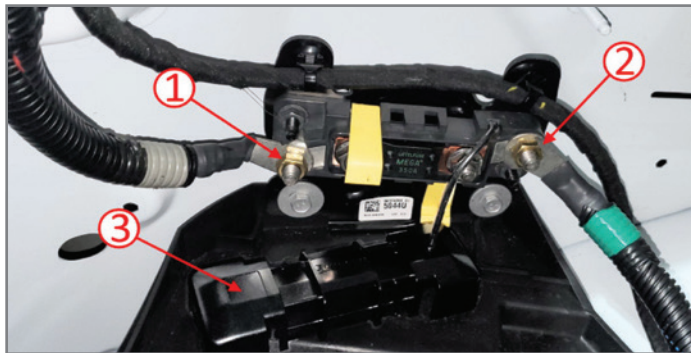
1. Pre-positive cable
2. Post-positive cable
3. Mega fuse cover

Some 2021 Express and Savana vans equipped with the 6.6L V8 engine (RPO L8T) may have a low battery charge after sitting for a short period of time. The low battery charge may be due to the a voltage draw caused by the anti-rotation tabs on the positive-side cables, located at the mega fuse, contacting the mega fuse mounting stud nuts.

If the vehicle has a low battery charge, check for battery cable contact with the mega fuse mounting stud nuts. If there is contact, trim the anti-rotation tabs on the positive battery cables.

To trim the anti-rotation tabs, first remove the battery, mega fuse cover and the fasteners that secure the pre- and post-positive

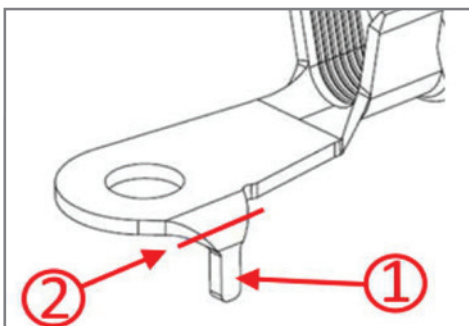
From the bottom of the anti rotation tab (#1), measure up approximately 2 mm (#2).

Approximately 2 mm of the anti-rotation tab should be trimmed from the bottom of the tab.

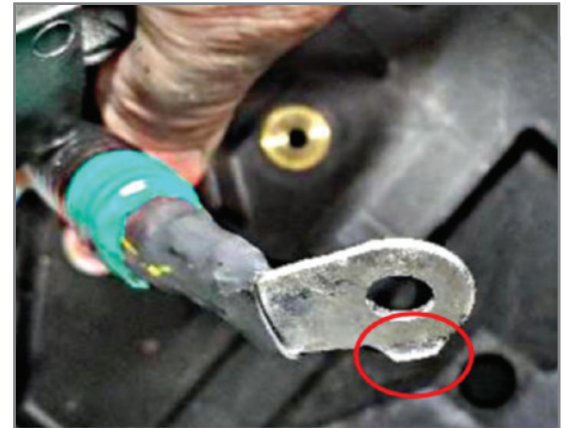
Only cut enough of the tab so that it does not contact the stud or the fastener.

the stud or the fastener. Do not cut the anti-rotation tab flush. Cutting the tab flush may cause the cables to rotate and contact the fasteners or the mega fuse mounting studs.

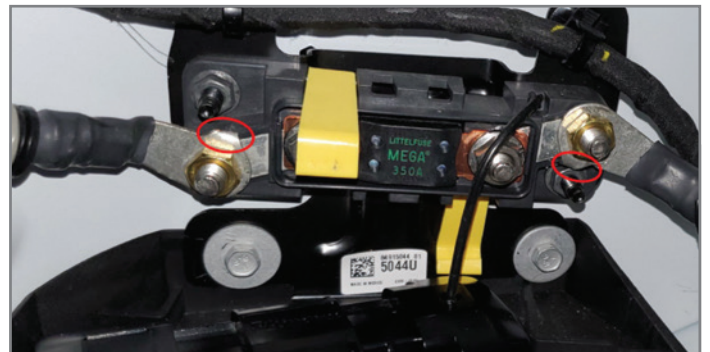
Trimmed anti-rotation tabs on installed cables.

post and tighten to specification. When tightening the fasteners, hold the cables so they do not contact the studs.

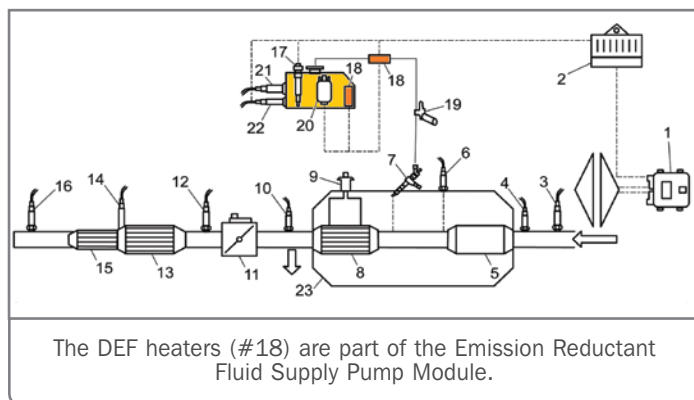
The faulty Emission Reduction Fluid Tank heater may be caused by the tank heating elements being exposed to Diesel Exhaust Fluid (DEF) and shorting to the pump ground. Within the Emission Reduction Fluid Tank is the Emission Reductant Fluid Supply Pump Module, which contains an electrically operating reductant pump; reductant level, quality, and temperature sensors; and reductant system heaters. The reductant control module is mounted outside the tank.

To determine if there is a short to ground, measure resistance at the Emission Reductant Fluid Supply Pump Module, which would indicate that the heater has been exposed to DEF.

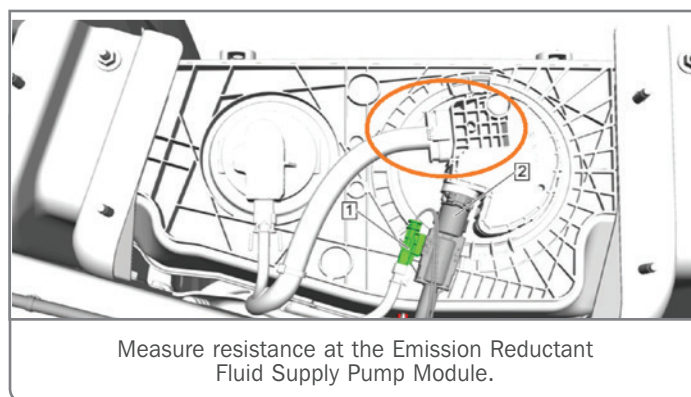
With the Emission Reduction Fluid Tank wiring harness disconnected, measure resistance from pin 9 to pin 14 using a Digital Multimeter. Next, measure resistance from pin 10 to pin 14.

If either resistance reading is less than 10M ohm, the heater is faulty and the Emission Reduction Fluid Tank should be replaced. If both resistance readings are greater than 10M ohm, continue with diagnostics according to the appropriate Service Information.

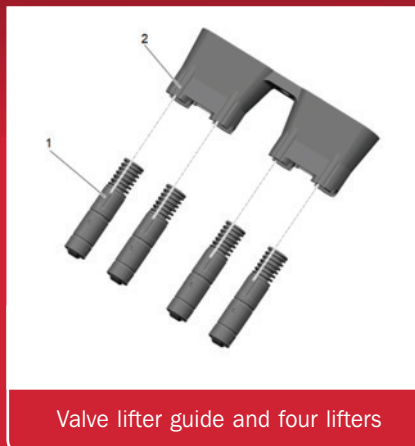
Valve lifter guide and four lifters

Some 2019-2021 Silverado, Sierra; 2021 Tahoe, Suburban, Yukon and Escalade models equipped with the 5.3L V8 engine (RPO L84) or 6.2L V8 engine (RPO L87) may have a misfire condition with a bent pushrod that leads to a collapsed lifter or the lifter comes apart. Misfire DTCs P0300 – P0308 may be set.

If Service Information diagnostics lead to a collapsed lifter and/or a lifter that has come apart, it is recommended to replace the valve lifter guide and the four lifters. It is not necessary to replace the oil control solenoid valve.

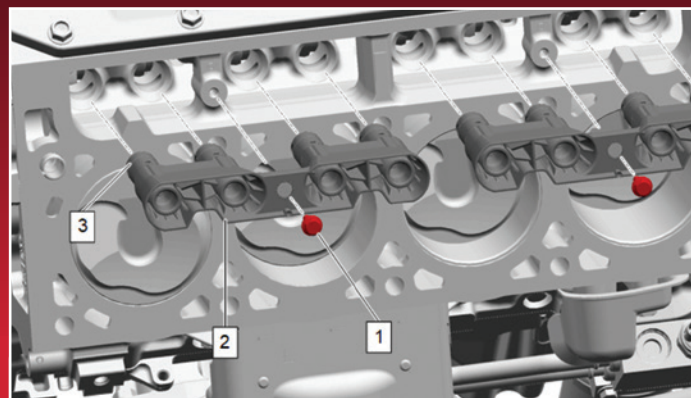
The notched area of the lifter guide aligns with the locating tab on the engine block.

Note the installed position of the valve lifter guide. The notched area of the lifter guide aligns with the locating tab on the engine block. Install the new valve lifter guide and the lifters as an assembly.

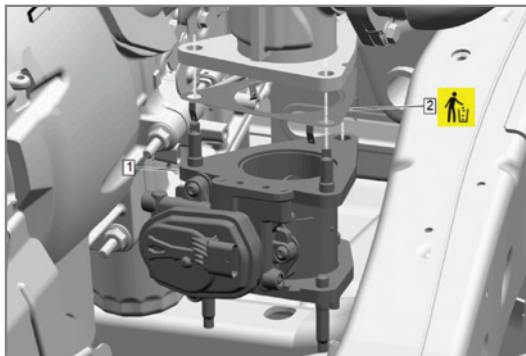
Exhaust backpressure valve

An exhaust odor in the cabin or in the engine compartment may be noticed on some 2020-2021 Silverado and Sierra models and 2021 Tahoe, Suburban, Yukon, and Escalade models, equipped with the 3.0L diesel engine (RPO LM2). The exhaust odor may be caused by an improper weld on the exhaust backpressure valve.

The exhaust backpressure valve is located between the downpipe from the Selective Catalyst Reduction (SCR) with filter and the under-floor SCR.

If an exhaust odor is present, test for a leaking exhaust backpressure valve weld joint using the GE-52250 Power Smoke Diagnostic Leak Detector or soapy water. Refer to the latest version of #PIP5684 for more information on using the GE-52250 detector.

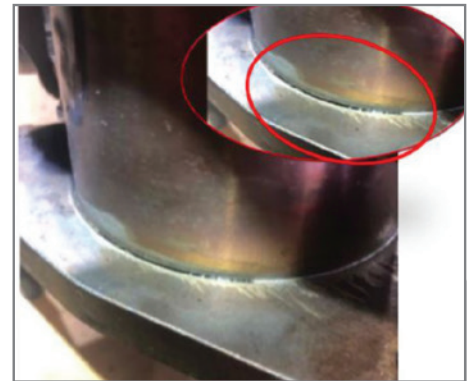
Ineffective weld at the flange joint

Repair any leaks identified after testing the exhaust system components. An ineffective weld at the flange joint may be a source of a leak. If the weld joint is leaking, replace the exhaust backpressure valve.
