TIPS FOR { Over-The-Air Software Programming

9T65 Transmission Replacement Pilot Program Update

Whining/Groaning Sounds Due to Front Intermediate Shaft Fretting 5

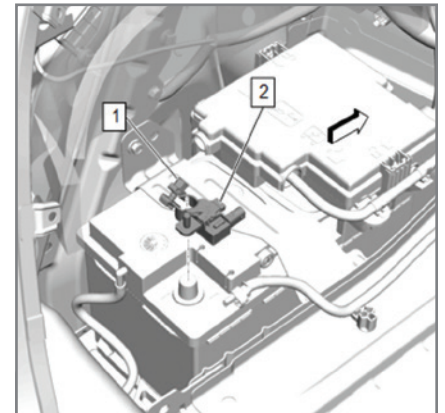
Battery Sensor Module (#2)

On some GM models, connecting the battery charger directly to the 12V battery posts will bypass the Battery Sensor Module, resulting in a default SOC value of 65 percent and a “Conditions Not Met” message.

TIP: The Battery Sensor Module is attached directly to the battery negative terminal. It determines the battery condition by calculating the battery SOC, functions, and state of health, which is used to help determine if the 12V Stop/Start system will allow an Auto Stop when the vehicle has come to a stop. To properly charge the battery, the negative lead of the charger must be connected to chassis ground, and not directly to the negative battery post. Connecting to chassis ground allows current to flow through the Battery Sensor Module during charging as well as be monitored. Connecting directly to the negative battery post charges the battery, but the current cannot be monitored by the Battery Sensor Module.

If a battery is improperly charged, the Battery Sensor Learn will be required to calibrate the Battery Sensor Module. With the ignition off, let the vehicle rest for a minimum of four hours without any interruptions (opening a door, using the key fob, etc.). Verify if the battery SOC is 70 percent or greater using GDS 2 before attempting to continue with an OTA update.

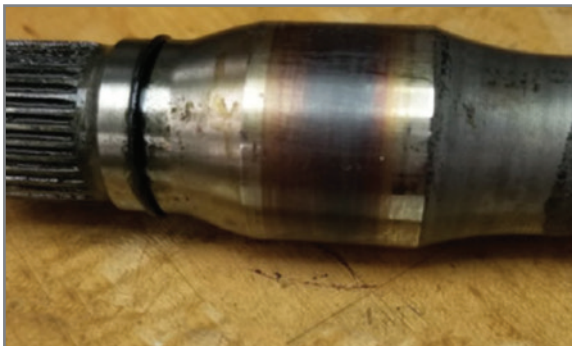
The fretting occurs between the front intermediate shaft (IDS shaft) and the front intermediate shaft bearing/housing (IDS bearing) as a result of the slip fit interface between the bearing and the IDS shaft, combined with a bearing that has approximately 0.5 Nm of torque to rotate (TTR). This may also cause red dust/debris to appear within the IDS bearing/housing.

Use the J-39570 Chassis Ears to determine if the sound is at the front intermediate shaft housing. If the sound is confirmed and isolated at the front intermediate shaft bearing/housing, replace both the IDS shaft and IDS shaft bearing/housing. Refer to the Front Wheel Drive Intermediate Shaft Replacement and Front Wheel Drive Intermediate Shaft Housing Replacement procedures in the appropriate Service Information.

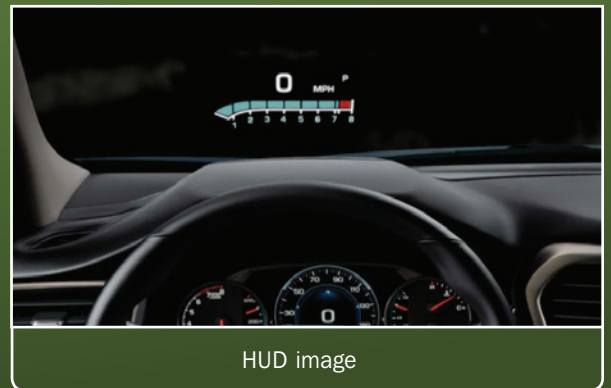
The Head-Up Display (HUD) image (RPO UV6) on some 2020-2021 Acadia models may be tilted or not level when displayed on the windshield. The tilted image may be due to the HUD image not being properly adjusted.

If the HUD image appears tilted, navigate to the Options menu on the instrument cluster. Scroll through the menu and select Head-Up Display. Next, select Head-Up Display Rotation to enter the adjustment mode.

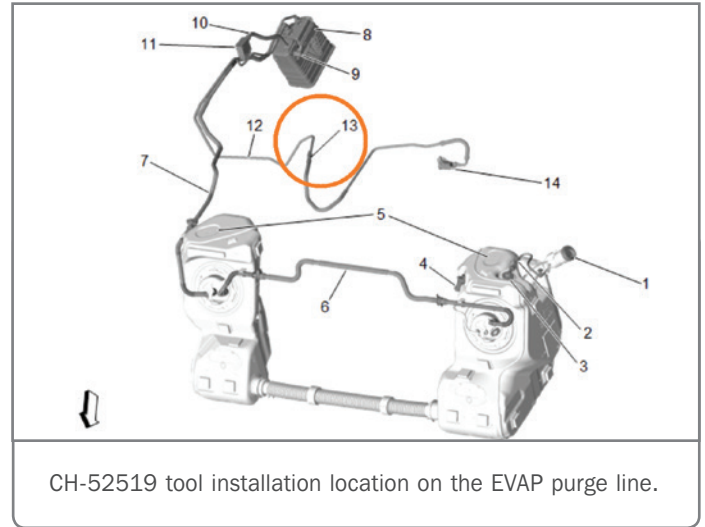
If the CH-52519 EVAP tool is not modified, or a commercially available low profile fuel line disconnect tool is not sourced to be used, it will result in the CH-52519 EVAP tool not being able to be removed from the EVAP purge line. The rib located on the CH-52519 EVAP tool needs to be modified in order for the tool to be removed from the purge line.

To modify the CH-52519 EVAP tool, partially file down the rib (#1) on the tool. File the rib evenly and do not file the rib flush as

damage to the sealing surface may occur. Leave a small amount of rib material on the tool without damaging the sealing surface (#2). This modification should not have any effect on how the tool works with other vehicles.
