## PROGRAMMING WITH THE Vehicle Intelligence Platform

GM TechLink is published for all GM retail technicians and service consultants to provide timely information to help increase knowledge about GM products and improve the performance of the service department.

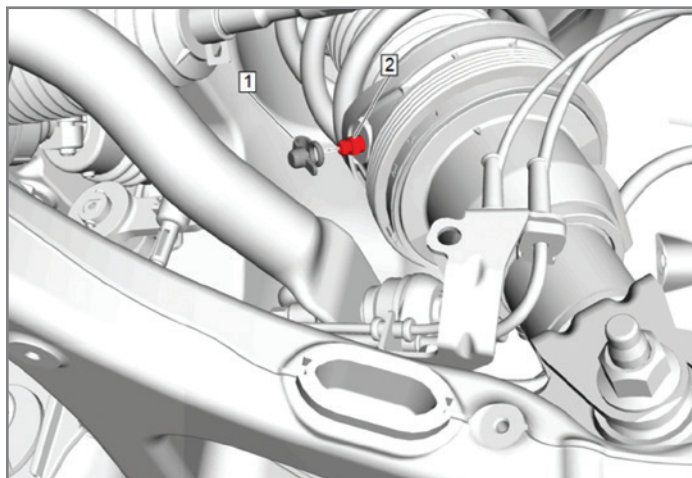
Test B covers performing the Prime Front Suspension Pump procedure using the scan tool if the DTCs reset. Perform the pump procedure five times in an attempt to purge any trapped air bubbles from the system.

Front hydraulic suspension actuator bleeder valve

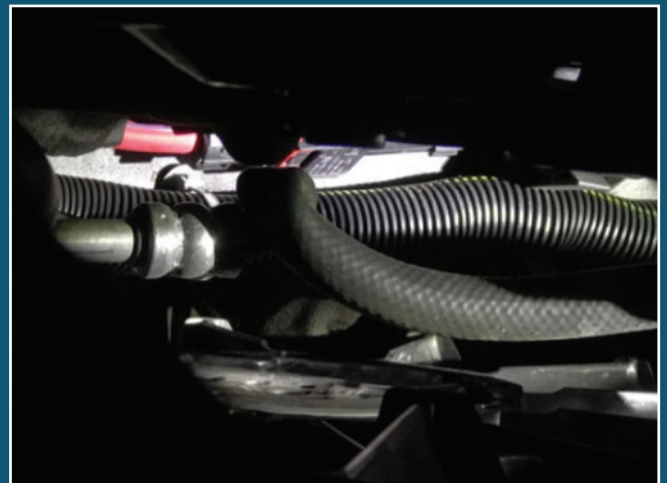
A harsh shift, shudder, surge or stall condition may be present on some 2021 Silverado, Tahoe, Suburban, Sierra, Yukon, and Escalade models equipped with the 6L80 or 6L90 6-speed automatic transmission (RPOs MYC, MYD), 8L90 8-speed automatic transmission (RPO MQE), or 10L80 or 10L1000 10-speed automatic transmission (RPOs MQC, MQB, MGM, MGU) and with low mileage. These conditions may be caused by a twisted transmission cooler line.

Example of twisted cooler line

If a twisted cooler line is found, disconnect the cooler line from the transmission auxiliary cooler and untwist it. Reconnect the cooler line if the rubber is not deformed or misshapen or there are not any other issues with the line. If the cooler line is damaged or deformed from being twisted, it should be replaced.

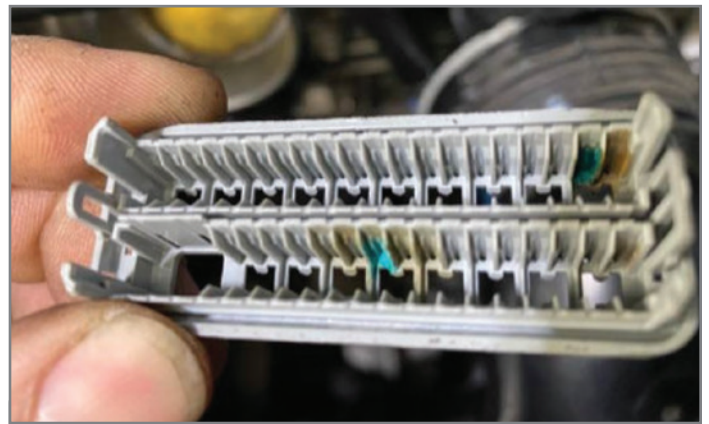
Use a bright light to inspect all the terminals in all three connectors for green corrosion, coolant or oil. Inspect all terminals regardless which DTCs may have set. Every terminal must be inspected since circuits that are corroded or contaminated can back feed into other circuits that are not corroded and set DTCs for associated systems.

Terminal guide removed from connector

Any terminal that has signs of green corrosion should be replaced with terminated leads. Do not clean the terminals. The contact area is difficult to clean and will lead to poor connections and intermittent DTCs. Solder all terminated leads and cover with

shrink tubing. Do not use crimp connectors to splice the circuits together.

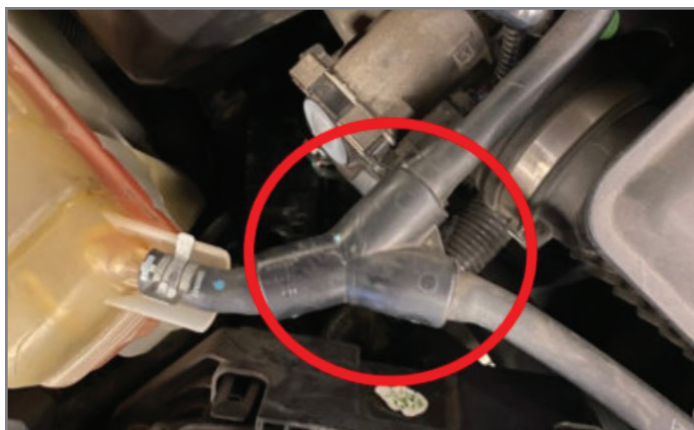
"Y" hose from coolant reservoir

If the coolant source is not from the coolant wicking up the engine coolant temperature circuits and into the ECM, inspect the coolant reservoir and "Y" hose located above the ECM for leaks. Replace the reservoir or "Y" hose as needed.

If the coolant was leaking down onto the ECM from the reservoir or "Y" hose, the ECM may have to be replaced, depending if coolant saturated the ECM and ECM sockets. Shake the ECM and listen for any coolant sloshing inside the ECM. Replace the ECM if coolant is heard inside the ECM. If coolant is only in the ECM socket, clean the ECM sockets with electrical contact cleaner and blow out with compressed air.

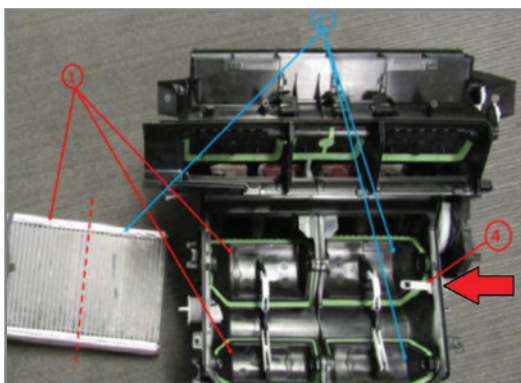
1. Two passenger-side temperature doors and heater core
2. Two driver-side temperature doors and heater core
4. EAT sensor location in relation to the driver-side temperature door.

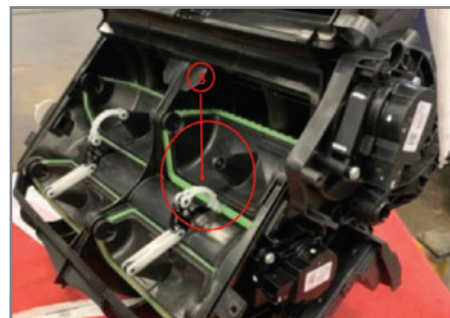
Inside the HVAC case, there are four white links that connect each of the four temperature doors. If one of these white links becomes disconnected, the doors will not operate properly.

There are four white links (#3) that connect each of the four temperature doors.

If a temperature door is not moving properly, there may be an issue with one of the white links that connect a temperature door, a temperature door issue, or an actuator issue. Follow the diagnostics in the appropriate Service Information to determine the root case. It may be necessary to disassemble the HVAC case to identify the source of a door issue and to replace any parts.

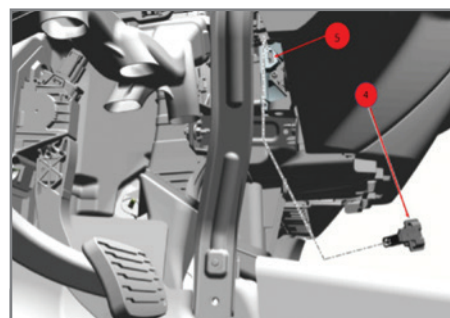
Use a bore scope through the opening (#5) for the EAT sensor (#4) to inspect both driver-side temperature doors.
