Latest Labor Time Guide

Engine Rattle Sound from Purge Solenoid

Common Concerns from the Escalade TAC Action Center

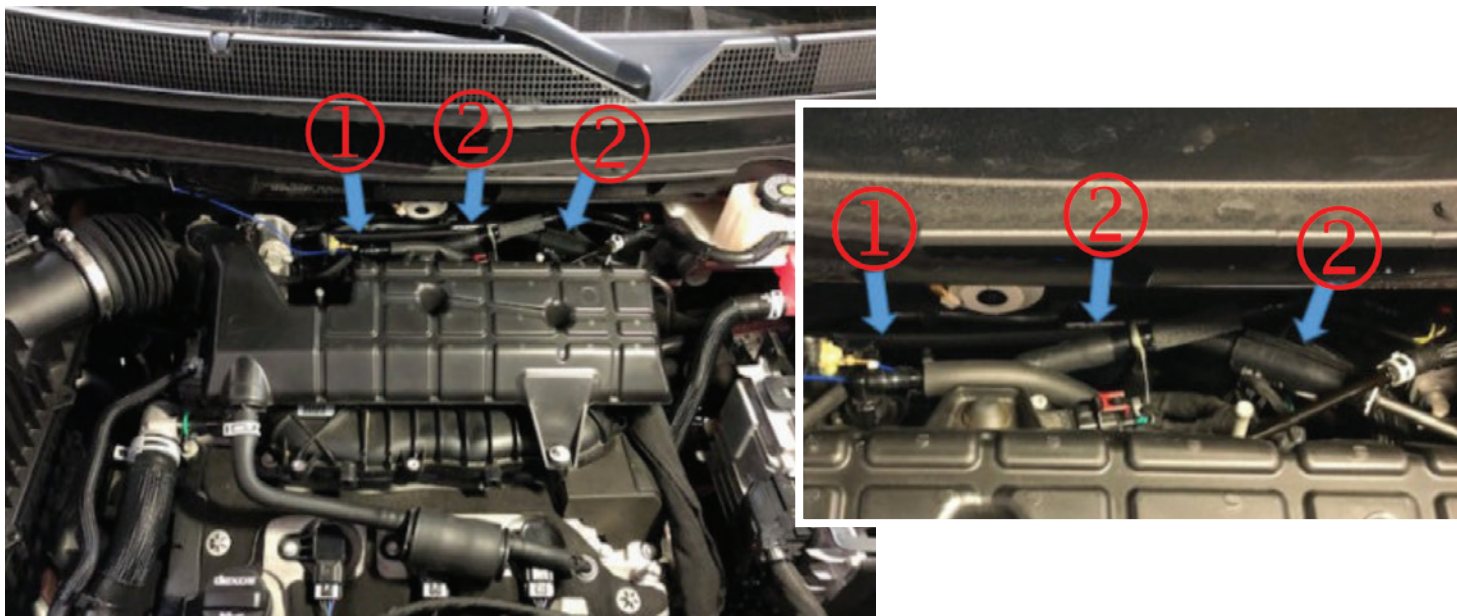
Purge line (#1) and damper installation locations (#2)

A loud ticking or rattle sound may be heard coming from the engine compartment on some 2020-2021 Enclave and Traverse models equipped with the 3.6L V6 engine (RPO LFY). The sound may be caused by pressure pulsations in the purge solenoid tube that occur when the purge solenoid is commanded on. The pulsations create an audible rattle or tick sound that can be heard inside and outside the vehicle.

To correct this condition, verify the noise is coming from the purge tube by commanding the purge solenoid on and off. If the noise can be duplicated, it will be necessary to install insulator/dampers on the tube at the identified locations.

Two insulators/dampers should be made using two 3-inch (76 mm) pieces of 3/8-inch rubber fuel hose and two 3-inch (76 mm) pieces of 1/2-inch rubber fuel or vacuum/heater hose placed on the outside of the 3/8-inch hose. Split the hoses lengthwise and install each insulator/damper with the seam facing down at the specified locations on the purge tube. Secure the insulator/dampers using two tie straps on each one.

A damper to further dampen the sound is being developed. Refer to #PIP5796A for additional information.

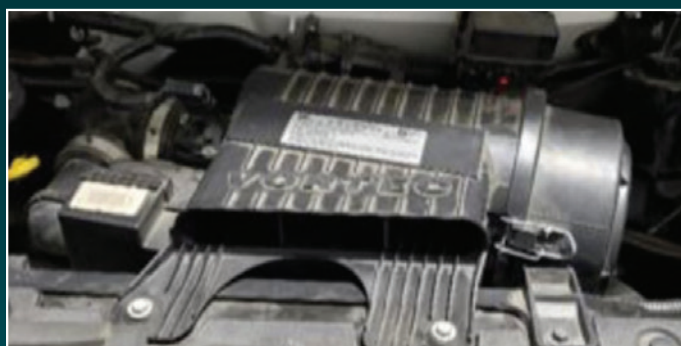
The poor engine performance may be due to the high ambient temperatures affecting the intake airflow to the engine. The GDS 2 scan tool data will show an increase in total knock retard and backed out ignition timing, both of which may occur when the vehicle is under load or driving up a grade and more throttle input is required. The Engine Control Module (ECM) is adjusting to protect the engine from damaging spark knock, which is a normal operation under these conditions.

If poor engine performance is noticed, there are a number of components to check to determine if they are installed correctly or not missing or damaged. Any missing or damaged components could allow hot air into the intake duct, resulting in a lack

Check the intake duct for any restrictions.

of power. For example, check the intake duct for any restrictions, proper installation and any missing clamps.

Other components to inspect include the hood seal, radiator baffle, air box, and exhaust system as well as any modified components. Refer to #PIP5800 for a complete list of components that should be inspected if the lack of performance condition is present.

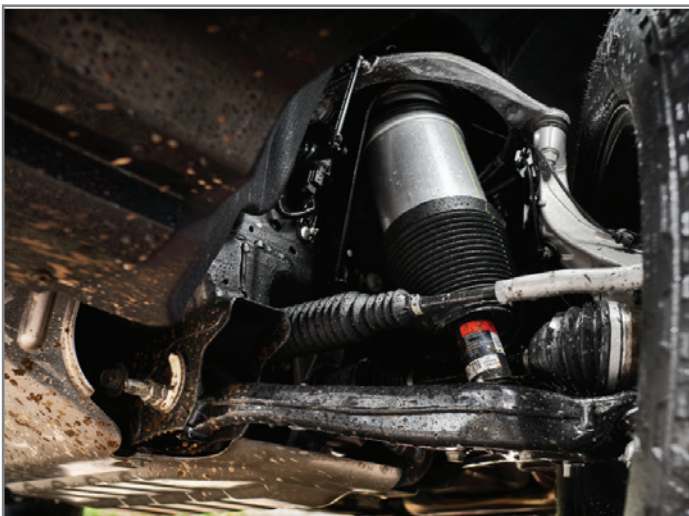
Air Ride Adaptive Suspension

The vehicle should not be driven without air in the air springs. There have been multiple vehicles returned to dealerships for blown out bags on the air springs. The main cause for this is either driving the vehicle with no air in the springs or lowering the vehicle down from the hoist and allowing the air bags to bottom out.

TIP: If the vehicle was driven for a period of time with no air pressure in an air spring, it may have damaged the air spring. Once the vehicle is repaired, a thorough inspection of the inflated air spring should be performed. If any damage is found or if it is uncertain that any damage occurred, the air spring should be replaced.

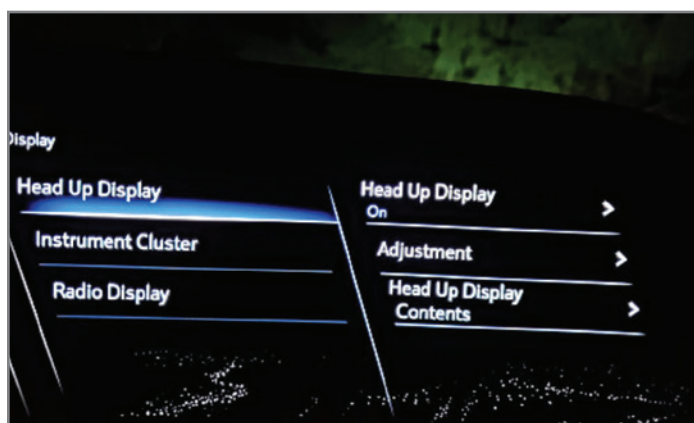
The white dots seen on the screen represent a city lights design.

There may be white dots in the background of the Infotainment Screen display. This is a design intent feature and the display is functioning properly. The white dots seen on the screen represent city lights and may be more noticeable at night. This information should be shared with customers. Do not replace the Integrated Center Stack for this concern. Refer to Bulletin #21-NA-051 for additional information.

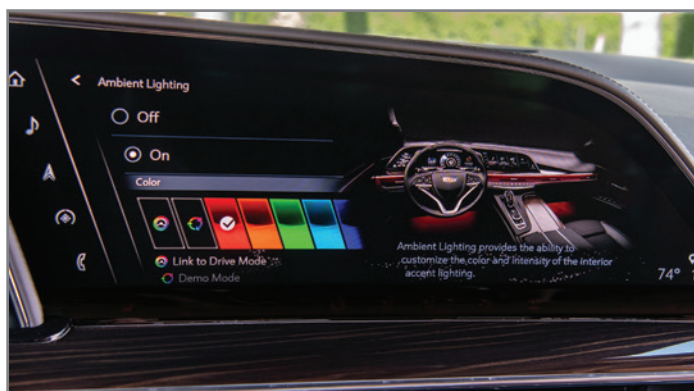
Ambient light sensor setting

The sill plate lighting may appear to be inoperative after installing the LPO Illuminated Sill Plate kit. The lighting concern may be caused by current ambient lighting conditions. The light sensor needs to see a dark condition. To ensure the vehicle is in

the night mode, cover the ambient light sensor and verify that the headlights icon is illuminated on the instrument cluster. In addition, check that the ambient light sensor setting under settings > Vehicle > Lighting is not turned Off. If off, select On to enable that ambient lighting. Refer to #PIT5835 for additional information.

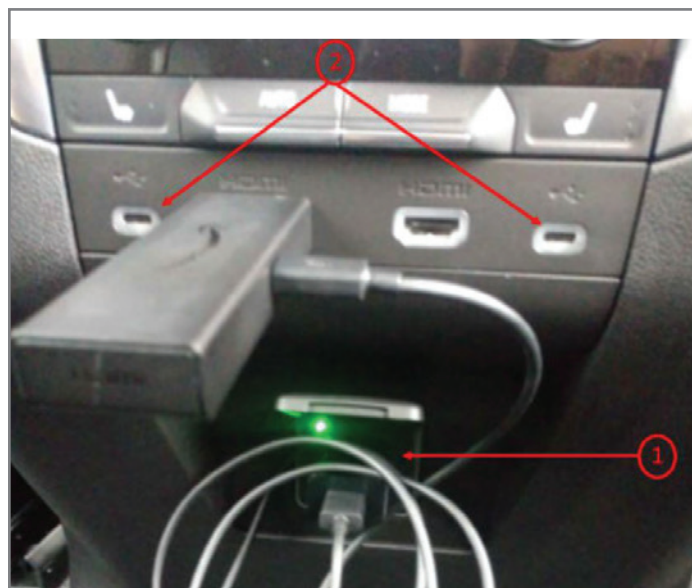
1. 110 volt power outlet
2. USB-C ports

The 110 volt power outlet will momentarily turn off during an Auto Stop event. If the power outlet is being used to power a streaming device, for example, an Amazon Fire Stick, when the power outlet turns off and back on, it can cause the device to reboot, which interrupts its operation. This is normal operation of the 110 volt power outlet during engine cranking. Do not replace the T1 AC and DC Power Control Module for this condition.

To help reduce the power interruption to a device, suggest to customers to use the USB-C ports, if possible, which do not turn off during an Auto Stop event. A USB-C to USB-A adaptor may be needed.

If an uninterrupted power supply is required while driving, disable the Auto Stop feature by pressing the Auto Stop Disable Switch on the instrument panel. Refer to #PIT5787A for additional information.
