## Let's Take a Look

# False Park Assist Alerts

# Testing Setup and Valid Test Codes

# Engine Overheating Message

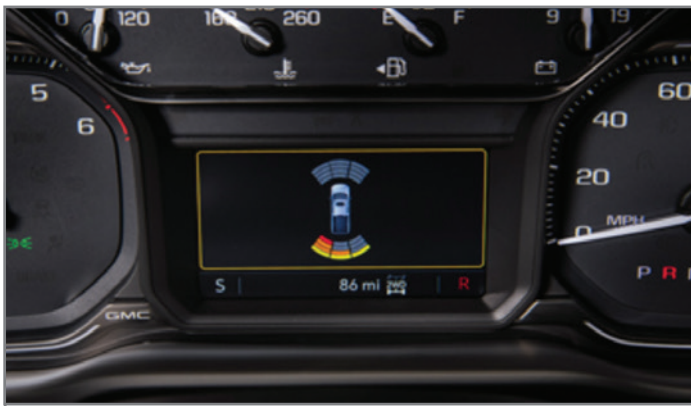
Park Assist display

False Park Assist alerts may occur on some 2019-2021 Silverado and Sierra trucks when there is not an object in front and/or behind the vehicle. As a result of the alert, the system may disable itself and a Park Assist Off message may be displayed on the Driver Information Center (DIC). The indicator in the Park Assist switch also will be disabled.

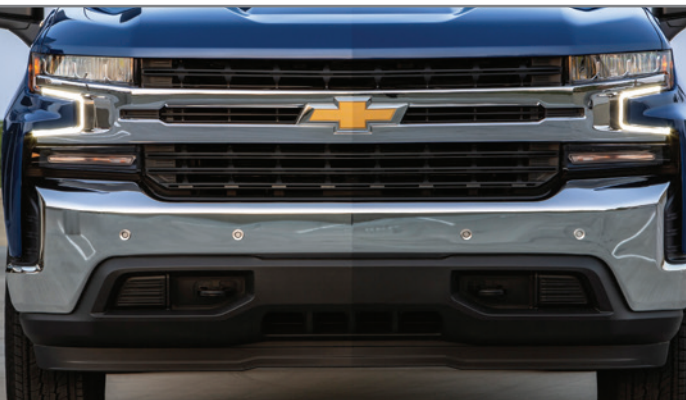
Park Assist sensors

Depending on the way the Park Assist sensor and/or bezel is mounted or painted, the sensor can ground out or pick up normal vehicle vibrations that may be interpreted as an object. If the sensor is properly mounted and isolated from the vehicle, these normal vehicle vibrations would not be picked up the sensor. Since the sensor is working normally, no DTCs will be set.

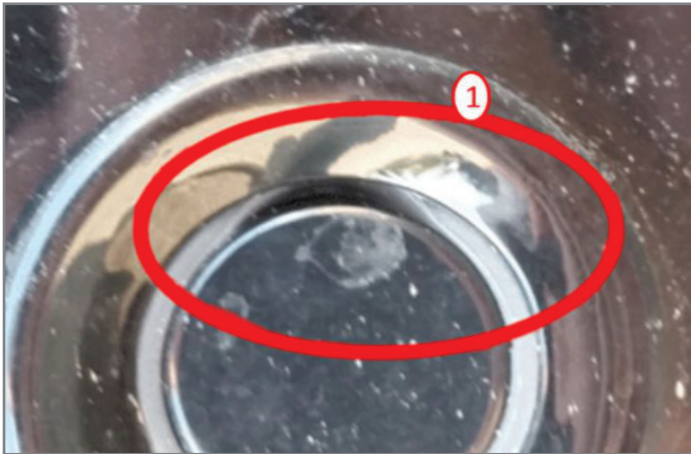
Once it has been determined which sensor(s) to inspect further, check the Park Assist sensor and bezel for any damage. Look for any stone chips, paint chips or dents as well as any issues with

the silicone ring, including proper ring installation. Repair as necessary. These inspections may require the bumper to be removed.

Check for damage and proper installation.

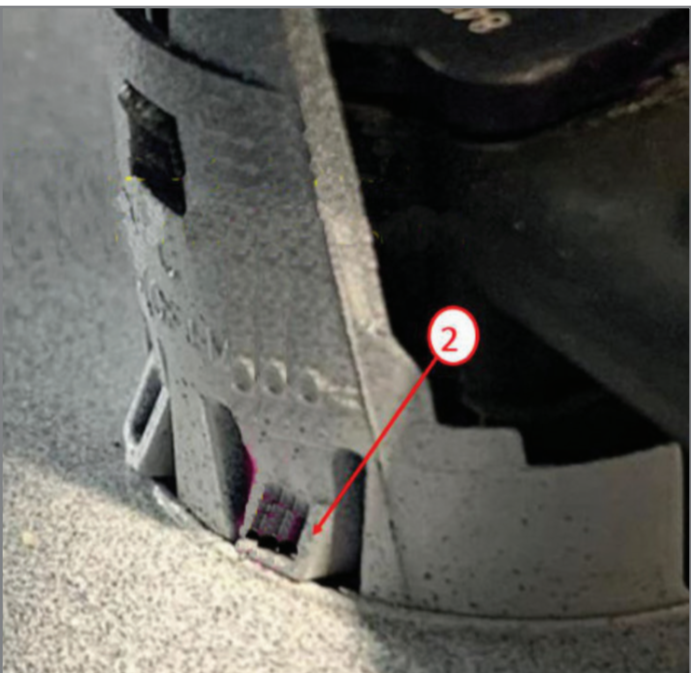
Bezel locking tab

Inspect the Park Assist sensor bezel for proper mounting in the bumper hole. If the bezel is not properly mounted, it can lead to a sensor grounding out or the sensor getting squeezed. Check

that all four locking tabs that secure the bezel to the bumper are fully engaged. If a tab is not fully engaged, determine what is preventing the tab from engaging, such as excessive paint or plastic flashing. Do not replace the sensor or bezel unless they are damaged.

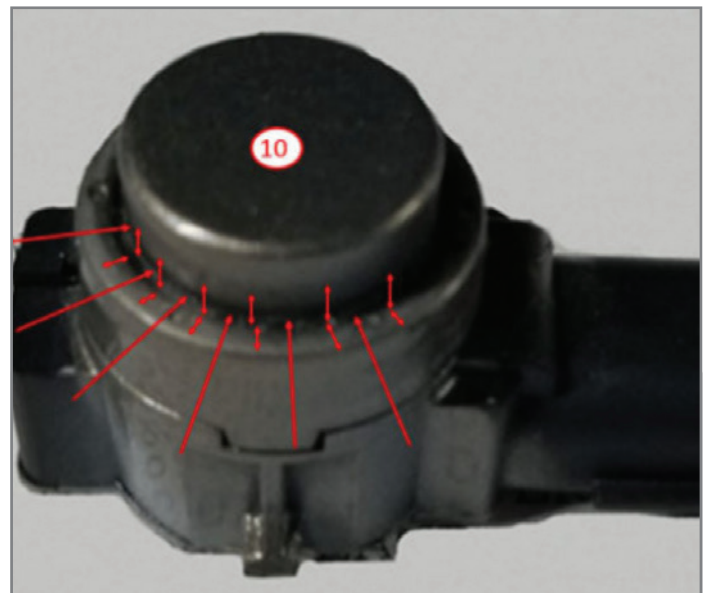
Gap between the body and sensor tip

If the Park Assist sensors have been painted, check that the tip of the sensor is isolated from the sensor body by the internal decoupling ring. Any paint or clear coat that has run down the side of the sensor's tip into the gap between the body and sensor tip may cause the sensor to ground out.

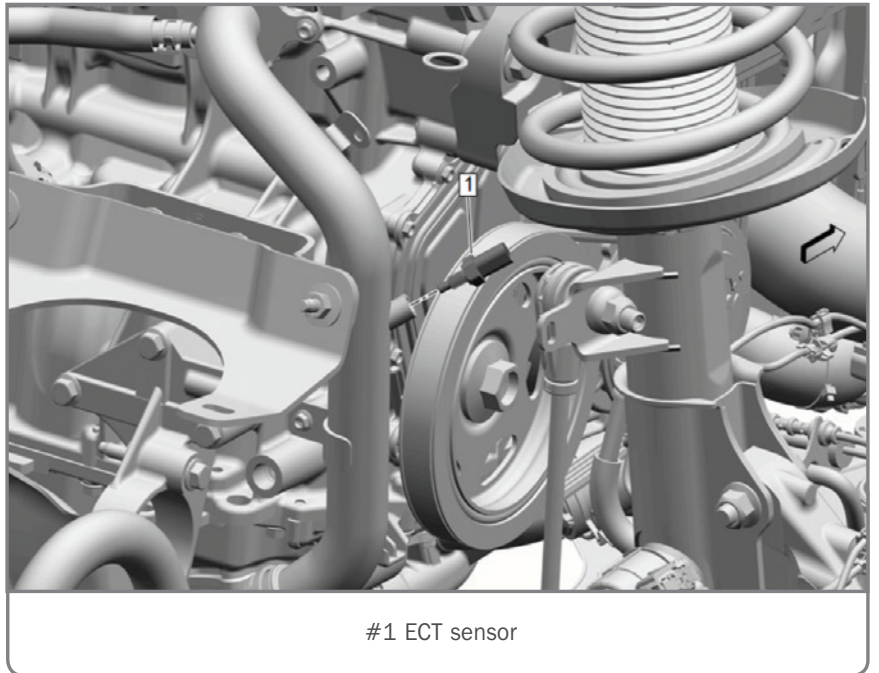
Some 2019-2021 XT4, XT5, Blazer, Acadia; 2020-2021 CT4 and CT5 models equipped with the 2.0L 4-cylinder engine (RPO LSY) may have a possible engine overheating condition along with an Engine Over Temperature message on the Driver Information Center (DIC). These conditions may be the result of an inaccurate #1 Engine Coolant Temperature (ECT) sensor.

Data has shown that a #1 ECT sensor that is reading several degrees colder than ECT sensors 2, 3, 4, 5 and 6 could cause a potential Engine Over Temperature message to display in the DIC as well as the engine coolant temperature to operate at elevated levels.

Using GDS2, confirm the accuracy of the #1 ECT sensor by comparing readings of ECT sensors 2, 3, 4, 5 and 6 to the #1 ECT sensor reading. To check the sensors, allow the engine to cold soak for several hours and then review the six ECT sensor readings (at key on, engine off) using GDS2. Verify the sensors are within a few degrees of each other. The ECT sensor readings can be compared to a like vehicle under similar test conditions with the same engine RPO option.
