December 2016, Volume 18, No. 23

New Essential **Tool GE-5220C** Propulsion System Lift

Harsh Shifting on the 8L90 Automatic Transmission

Unwanted Brake Apply in Reverse without Park Assist Activation

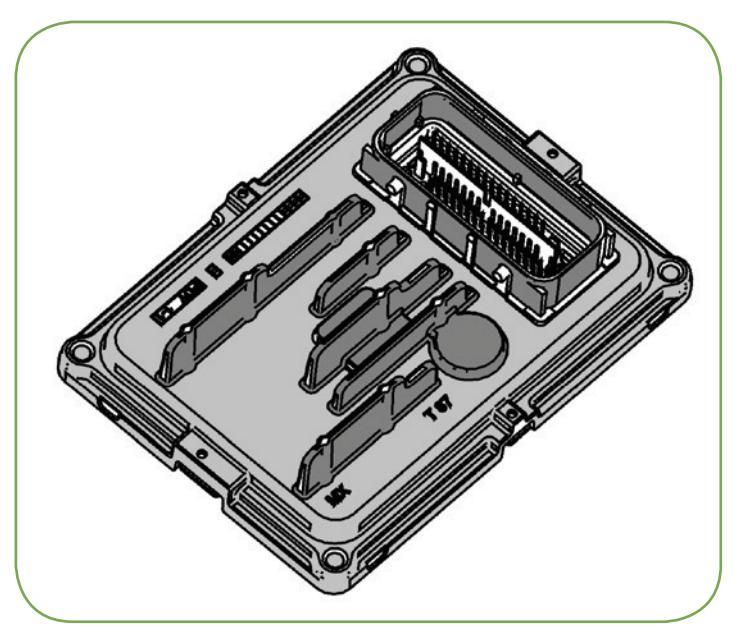
There may be several harsh shifting conditions on some 2015-2016 Silverado, Sierra, Yukon and Escalade models equipped with the 5.3L engine (RPO L83) or 6.2L engine (RPO L86) and the 8L90 automatic transmission (RPOs M5U, M5X). The shift conditions may include:

- Harsh 1-2 upshift (except for the first 1-2 upshift of the day)
- Harsh 3-1 downshift when de-accelerating to a stop
- Harsh downshift under heavy throttle apply
- Active Fuel Management (AFM) V4 to V8 transition harshness (6.2L engine only)
- Coast-down downshifts (6.2L engine only)

TCM on the 8L90 transmission

There is new Engine Control Module (ECM) and/or Transmission Control Module (TCM) software that is available to improve these conditions. Use the Service Programming System (SPS) and follow the on-screen instructions to complete the programming. If both controller options are listed in SPS, select K20/K71 Transmission Control Module.

TIP: Installation of the new TCM software will require that the Transmission Service Fast Learn (SFL) procedure be performed using GDS 2 or SPS through the TIS2Web application. The transmission may exhibit poor shift quality until the clutch values are learned. Performing the SFL will reset and relearn all the shift adapts.

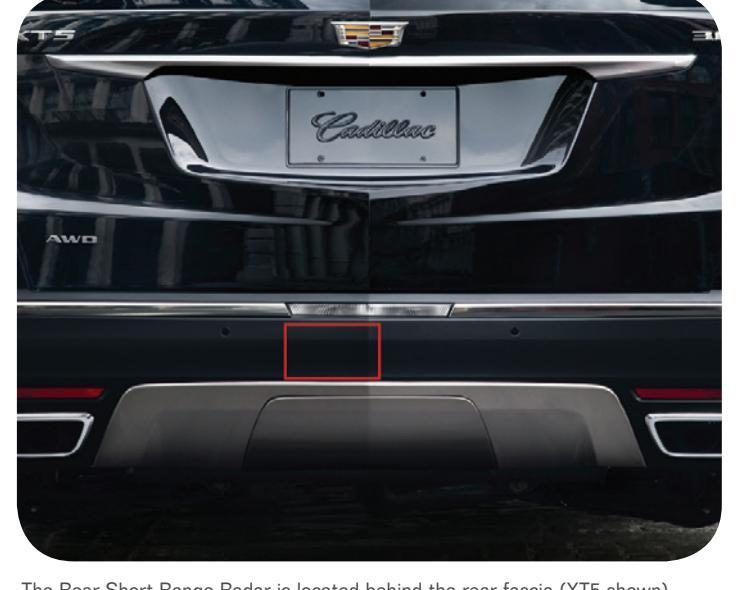
Some 2016-2017 CT6 and 2017 XT5 models may have an unwanted brake apply condition while in Reverse when there is no object behind the vehicle or around the vehicle. This condition may occur most often when the vehicle is cold in the morning (overnight cold soak) or has been sitting outside for several hours in colder temperatures.

The Rear Short Range Radar is located behind the rear fascia (XT5 shown).

of the rear Short Range Radar Sensor may be degraded at cold ambient temperatures below 50°F (10°C), which may result in unintended brake activation while the vehicle is backing up.

Do not replace any parts or attempt any repairs for this condition. GM Engineering is determining a root cause. To address this condition at this time, use remote start to

start the vehicle before driving, which will allow the rear Short Range Radar Sensor to warm up, or turn off the Park Assist feature when backing up after a cold start.
