GMC

March 2017, Volume 19, No. 5

Duramax Diesel Engine Coolant Leak

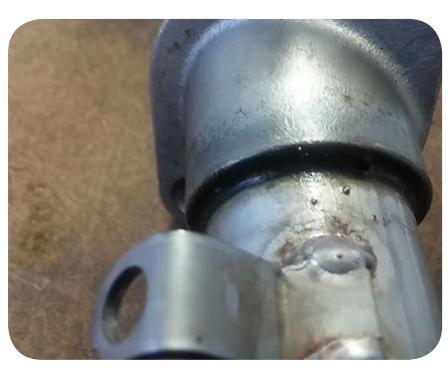
Check for coolant leaks at the welded flange on the Exhaust Gas Recirculation (EGR) coolant return pipe and coolant feed pipe.

Check the welded flange on the EGR coolant return pipe.

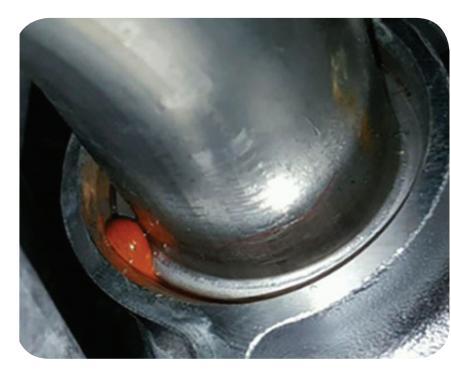
In addition, check the O-ring seal on the EGR coolant feed pipe for a coolant leak. The O-ring may be pinched or rolled. It may be necessary to remove the front accessory drive bracket and alternator.

Check the O-ring seal on the EGR coolant feed pipe.

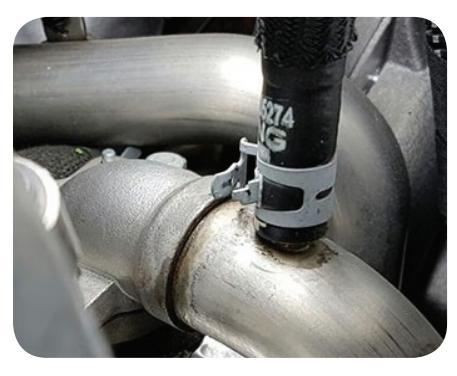
Check the welded flange on the EGR coolant feed pipe.

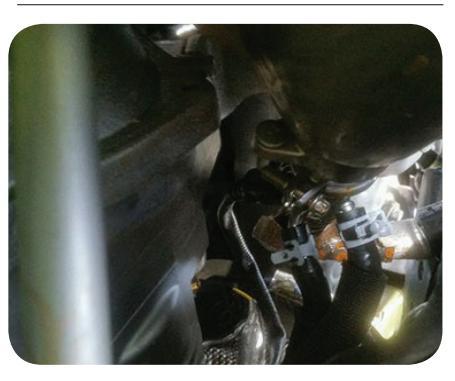
Coolant also may leak from the coolant hoses at the Emission Reduction Fluid Injector (DEF injector).

Check the coolant hoses at the DEF injector.
