New 9T50 9-Speed Automatic Transmission

Missing Connector Seals

Fuel Line Pulsation Sound

Supercharger Idler Pulley Sounds

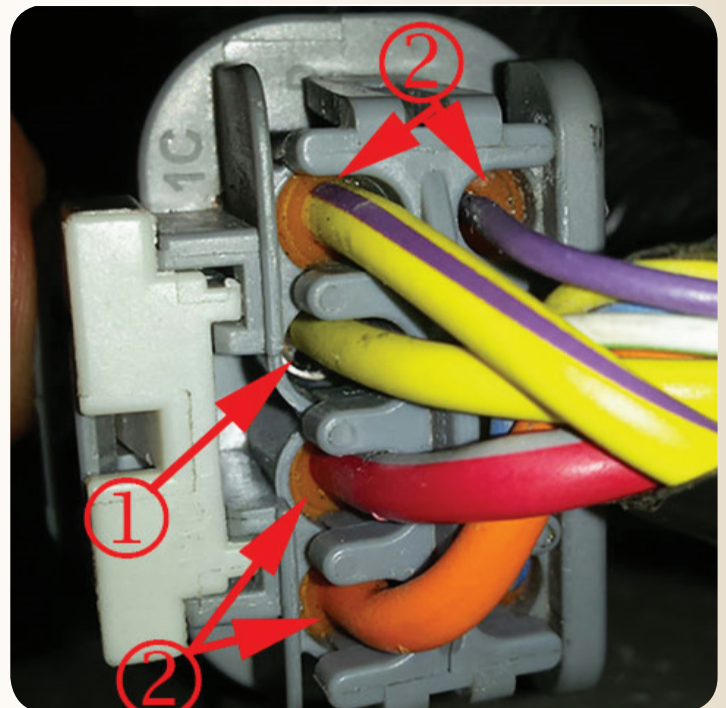
Some 2015-2017 Silverado, Tahoe, Suburban, Colorado, Sierra, Yukon, Canyon, and Escalade models equipped with 4WD (RPOs NQF, NQH, NQ6, NPO, NG7) may have an intermittent Service 4 Wheel Drive message displayed on the Driver Information Center (DIC). There may be several wiring terminal issues caused by missing seals.

When diagnosing intermittent Transfer Case Control Module DTCs related to signal or circuit integrity, including DTCs C0321, C0392, C0396, C0398, C0306, C039E, and C038D, inspect the associated connectors to ensure that the seals are properly installed in the connectors. Missing seals allow moisture inside the connector and will cause repeat conditions or other intermittent conditions.

1. Missing seal
2. Proper seals

Some connectors are serviced as a connector, while some have terminated leads and others are available as a harness only. If there is corrosion in the connector and it has to be replaced, the mating side of the connector should also be replaced regardless if it is another connector or an electrical component. For example, if the connector at the transfer case actuator is replaced due to a missing seal and corrosion is present, the transfer case actuator should also be replaced.

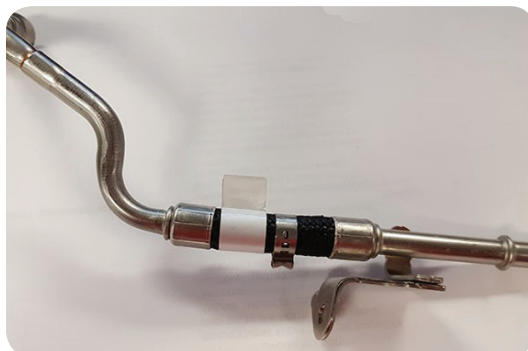
A rattle or ticking sound may be heard coming from the back of the left valve cover on some 2014-2017 Corvette, Silverado, Sierra; 2015-2017 Tahoe, Suburban, Yukon, Escalade; 2016-2017 CTS-V, and Camaro models equipped with the following engines: 6.2L (RPO LT4, LT1, L86); 5.3L (RPO L83); or 4.3L (RPO LV3) It may sound similar to a lifter ticking and may be louder inside the vehicle.

Listen to the fuel line connection at the left side of the engine. The fuel feed line between the high pressure fuel pump and chassis fuel line may be allowing high pressure pulsation back to the low side of the fuel system. If the sound is heard, the line will need to be replaced. On some trucks and SUVs, a vibration also may be observed in the fuel line at the fuel tank.

Fuel line for Corvette, truck and SUV models.

There are two different types of fuel lines that contain a check valve. The lines vary by model. Only one line should be used on Corvette, truck and SUV models. The line connects the chassis fuel line to the high pressure fuel pump.

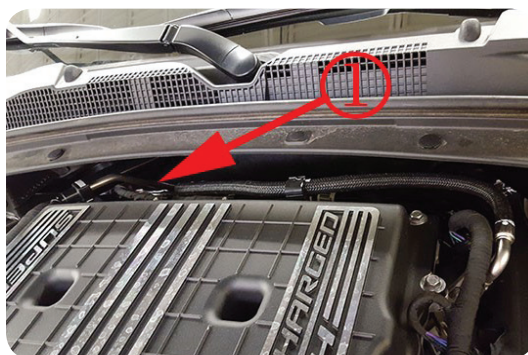
Line connecting the chassis fuel line to the high pressure fuel pump.

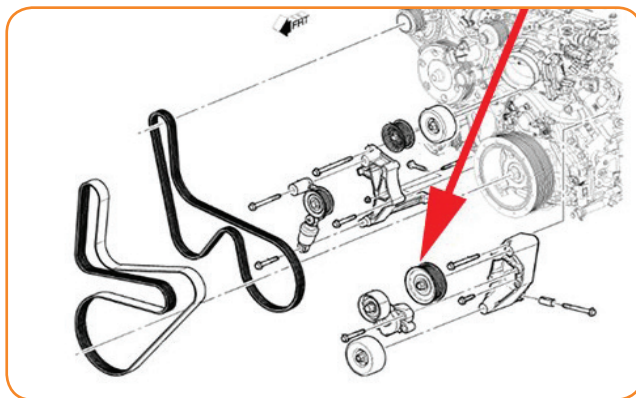
A scraping or moaning sound may be heard from the supercharger idler pulley on some 2017 CTS-V, Corvette; and 2017-2018 Camaro models equipped with the supercharged 6.2L V8 engine (RPO LT4). The sound will be most noticeable when the engine is idling.

If the pulley sound is found, replace the idler pulley assembly.
