Mid-June 2017, Volume 19, No. 12

Top Questions on New Models

Customer Care and Aftersales

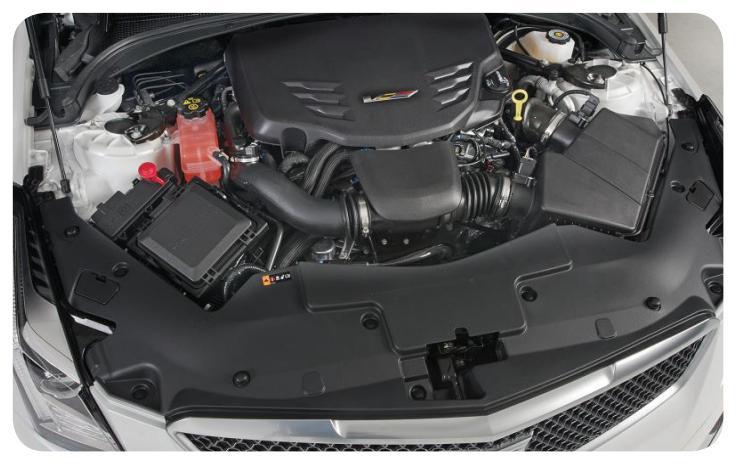
Open the hood to disable the remote start function.

When performing repairs in the engine compartment or under the vehicle, always fully open the hood, or open the hood to its secondary latch, so that the remote start function will be disabled. Failure to fully open the hood, or open it to its secondary latch, during service could result in personal injury or damage to the vehicle if an inadvertent remote start occurs.

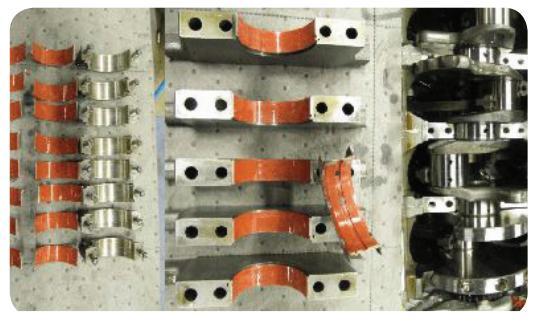
If end play is found to be out of specification, remove the engine and check for possible crankshaft thrust bearing or crankshaft wear. The crankshaft and bearings should not show signs of excessive wear. Inspect the thrust bearing for wear on one side and the crankshaft on the mating surface.

If wear is evident — the three vertical channels may be worn off — replace the connecting rods, main bearings, thrust bearing and crankshaft.

Good crankshaft and bearings that are not worn.
